BRIDGE NO. 00032

73070 - STAMFORD
I-95 & I-95 RAMPS
over
MNRR & LOCAL ROADS

Fracture Critical and Routine Inspection

10/15/2018

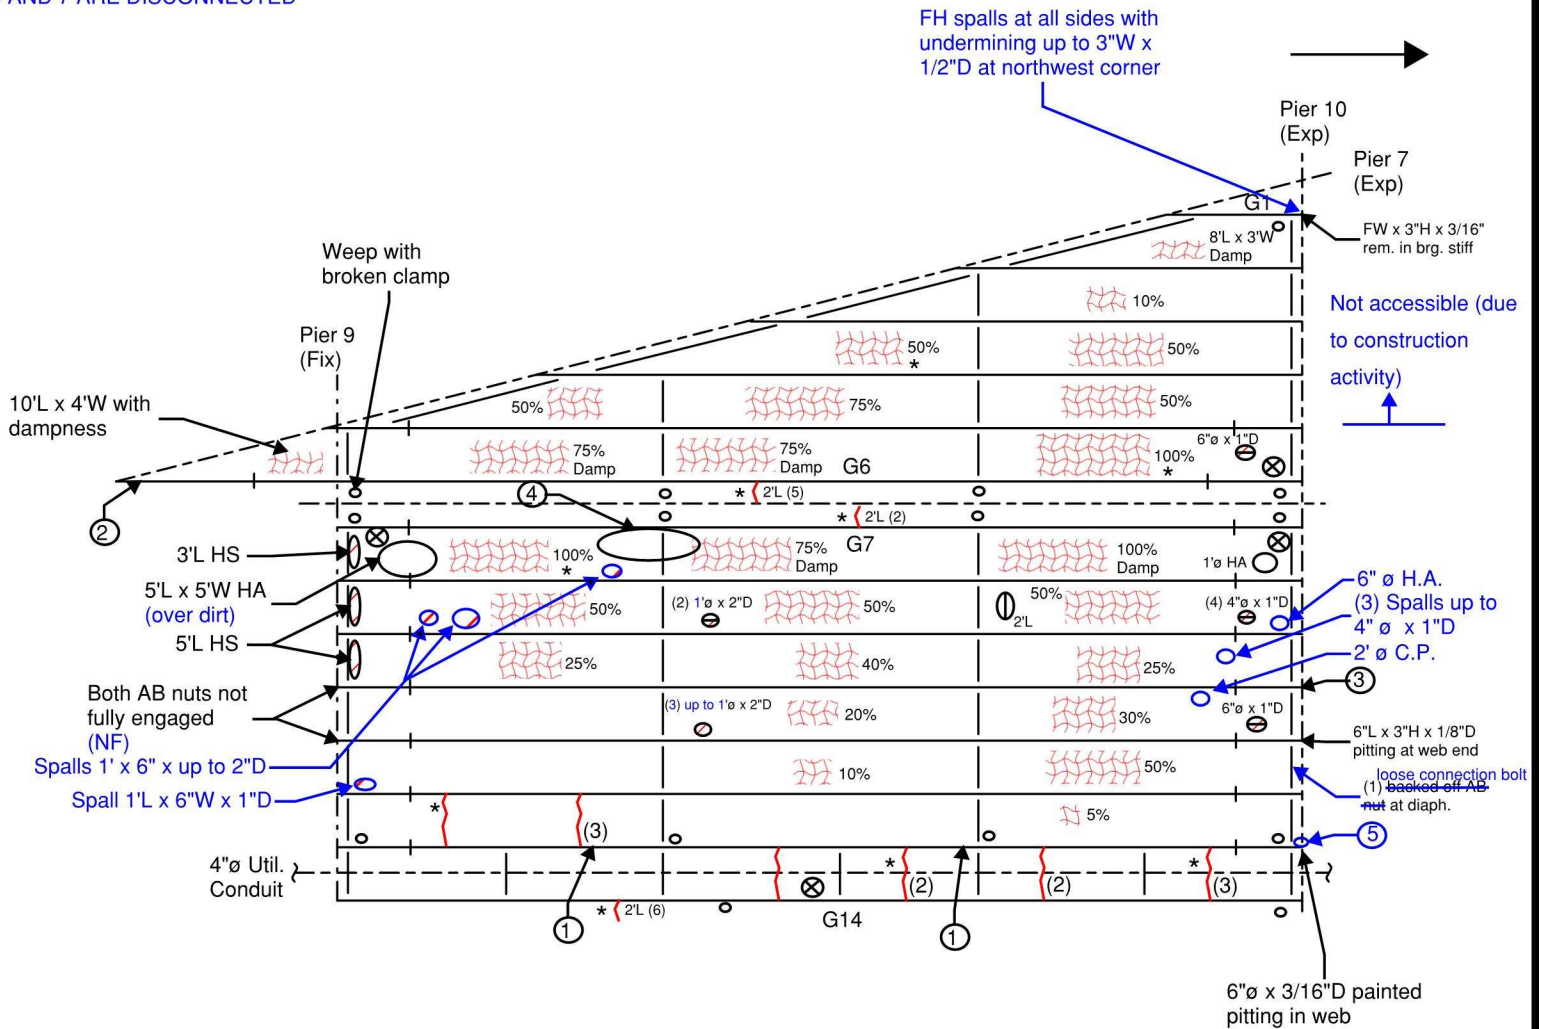
Underside of Deck and Framing - Span 10

PIER 9 AND 7 ARE DISCONNECTED

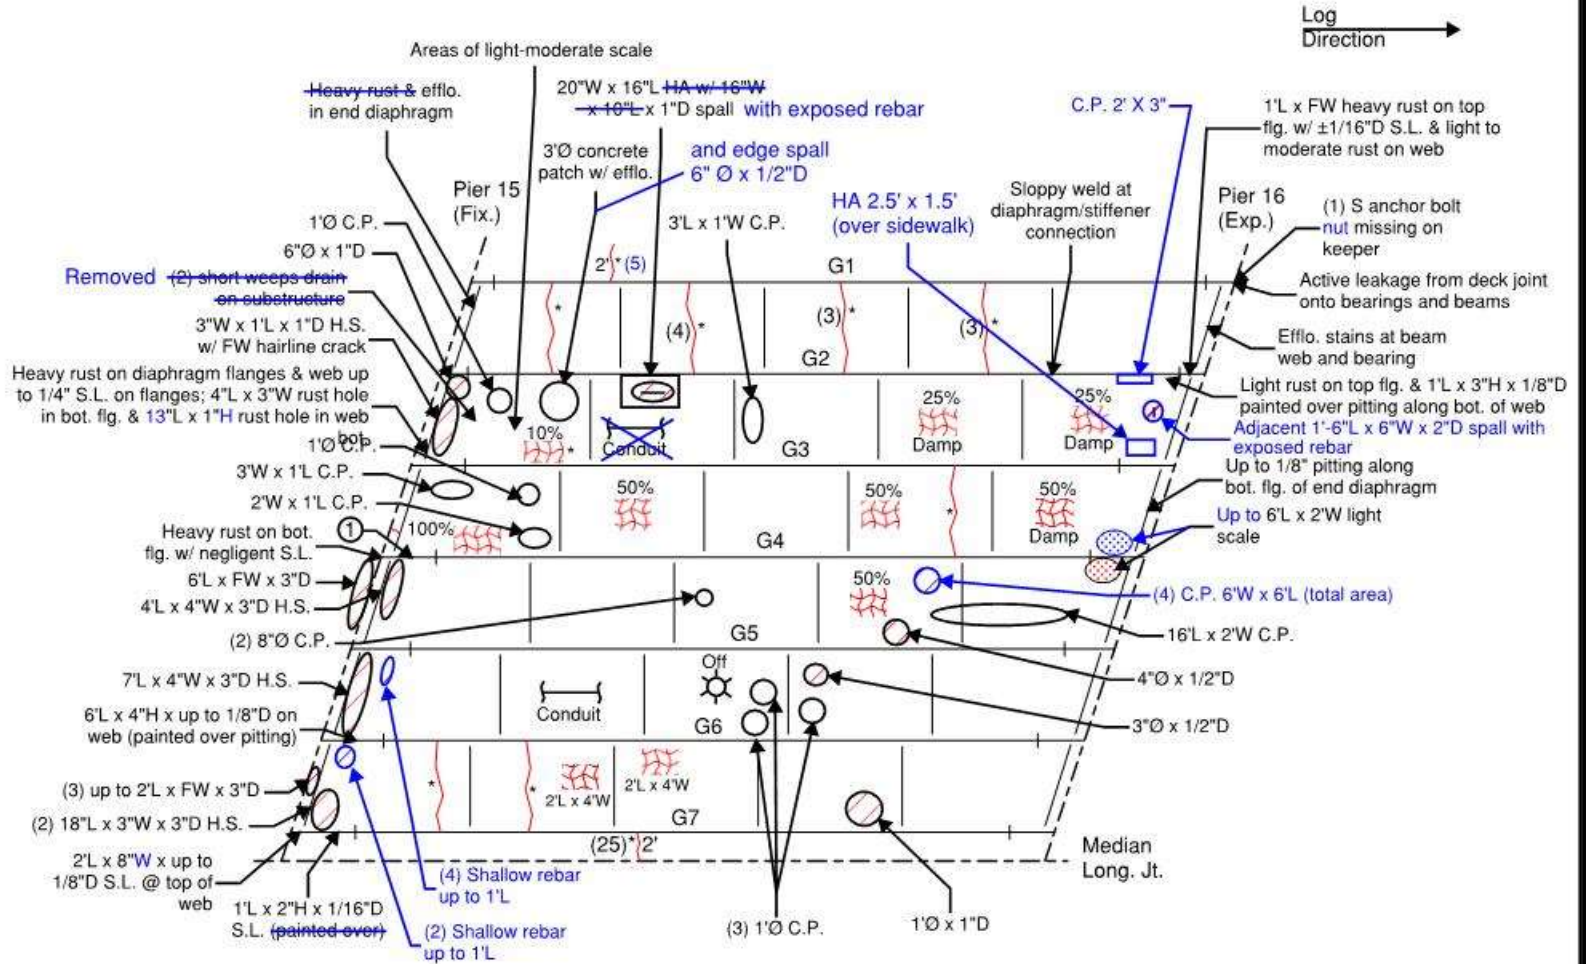
Deterioration Notes:

① - G4, west side web with 3'L x 4"H x up to 1/8"D painted over pitting

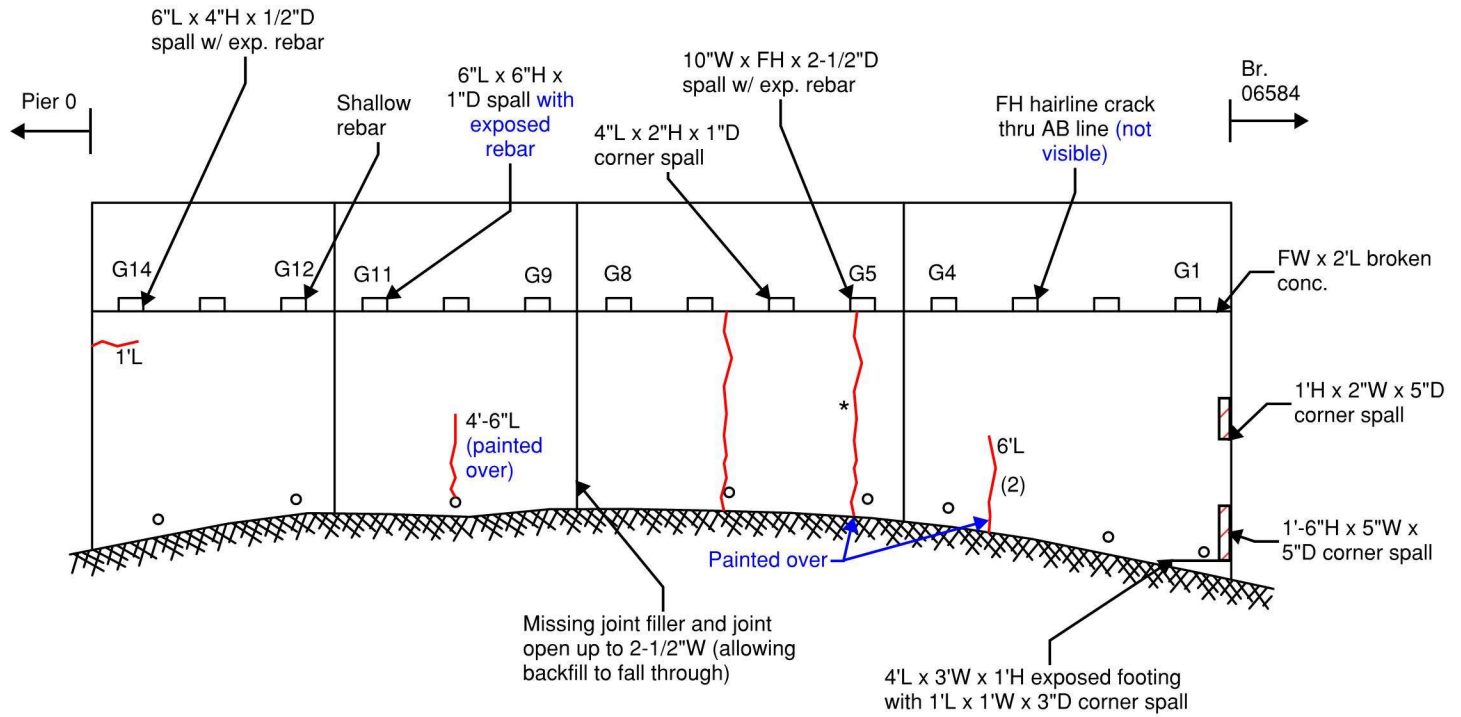
Abutment 1

- ① - Pedestal with 10"L x 6"H corner spall on front face and east face up to 6"D.
- ② - 7"L x 7"H x 1"D spall on pedestal front face and west face with 1.5'L x 3"H 3"D spall.
- ③ - Pedestal corner spall with exposed rebar 15"L x 5"H x 2"D on front and east face.

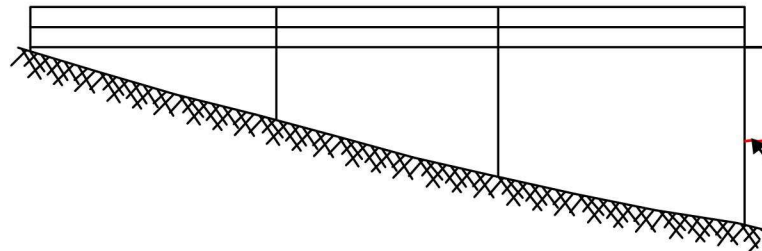
Wingwall 1B

(3) FL crks with efflo.

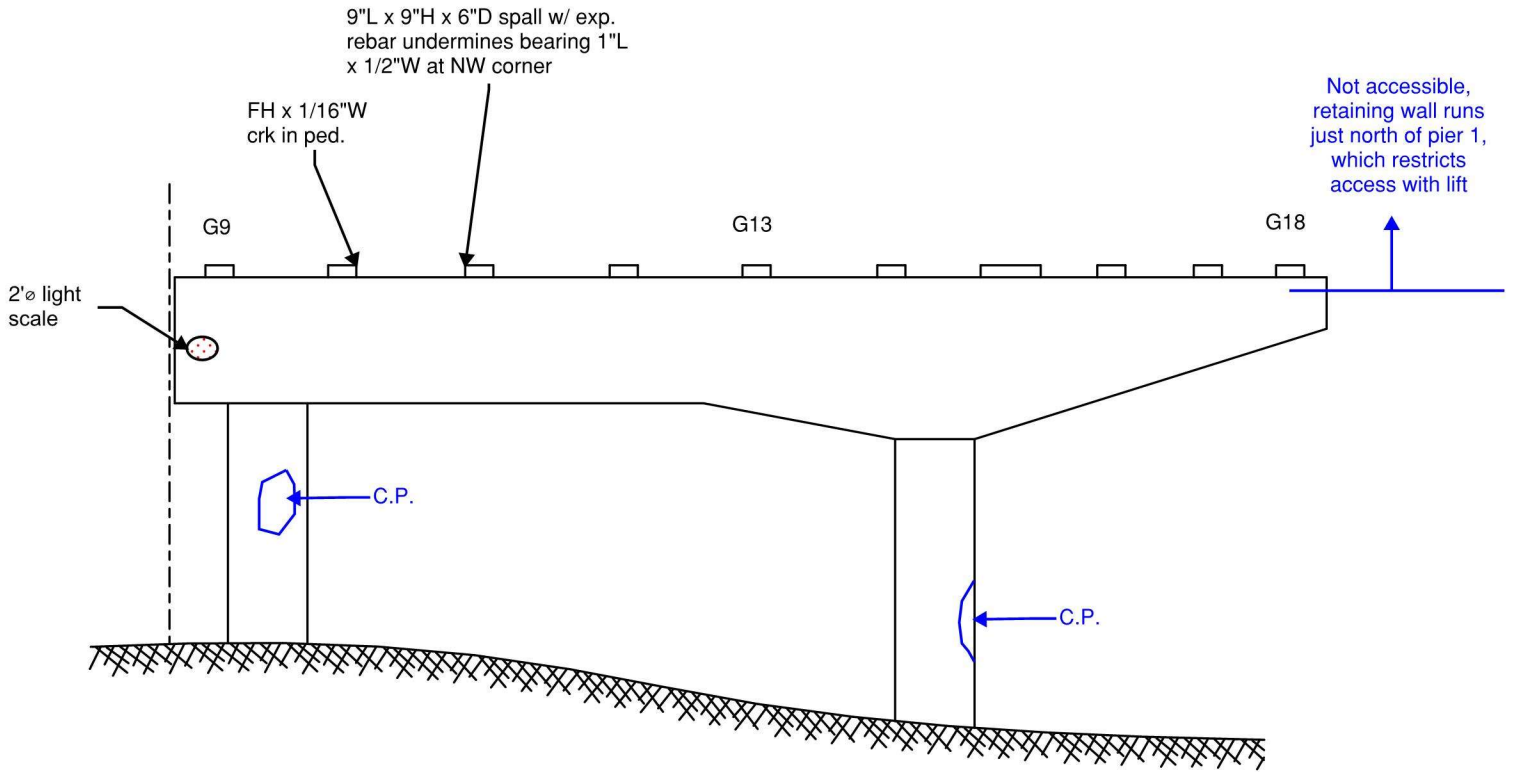
**Pier 1 - South Elevation
(East Half)**

- See "Pier 0 - South Elevation" general notes.
- There are concrete patches on 75% of the cap.
- ~~Scaffolding set up along pier 1 south elevation FL (repair work being done). N.F.~~

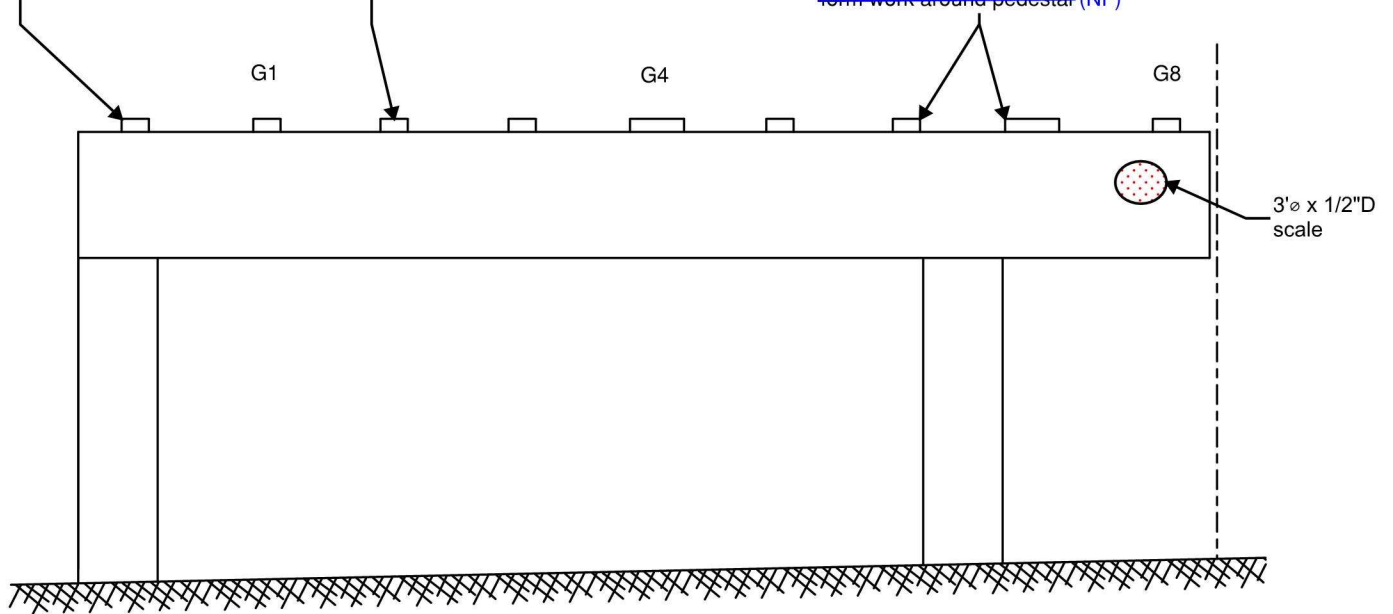
Pier 2 - South Elevation
(West Half)

Spalls on both sides of
ped. up to 1'L x 6"H x 1/2"D

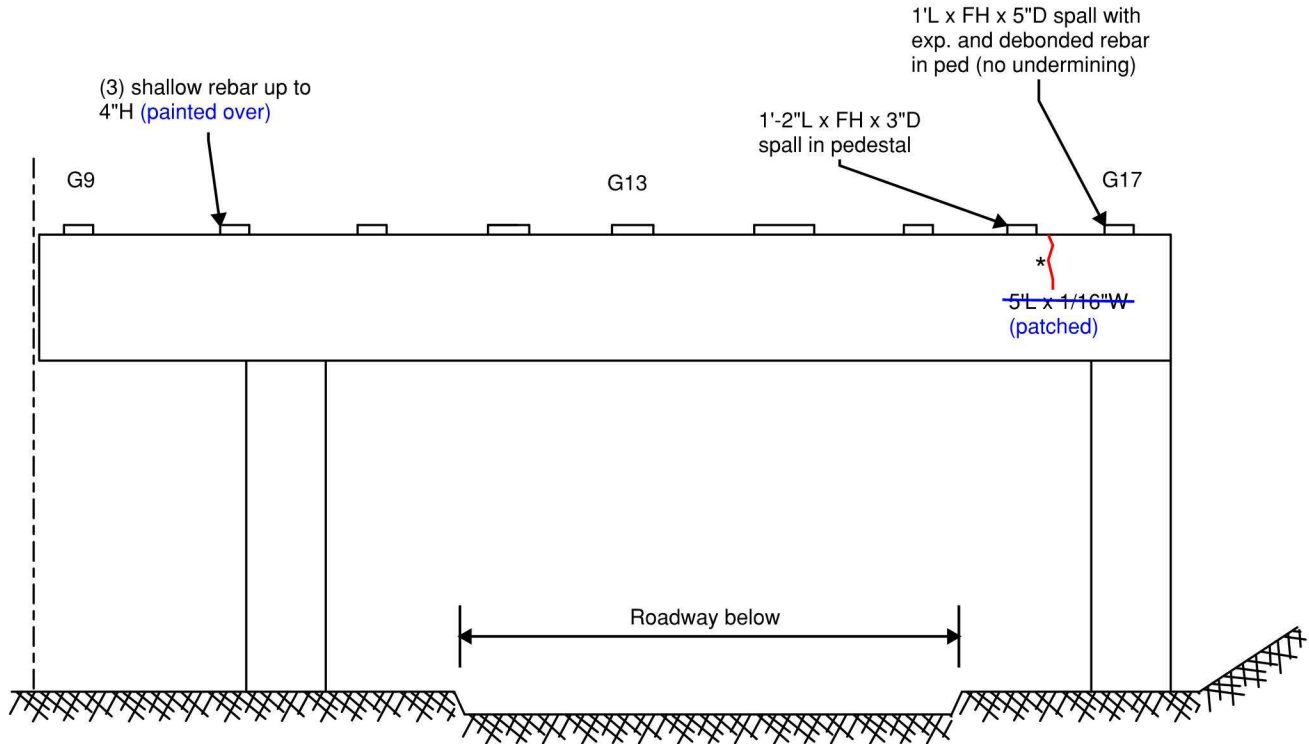
**Pier 2 - South Elevation
(East Half)**

General Notes:
 - See "Pier 0 - South Elevation" general notes.
 - There are concrete patches on 25LF of the cap.

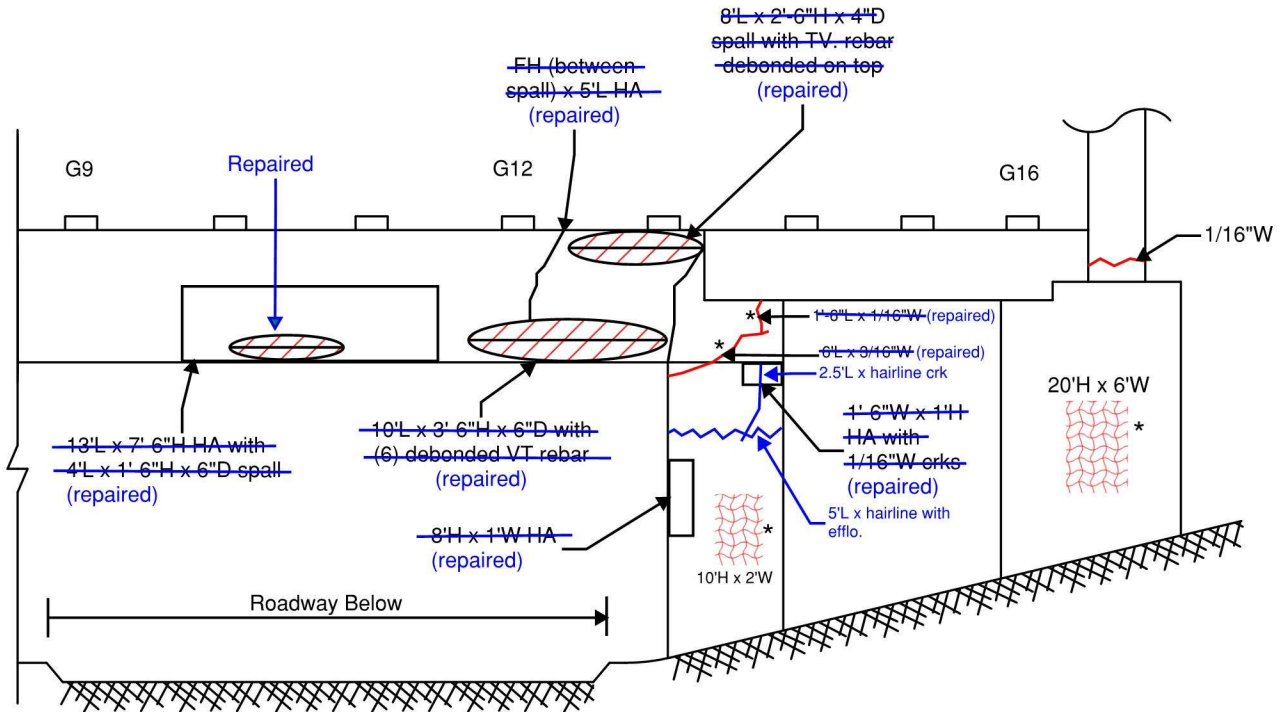
- See "Pier 0 - South Elevation" general notes.
- There is light debris on the pier cap.

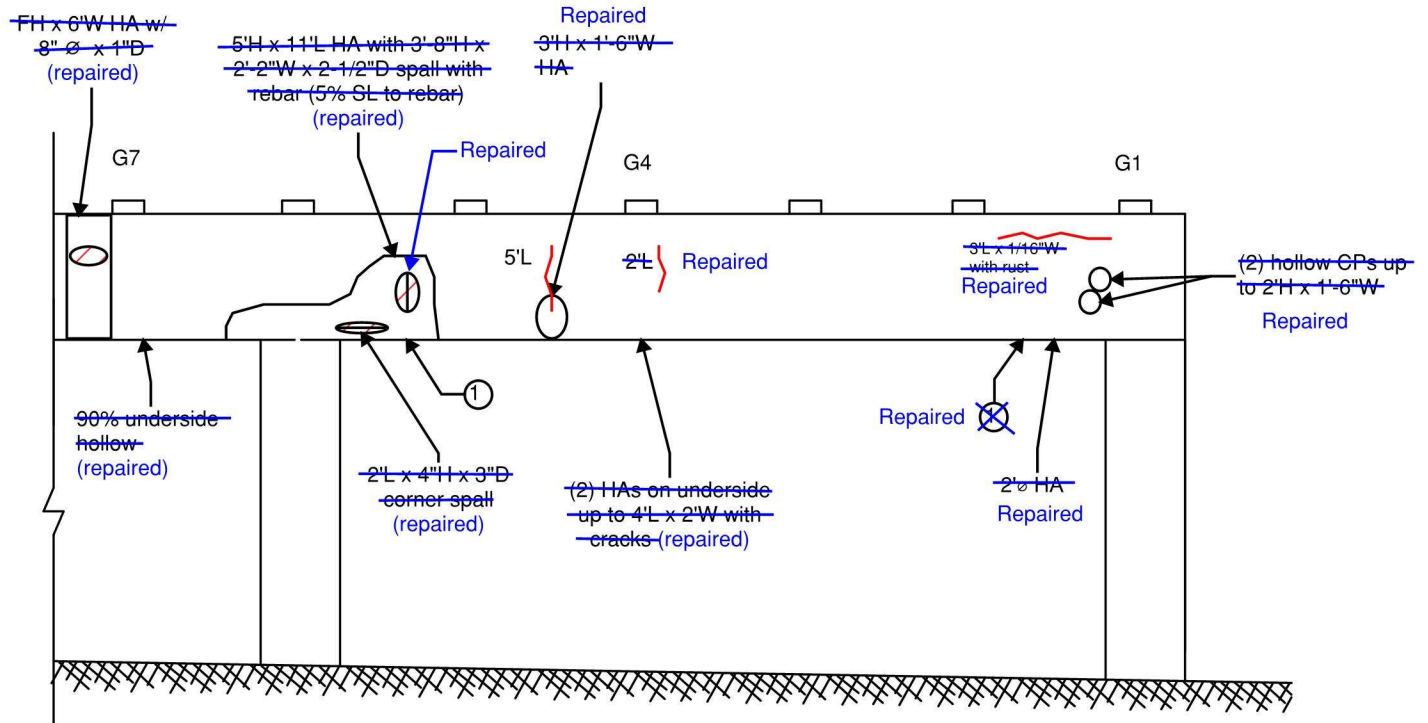
**Pier 3 - North Elevation
(West Half)**

General Notes:
 - See "Pier 0 - South Elevation" general notes.
 - There is heavy debris on the pier cap.

① - 3'-6" long x 1/16" wide longitudinal crack on underside of cap (repaired)

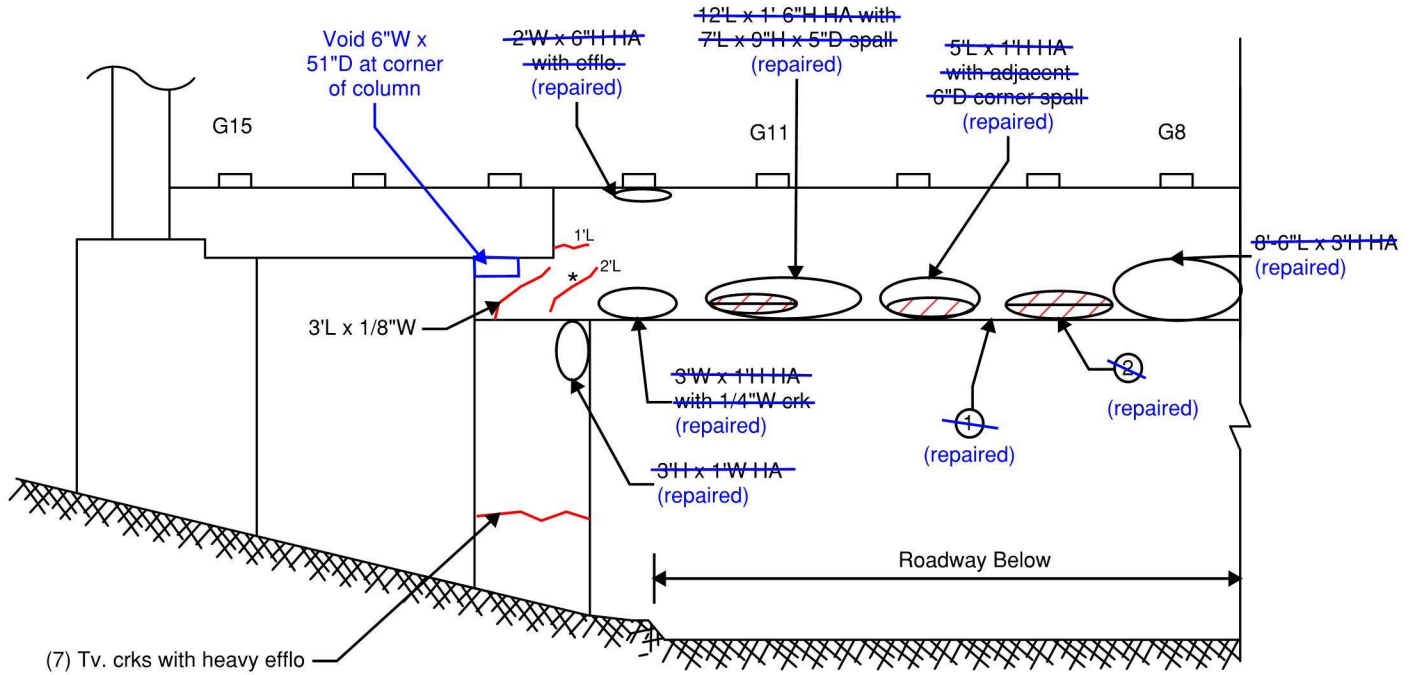
**Pier 3 - North Elevation
(East Half)**

- ⊕ - Underside of cap with HAs up to FW x 11\"L for 50% of underside. There are also (7) spalls up to 3\"-6\"W x 3\"-x 3\"-1/2\"D with exposed rebar. (repaired)
- ⊙ - 8\"L x 4\"H x 6\"D spall with exposed rebar and adjacent map cracking and 1\" HA ⊕ (repaired)

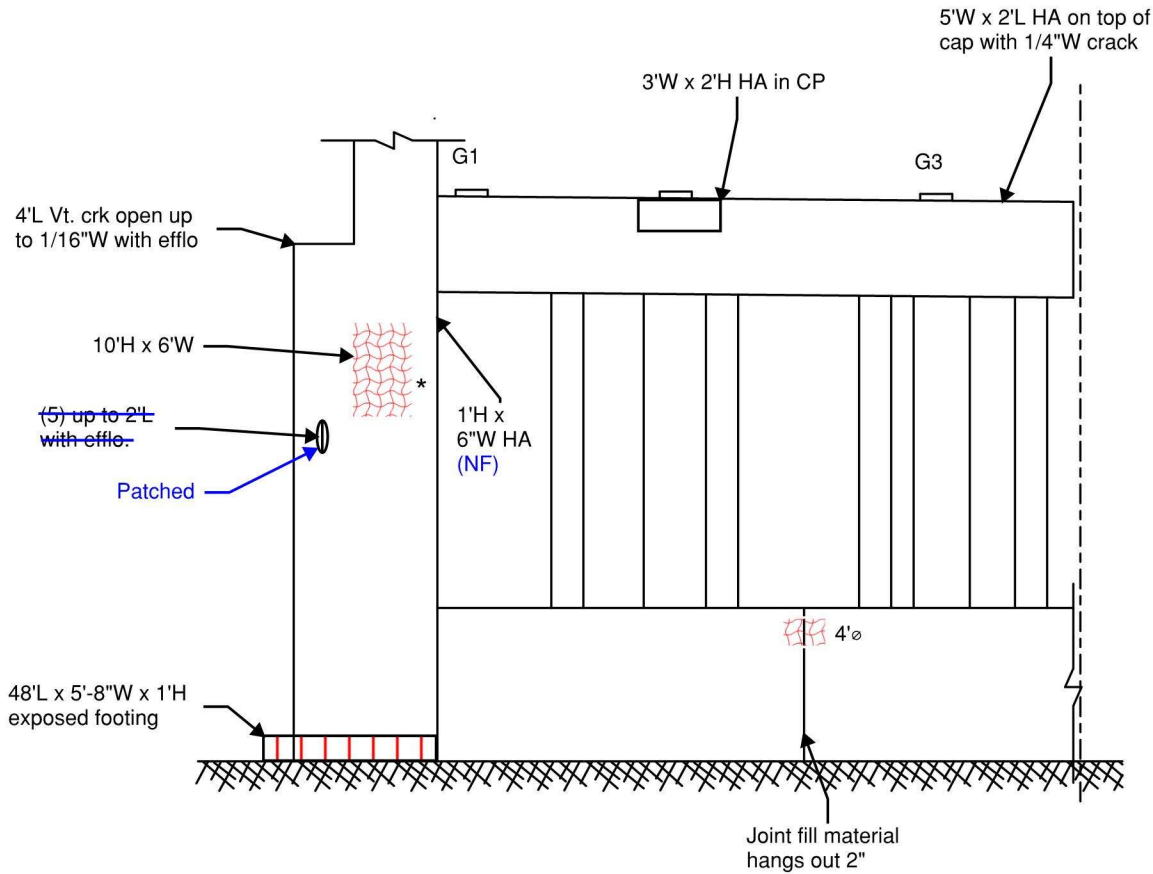
**Pier 6 - South Elevation
(West Quarter)**

- See "Pier 0 - South Elevation" general notes.
- Random horizontal hairline cracks and map cracking on the pier wall.
- North elevation of pier 6 was not inspected this inspection, due to inability to get track access. ~~There will be a special inspection for this span will be completed in 2017.~~

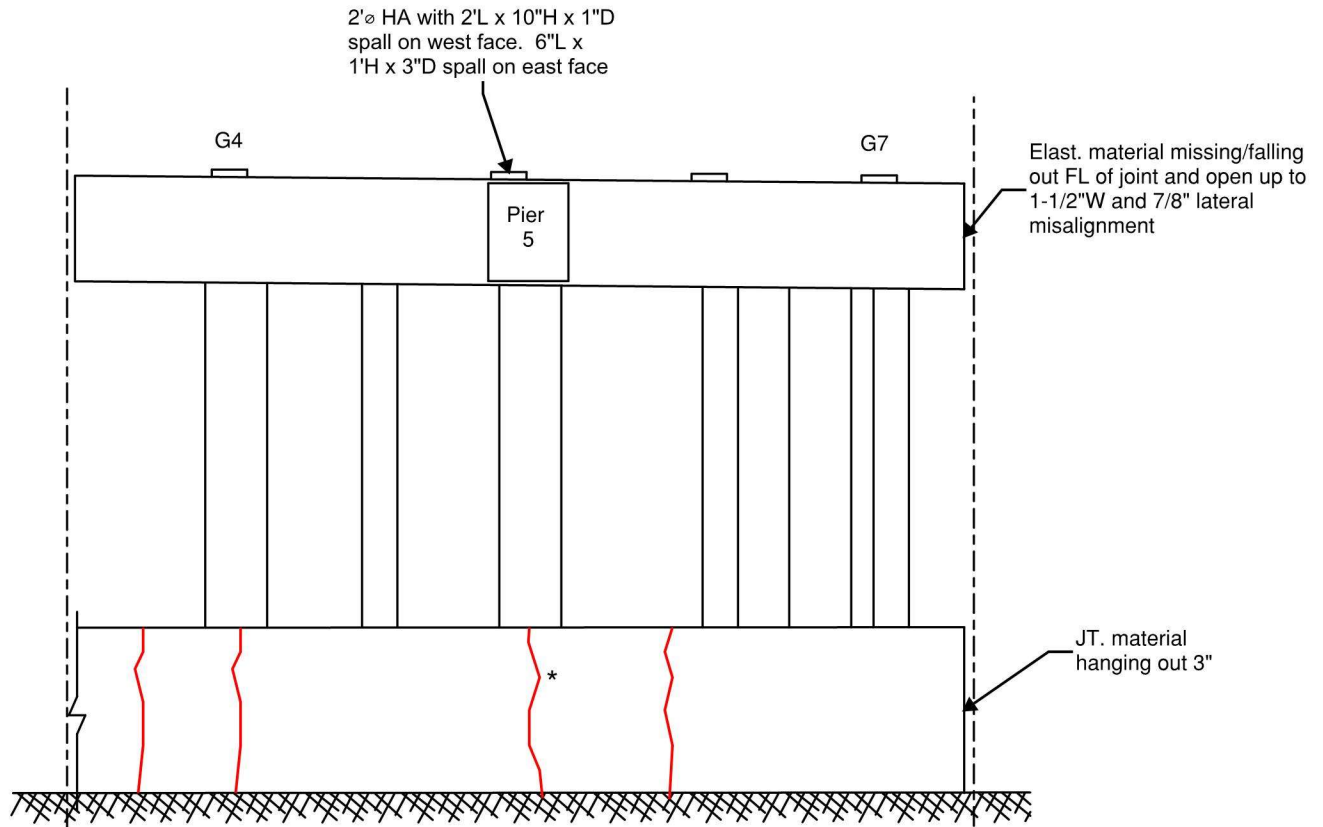
**Pier 6 - South Elevation
(West Center Quarter)**

- See "Pier 0 - South Elevation" general notes.
- Random horizontal hairline cracks and map cracking on the pier wall.
- North elevation of pier 6 was not inspected this inspection, due to inability to get track access. There will be a special inspection for this span will be completed in 2017.

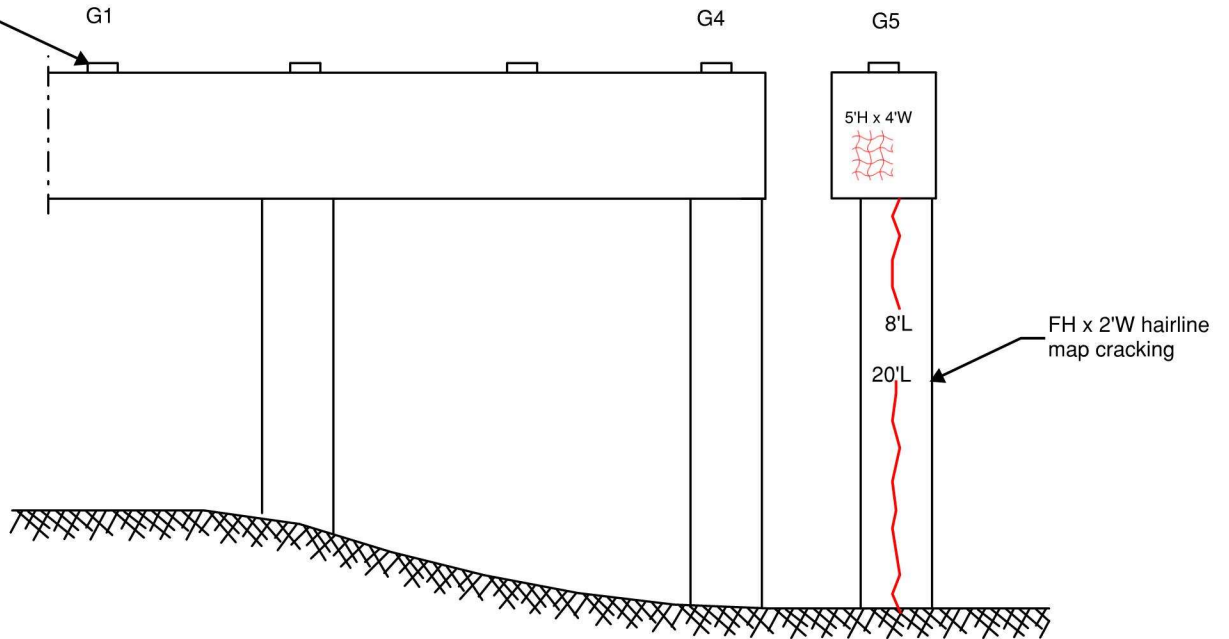
Pier 8 - South Elevation

FH x 1/16"W crk
with efflo on ped.
(NF)

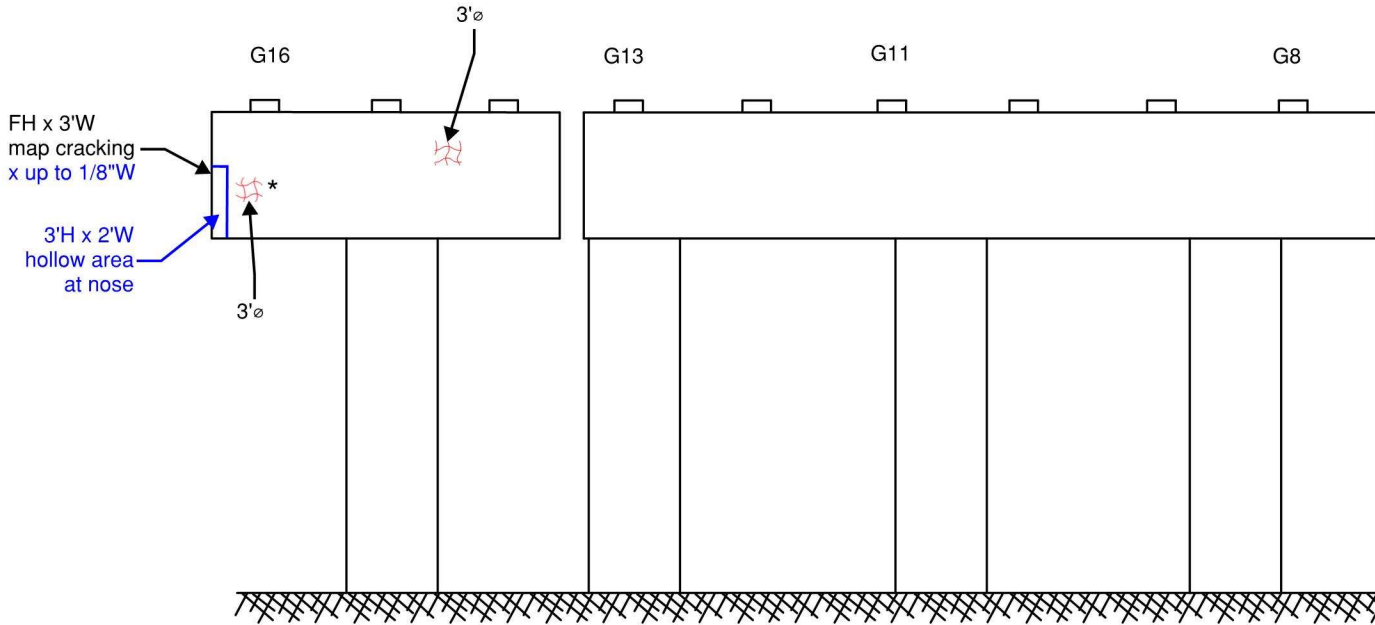
**Pier 13 - North Elevation
(East Half)**

- See "Pier 0 - South Elevation" general notes.
- There is a total of 24 LF of concrete patches on the pier caps.
- Concrete pedestals have full height hairline cracks and are painted over.

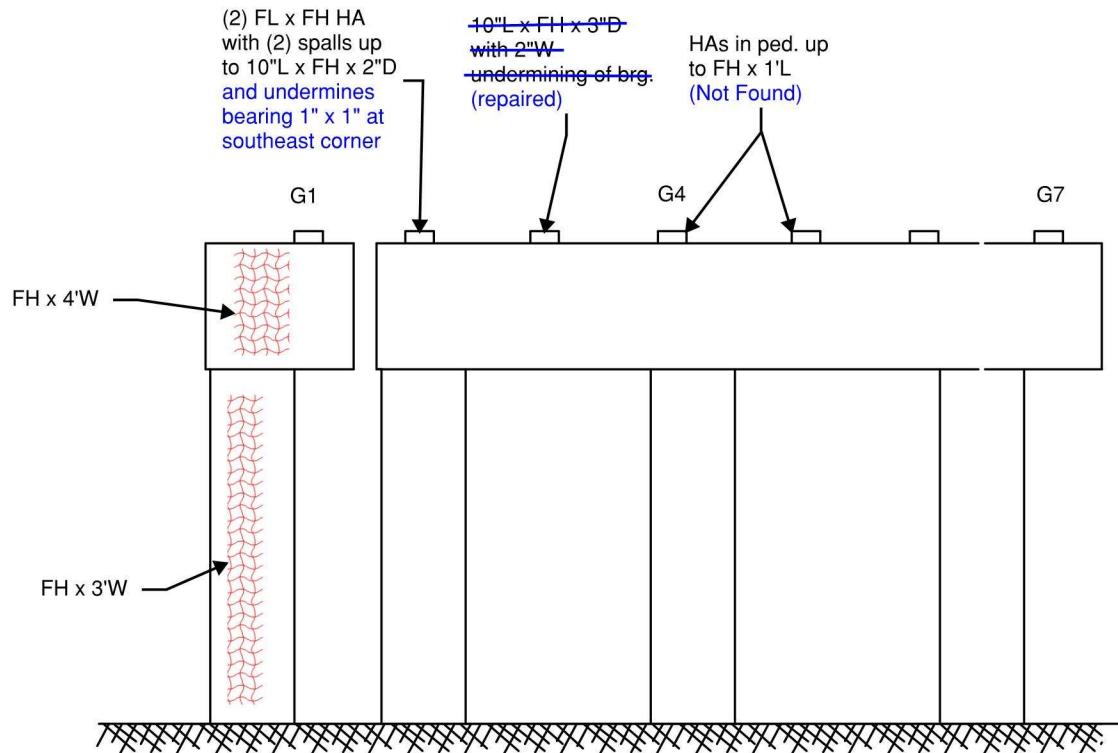
**Pier 14 - South Elevation
(West Half)**

- See "Pier 0 - South Elevation" general notes.
- There is a total of 24 LF of concrete patches on the pier caps.
- Active leakage at random locations.

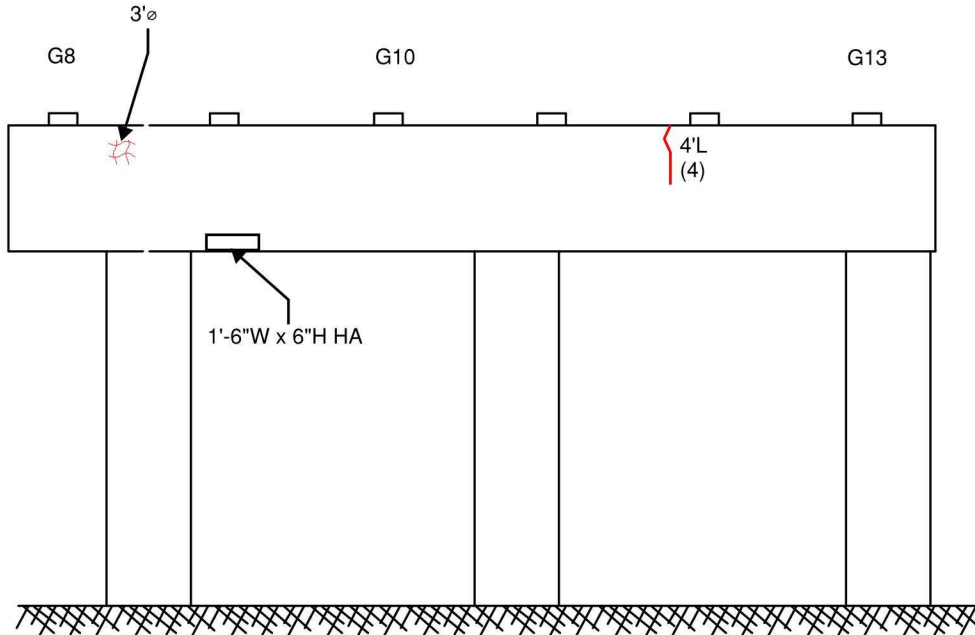
Pier 14 - South Elevation
(East Half)

- See "Pier 0 - South Elevation" general notes.
- There is a total of 20 LF of concrete patches on the pier caps.
- Concrete pedestals have vertical hairline cracks up to full height and are painted over.

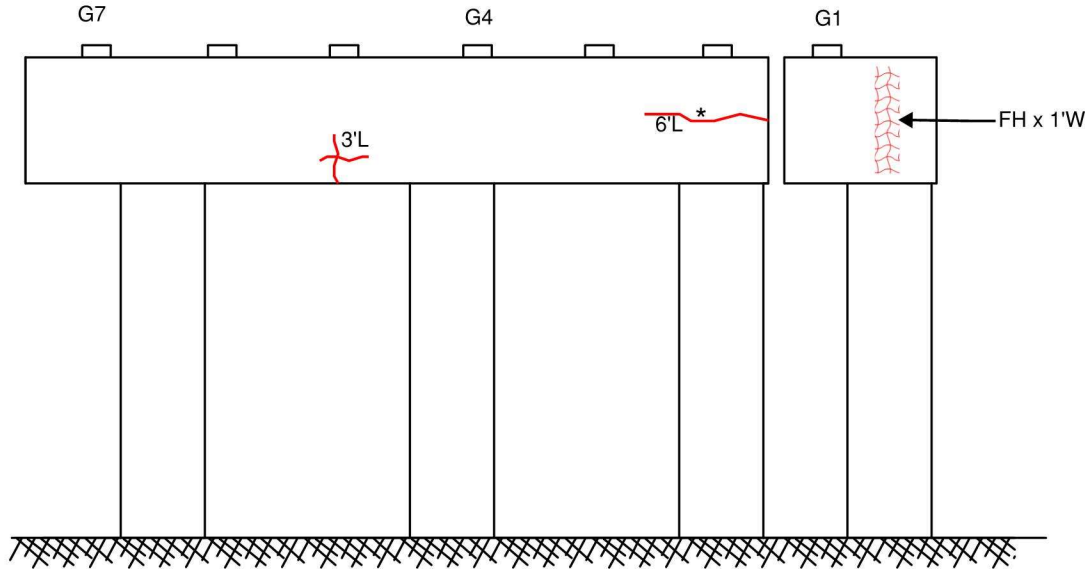
**Pier 14 - North Elevation
(West Half)**

- See "Pier 0 - South Elevation" general notes.
- There is a total of 12 LF of concrete patches on the pier caps.
- Concrete pedestals have vertical hairline cracks up to full height and are painted over.

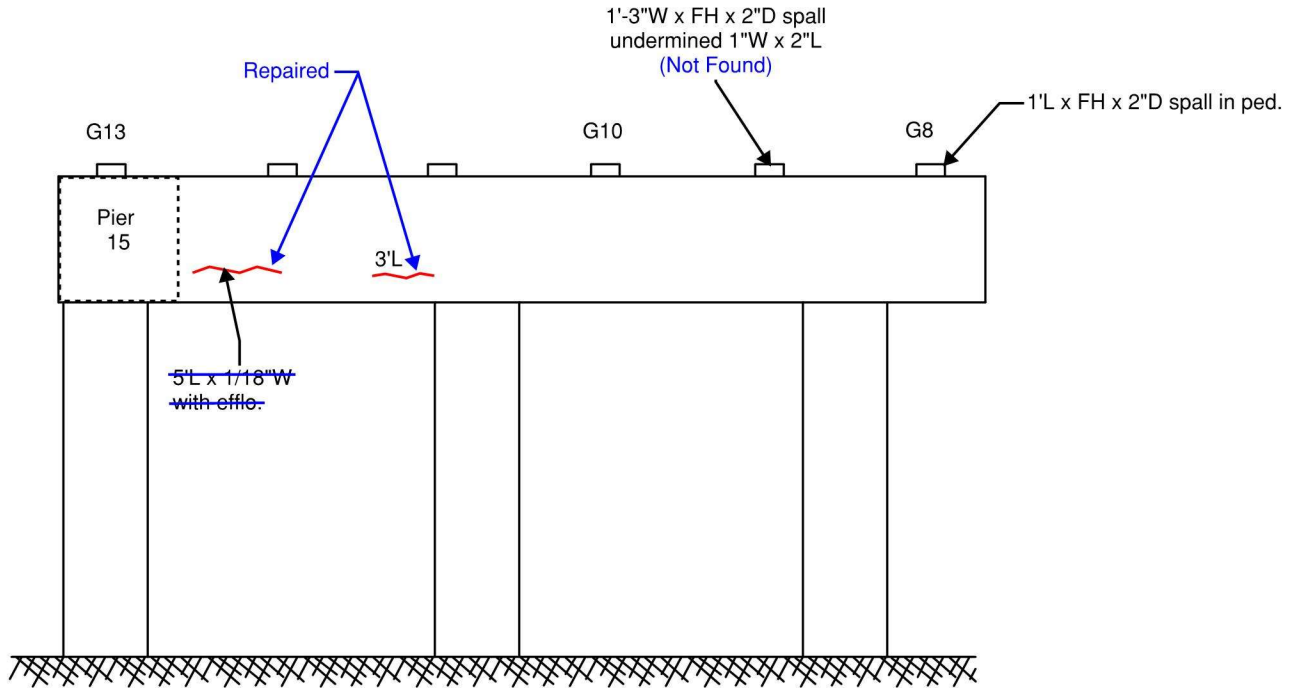
**Pier 14 - North Elevation
(East Half)**

- See "Pier 0 - South Elevation" general notes.
- There is a total of 20 LF of concrete patches on the pier caps.
- Concrete pedestals have vertical hairline cracks up to full height **and were painted over.**
- There is active leakage at random locations.

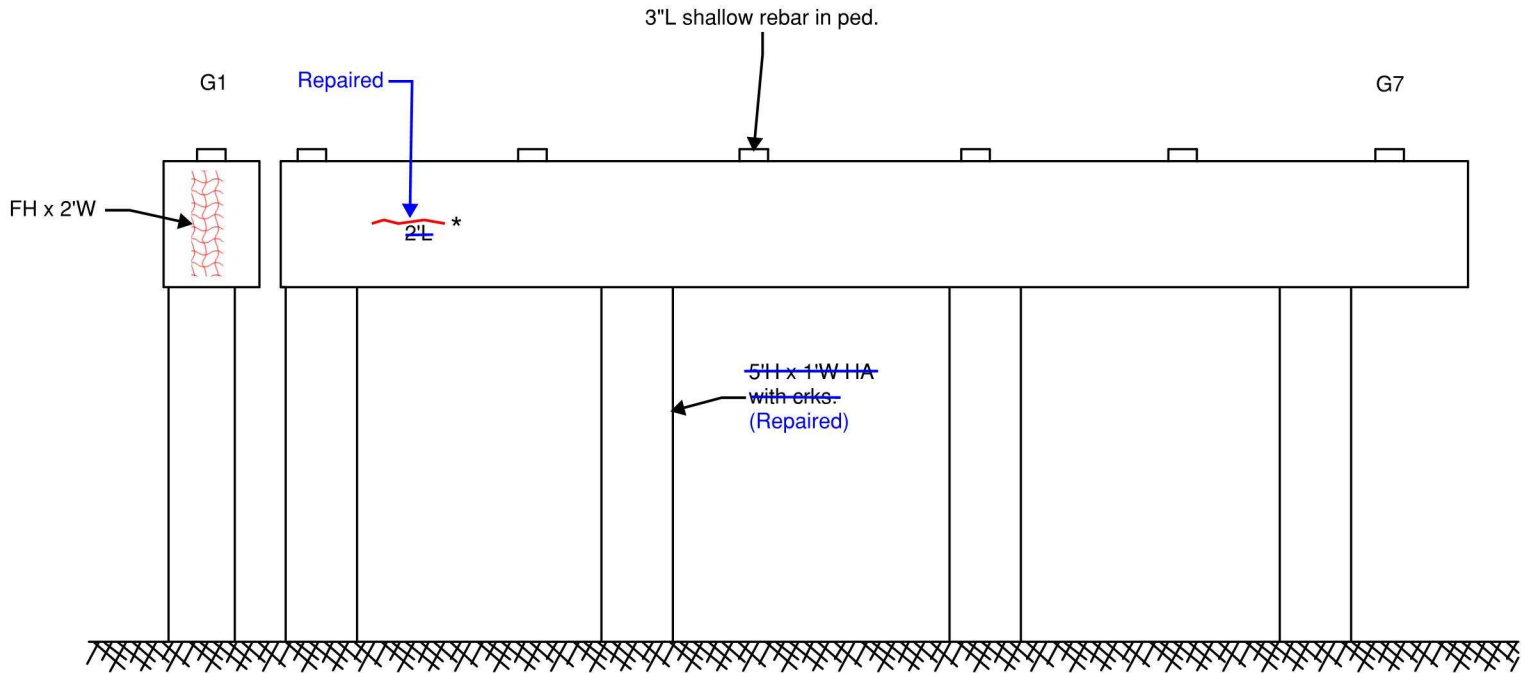
**Pier 15 - South Elevation
(West Half)**

- See "Pier 0 - South Elevation" general notes.
- There is a total of 22 LF of concrete patches on the pier caps.
- Concrete pedestals have vertical hairline cracks up to full height and popout (painted over) spalls up to 5" x 2" deep (no undermining)
- There is active leakage at random locations.
- ~~The north elevation of pier 15 was not inspected this inspection, due to construction on Myrtle Avenue. This will be inspected during a special inspection in 2017.~~

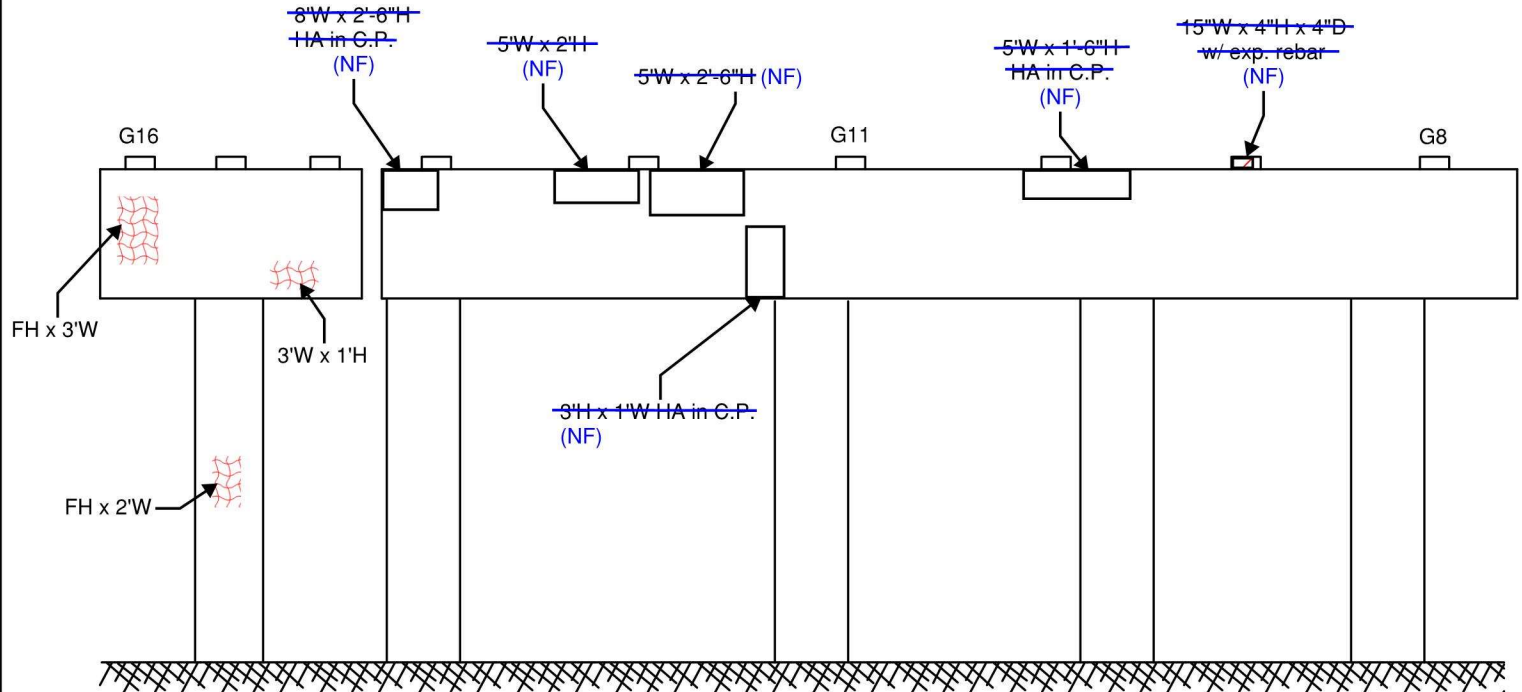
- See Pier 15-North Elevation (West Half) general notes.
- Active leakage noted at random locations.

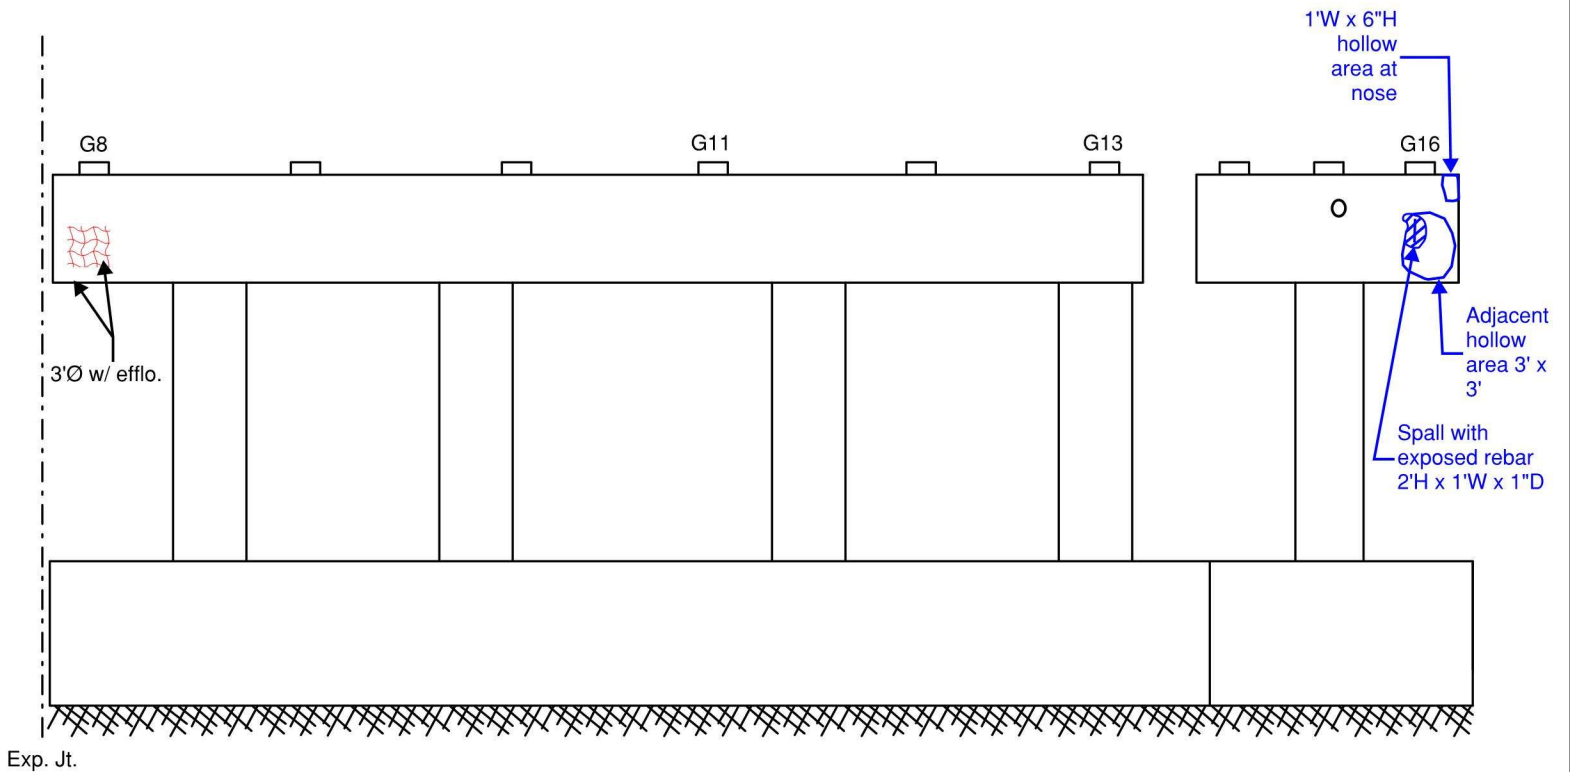
- 30LF concrete patches on cap and all columns except columns 1 and 10
- See Pier 15-North Elevation (West Half) general notes

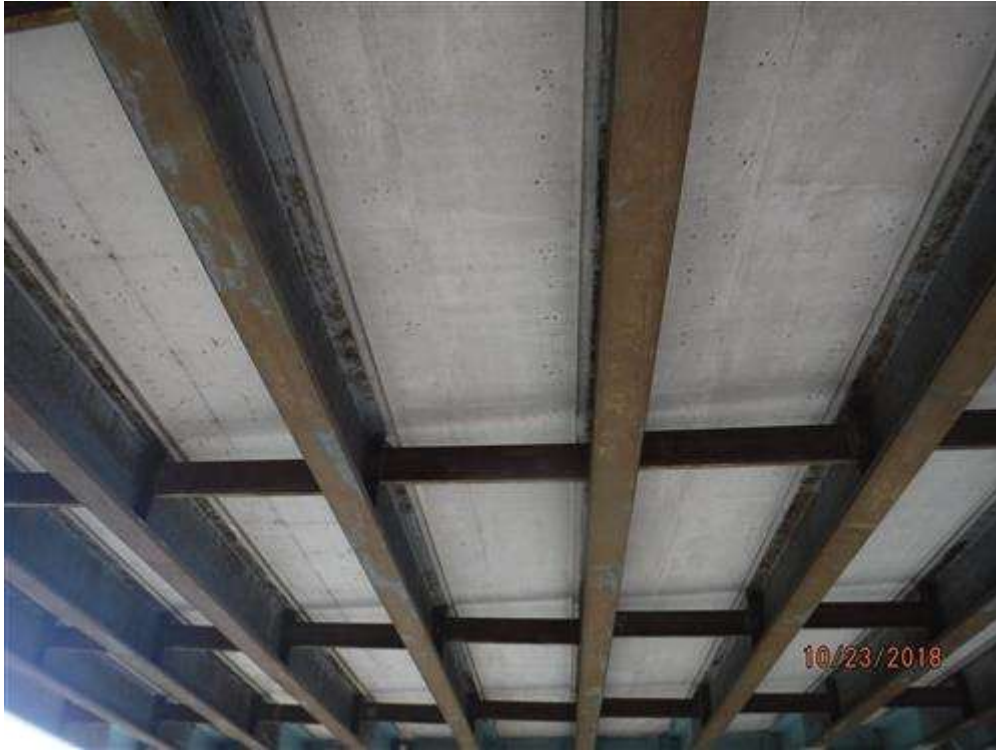
Photo Number: 11

Underside of deck and superstructure in span 2. Note the light rust on the girders.

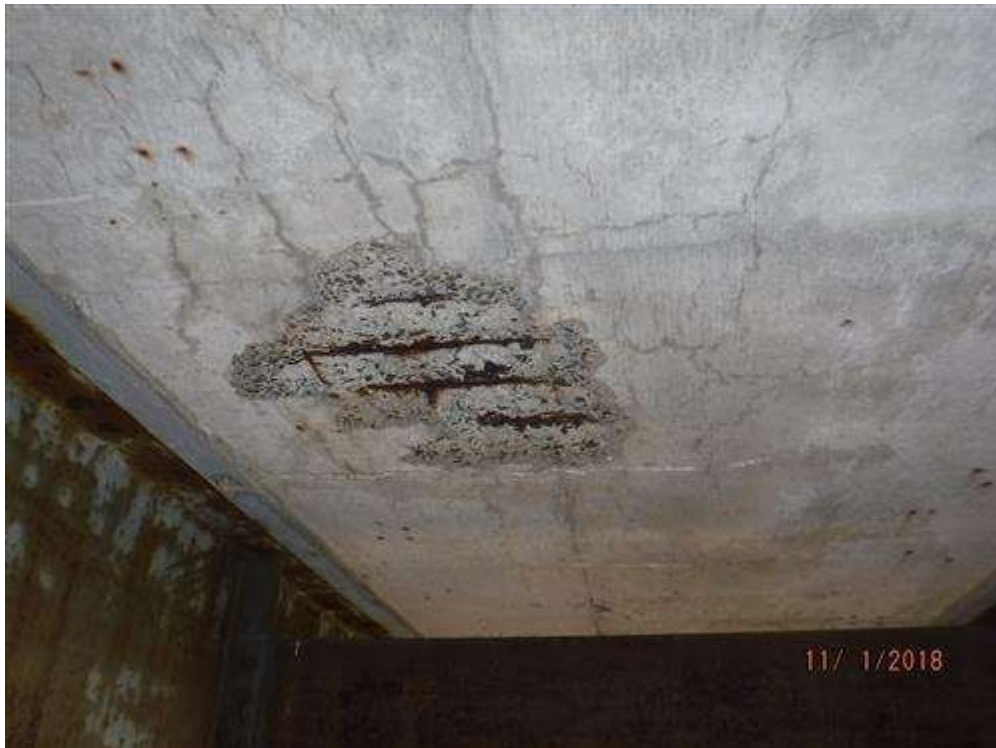
Photo Number: 14

Underside of deck in span 11, bay 6, panel 2 exhibits a hollow area and a spall with exposed and rusted rebar. Note the section loss to the rebar.
