BRIDGE NO. 00032

73070 - STAMFORD
I-95 & I-95 RAMPS
over
MNRR & LOCAL ROADS

Fracture Critical and Routine Inspection

10/15/2018

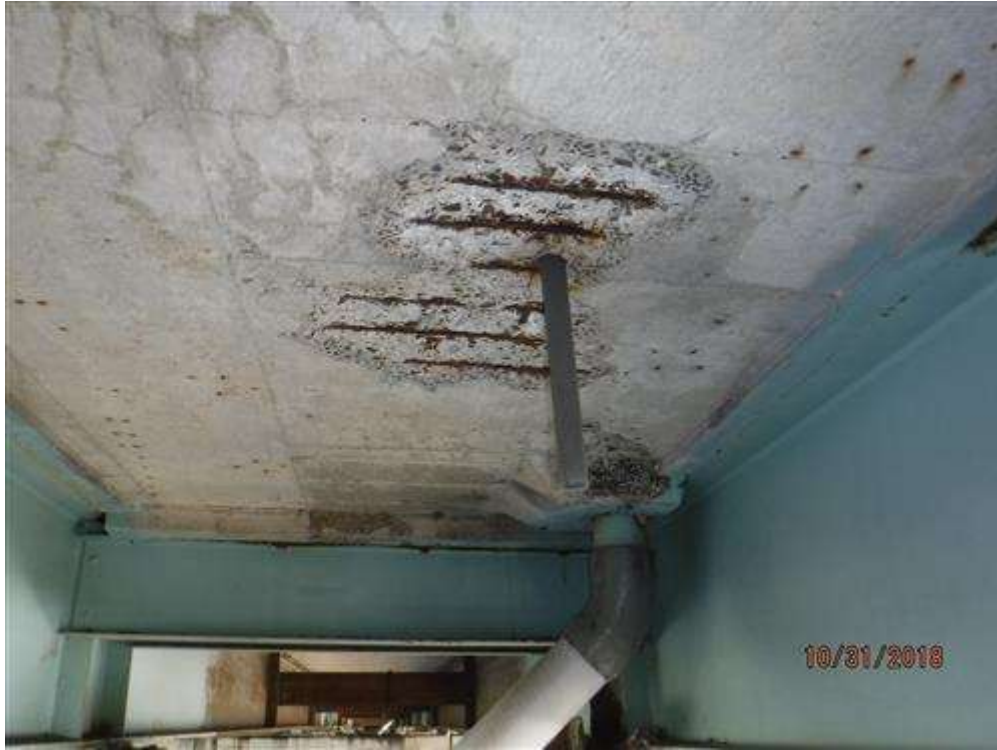
Photo Number: 15

Underside of deck in span 12, bay 6 near pier 12 exhibits a spall with exposed rebar. Note the short weep pipe with the potential to drain onto bridge.

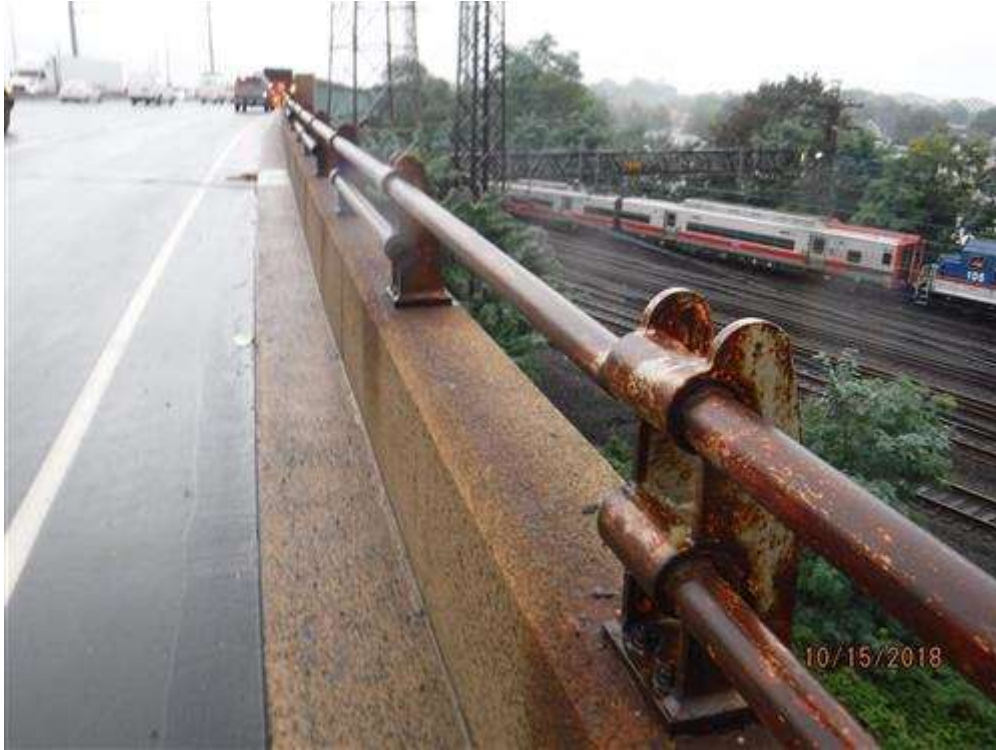
Photo Number: 17

East parapet in span 1 with missing bottom rails.

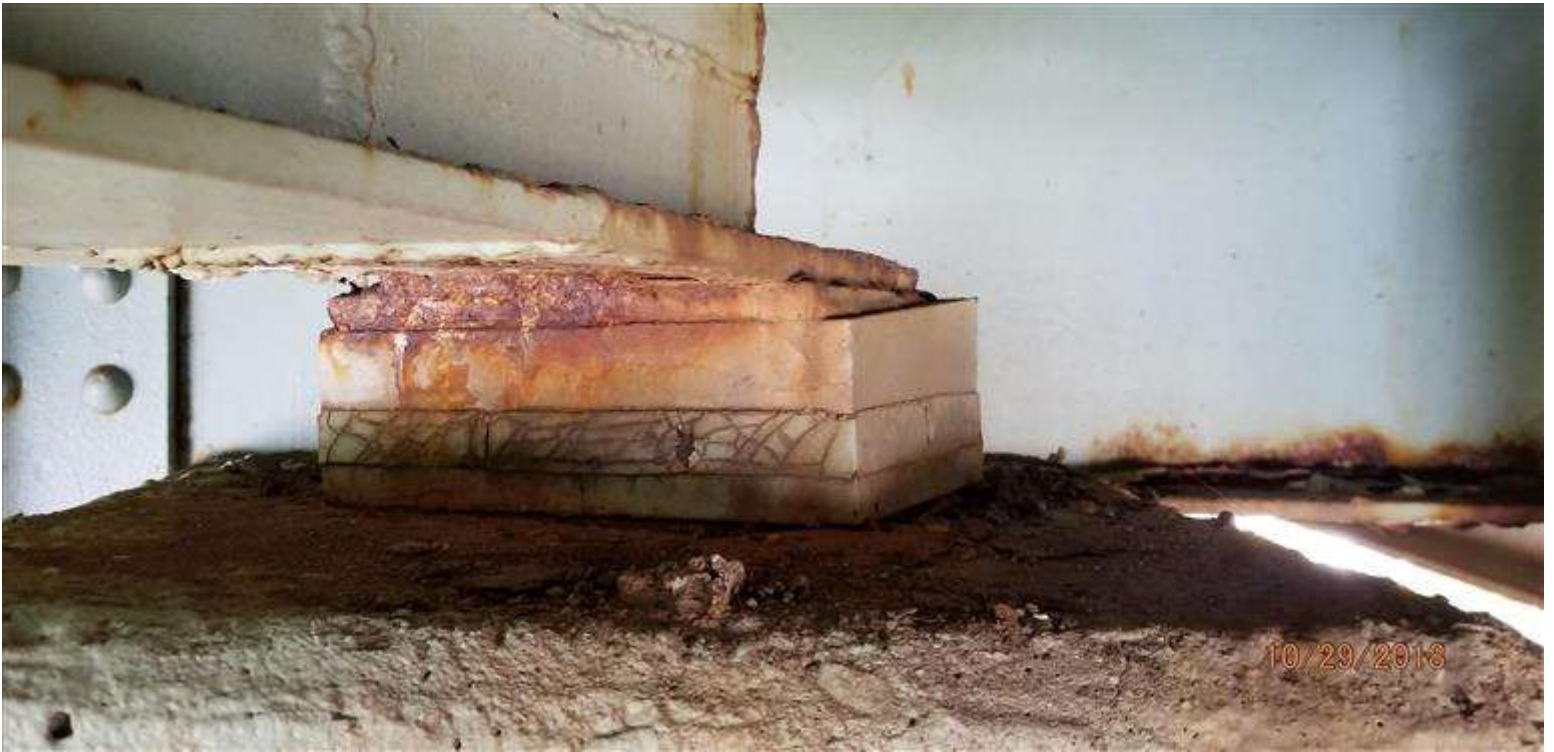
Photo Number: 23

Girder 1 bearing at pier 7 in span 8 with a gap below the masonry plate.

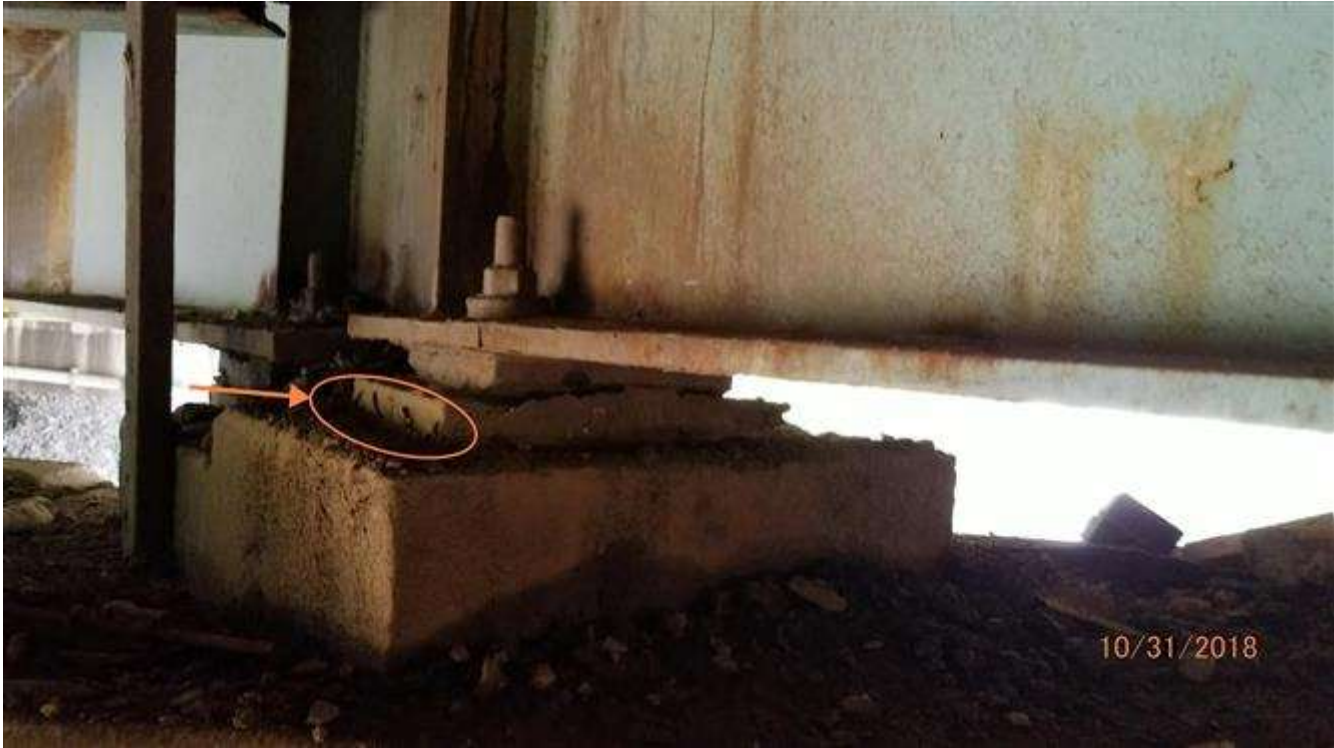
Photo Number: 25

Girder 11 at pier 15 in span 15 with a gap under the bearing.

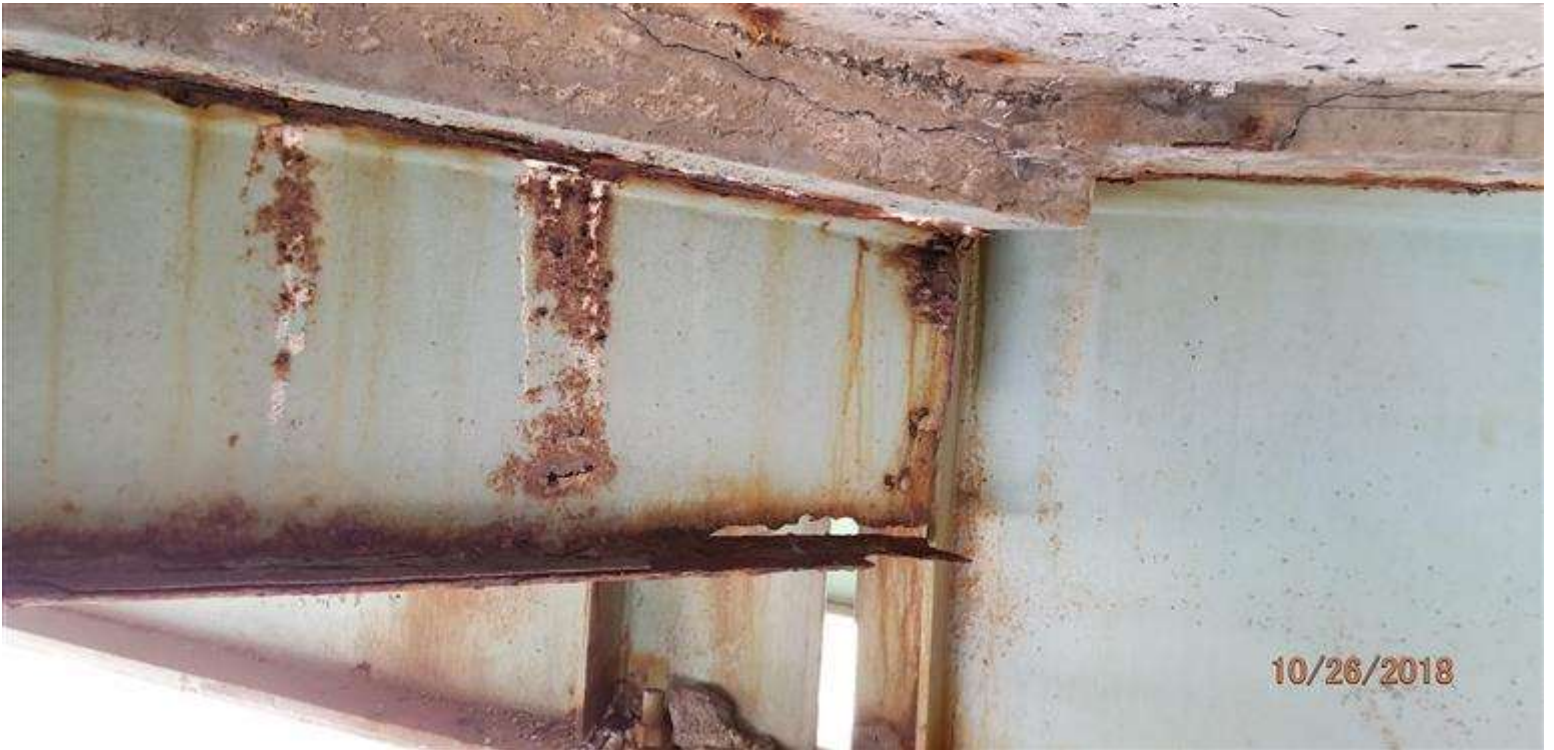
Photo Number: 29

Span 16, bay 2 at pier 15 end diaphragm with areas of heavy rust and perforations in the web and bottom flange.

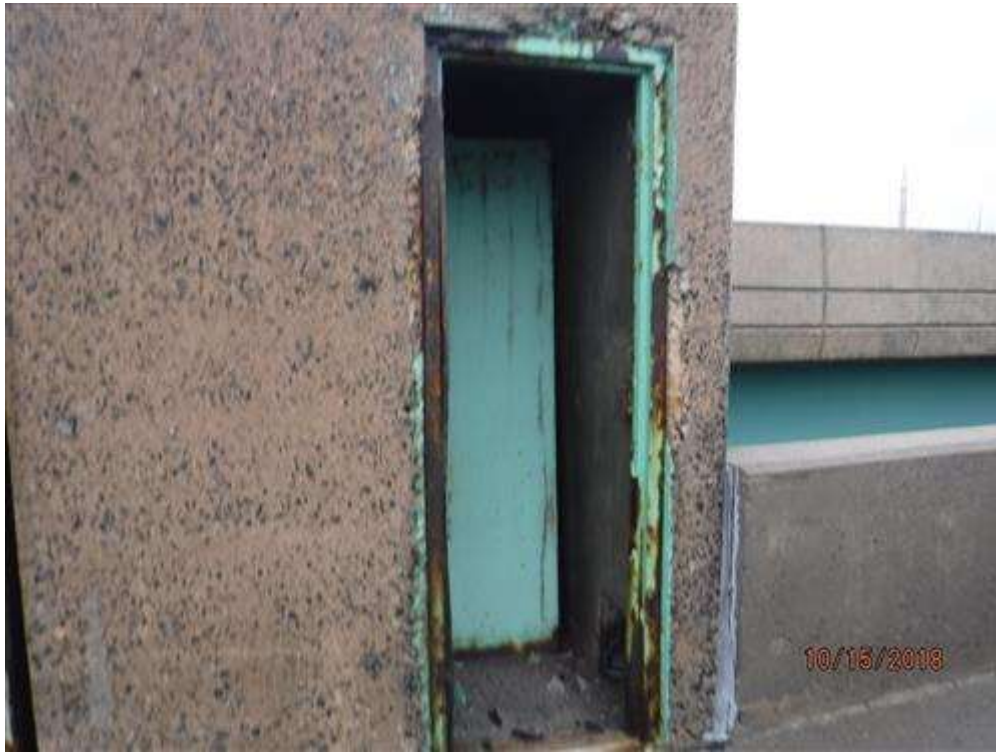
Photo Number: 31

Girder 1 at the north end of span 7 with a broken access door.

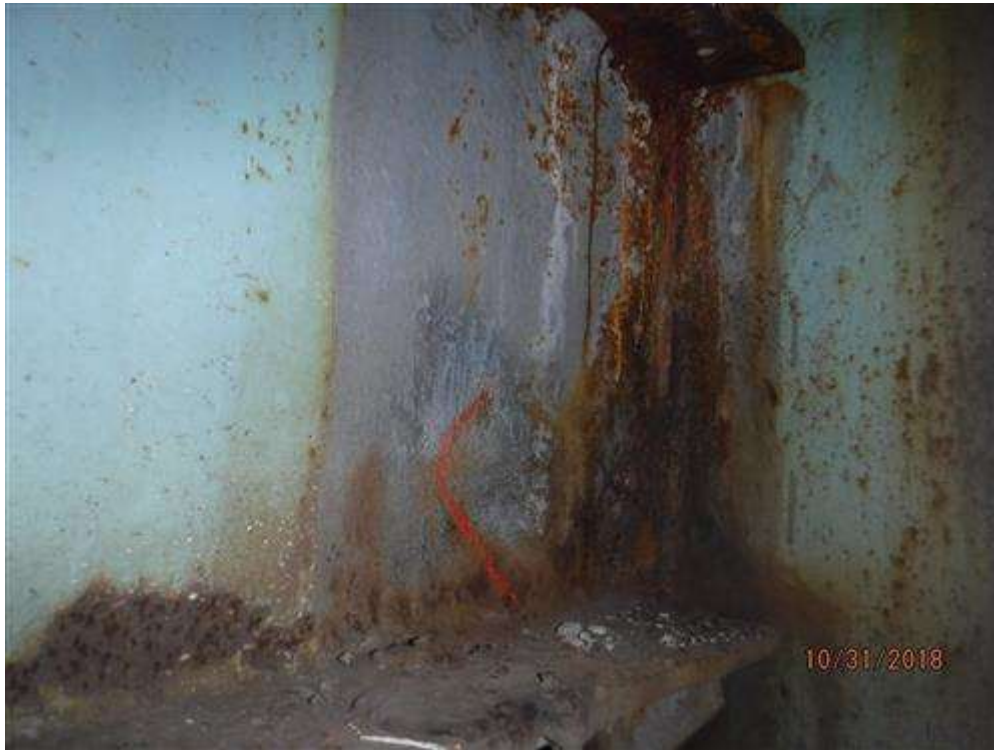
Photo Number: 33

Span 15, end diaphragm in bay 11 with a crack in the web.

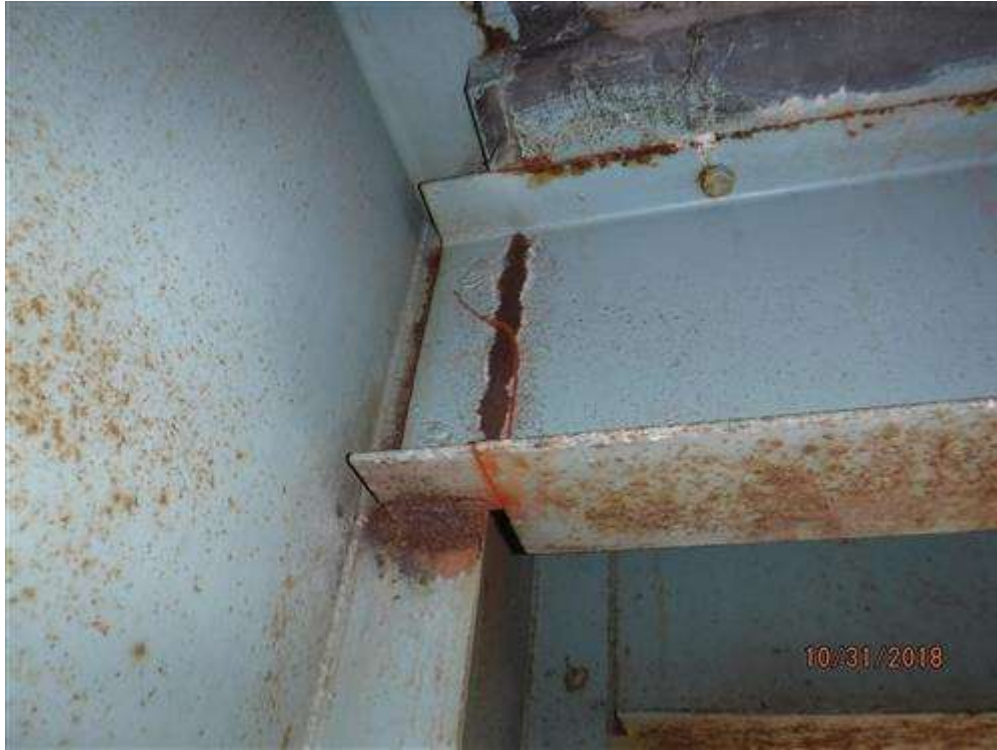
Photo Number: 35

Span 15, end diaphragm in bay 10 over pier 14, adjacent to girder 11. The bearing stiffener is cracked through the web and bottom flange.

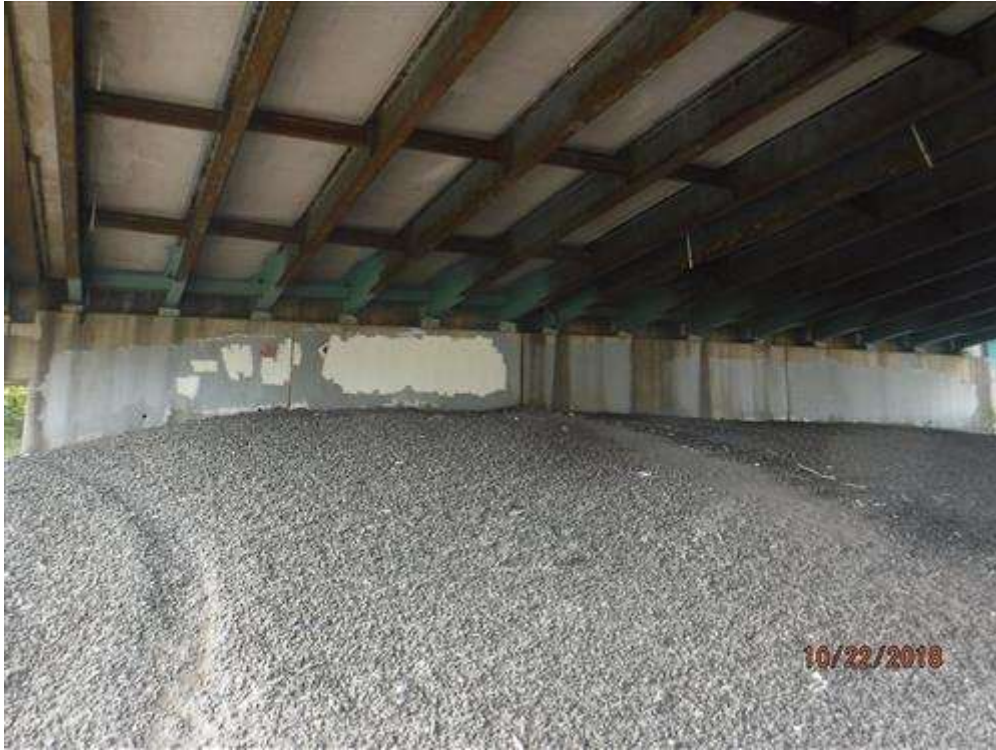
Photo Number: 37

Abutment 1.

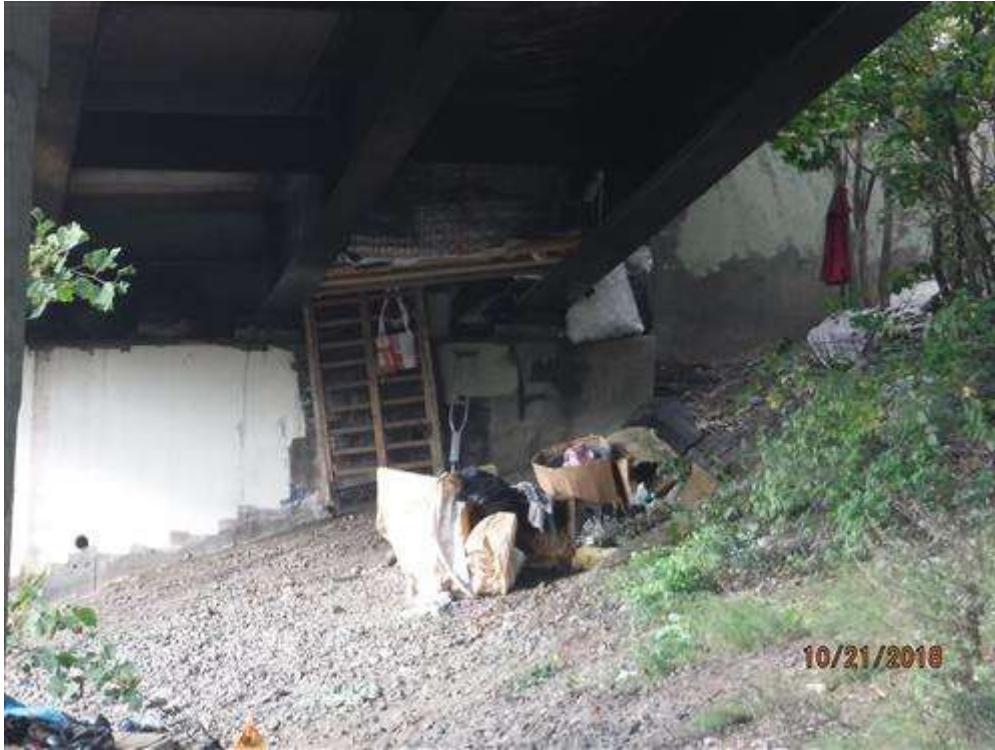
Photo Number: 39

West end of abutment 1A. The abutment could not be inspected due to the presence of homeless people.

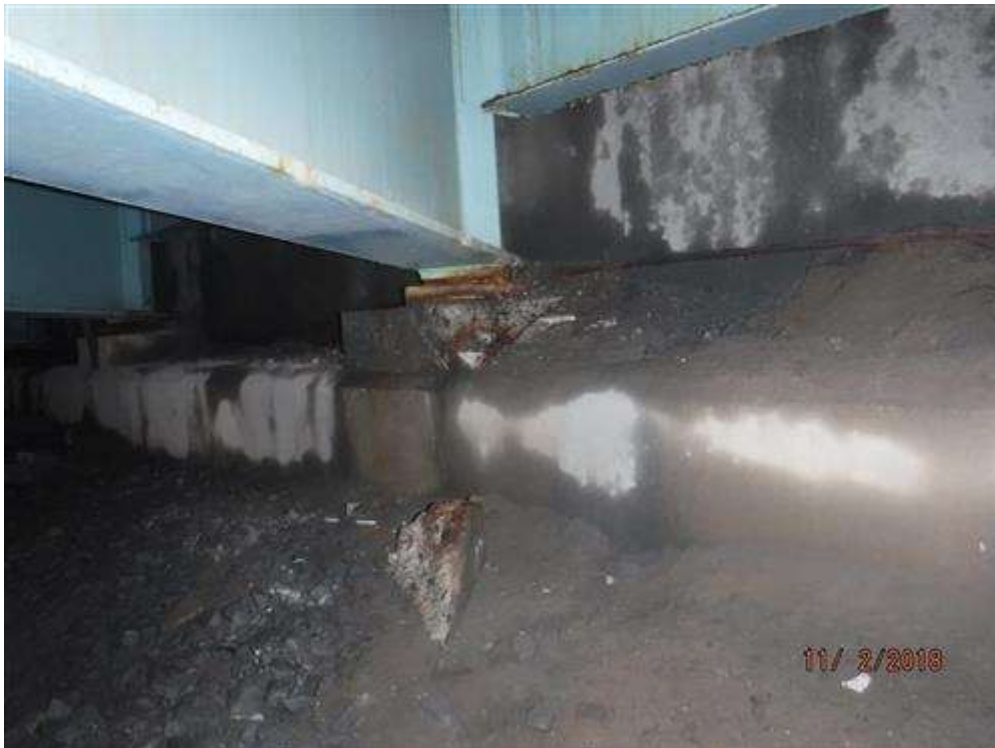
Photo Number: 40

Abutment 2, girder 12 pedestal with a spall with exposed reinforcement. Also, note the heavy sand/ debris accumulation on seat.

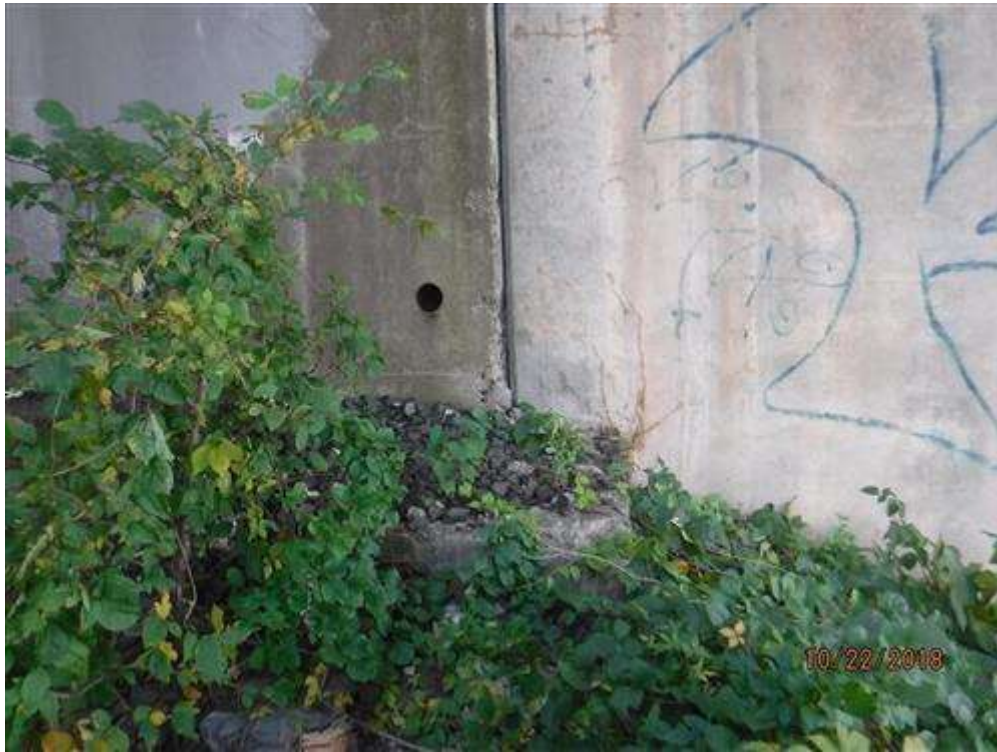
Photo Number: 41

Exposed footing at west end of abutment 1 with a corner spall.

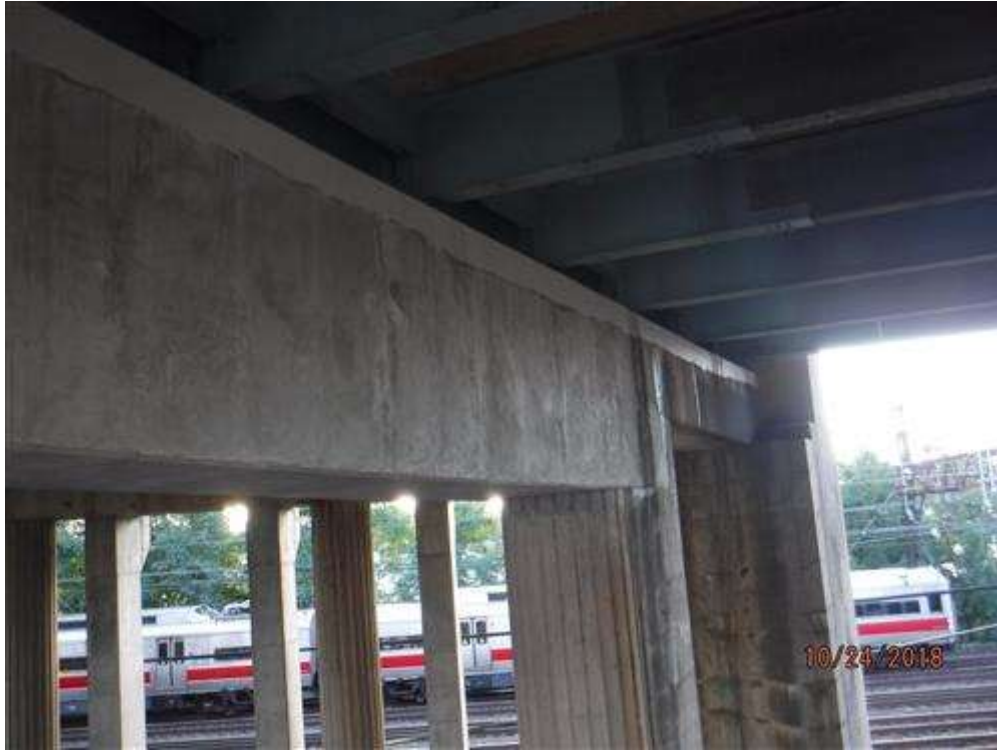
Photo Number: 43

South elevation of pier 3 over South State Street. The previously noted spalls and hollow areas have been repaired since the previous inspection.

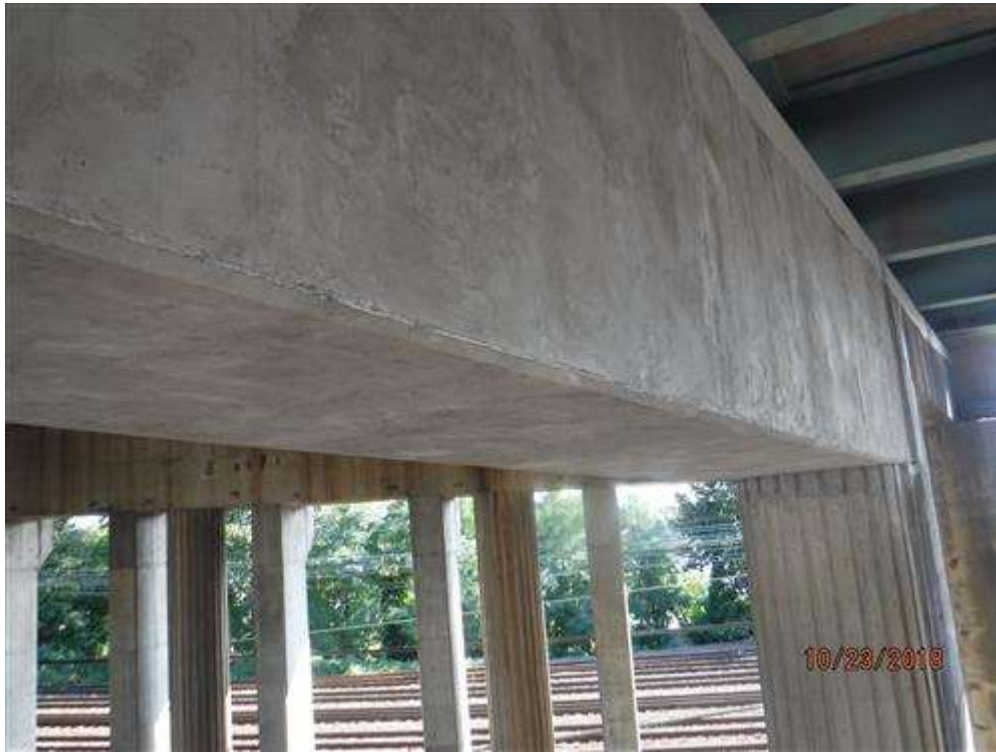
Photo Number: 45

South face of pier 3 cap between bays 10 and 11. The previously noted spalls with exposed rebar have been repaired since the previous inspection.

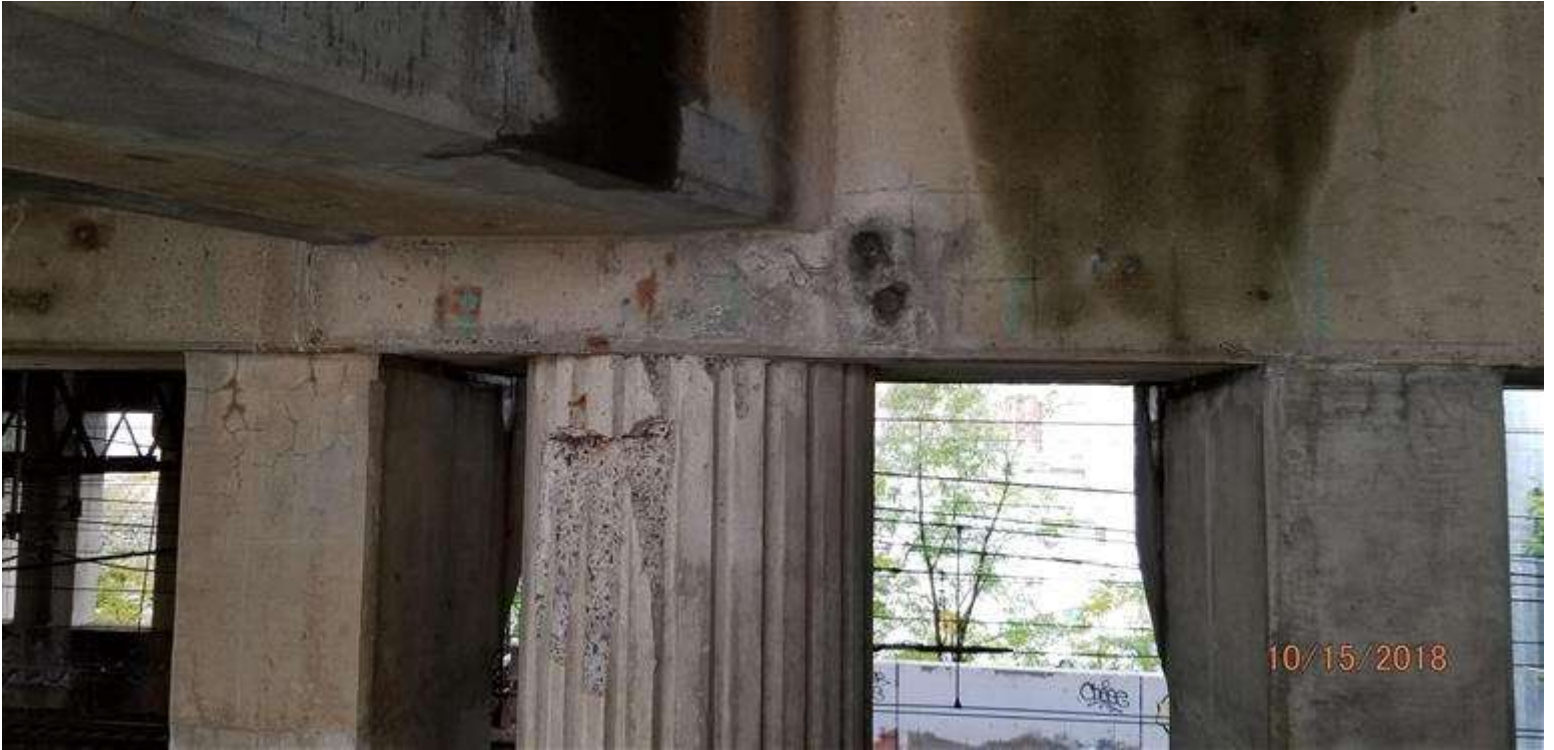
Photo Number: 47

North elevation of pier 7 to pier 8 connection exhibits hollow areas and spalls around the column and cap.
