Subject: On-Call Asbestos, Lead, Air Quality & Demolition Compliance  
Agreement No. 8.07-01 (18)  
HazMat Inspection – Bridge No. 02812 (Bridge/Culvert/ACCOMPA), West  
Stafford Road & Orcuttville Road, Stafford Springs, CT  
ConnDOT Assignment No. 519-6167  
ConnDOT Project No. 134-147  
TRC Project No. 289951.6167.0710

TRC performed a limited hazardous materials site investigation associated with the planned rehabilitation of Bridge No. 02812 (Bridge/Culvert/ACCOMPA) in Stafford Springs, Connecticut. Lead paint was identified on the metal bridge railing surfaces on the West Stafford Road section of the site. The black tar material in the bridge wall beneath the road on the West Stafford Road section of the site was sampled and found to contain no detectable amounts of asbestos. However, the black tar material and membrane inside the corrugated metal culvert pipes on the Orcuttville Road section of the site were both sampled and found to be asbestos containing materials. No other suspect materials were identified. XRF data, laboratory results, site sketch, TRC Mobile Data Solutions report and site description/site map are attached.

## ConnDOT, Stafford Culvert, Tolland, , Staff

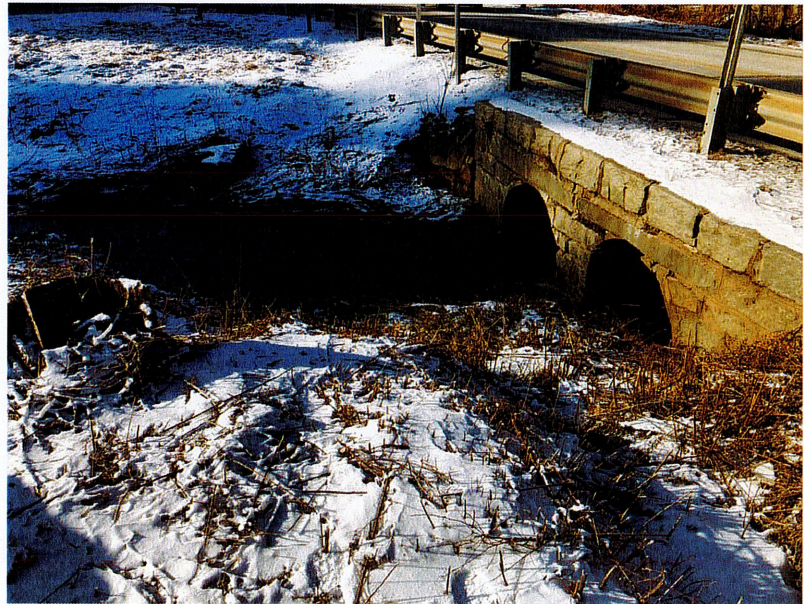
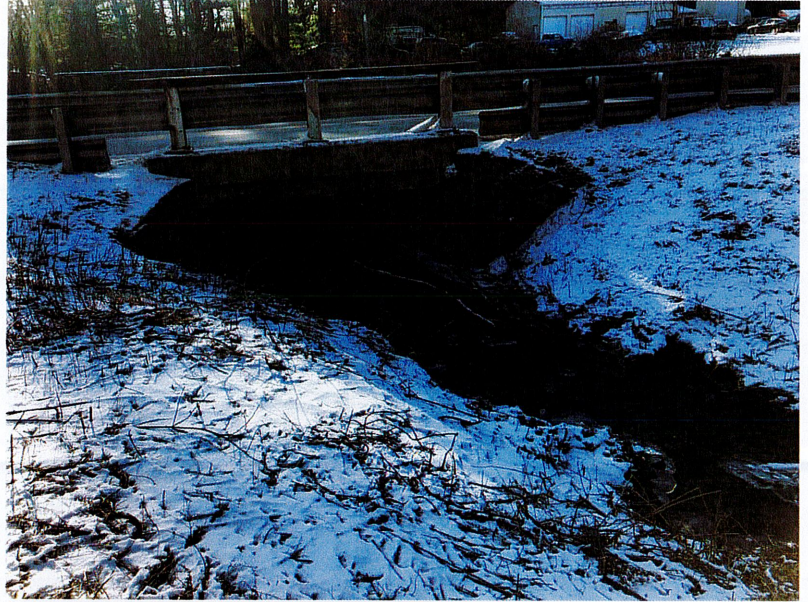
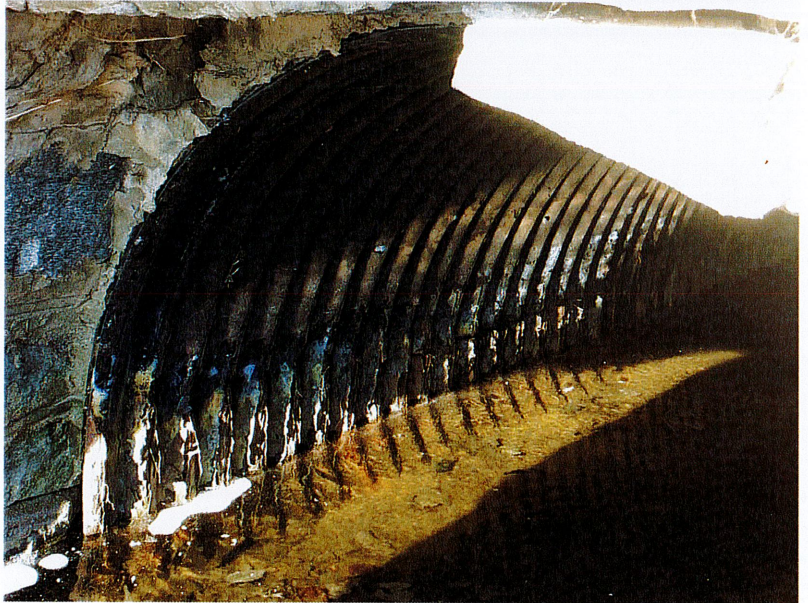
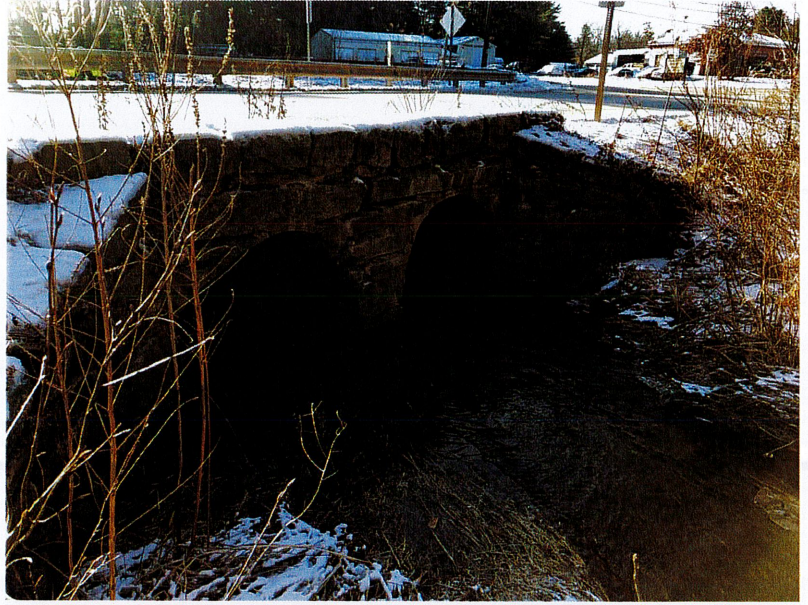
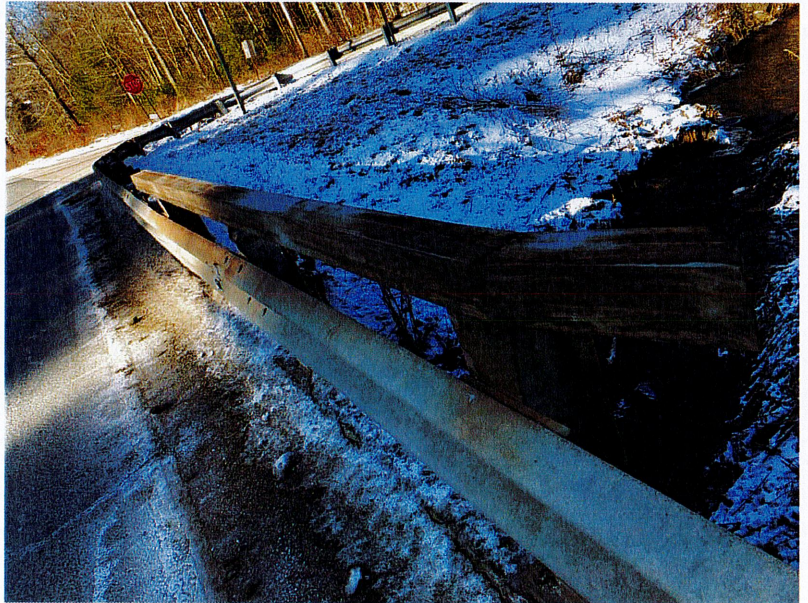
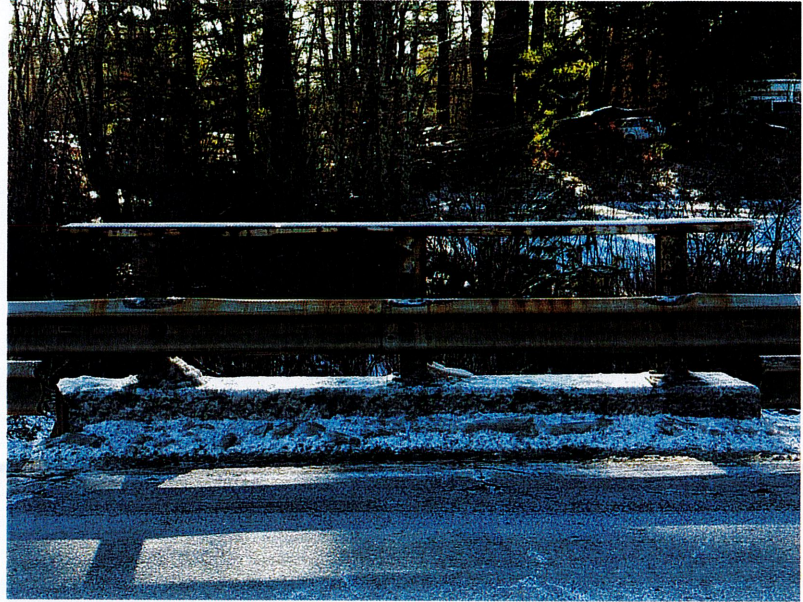
Overview Photo

Site Name	Stafford Culvert
Address	107 W Stafford Rd Stafford Springs, CT 06076
TRC Project Number	289951.6167.0710
Project Manager	Erik Plimpton
Inspector(s)	Brendan McClure, Tyler Noll
Client	ConnDOT
Type of Asbestos Survey	Reno/Demo
Additional Analysis for NOB Materials (Calc)	TEM NY NOB 198.4
PLM Turnaround Time (TAT)	24-hour
Date	2019-12-20
General Notes	No suspect materials under bridge 02812
