**PRE-RENOVATION  
INVESTIGATIVE SURVEY FOR  
HAZARDOUS BUILDING MATERIALS**

**WINDSOR MAINTENANCE FACILITY  
ROOF REPLACEMENT PROJECT  
WINDSOR, CONNECTICUT**  
Project No. 164-241

Issued  
September 2019

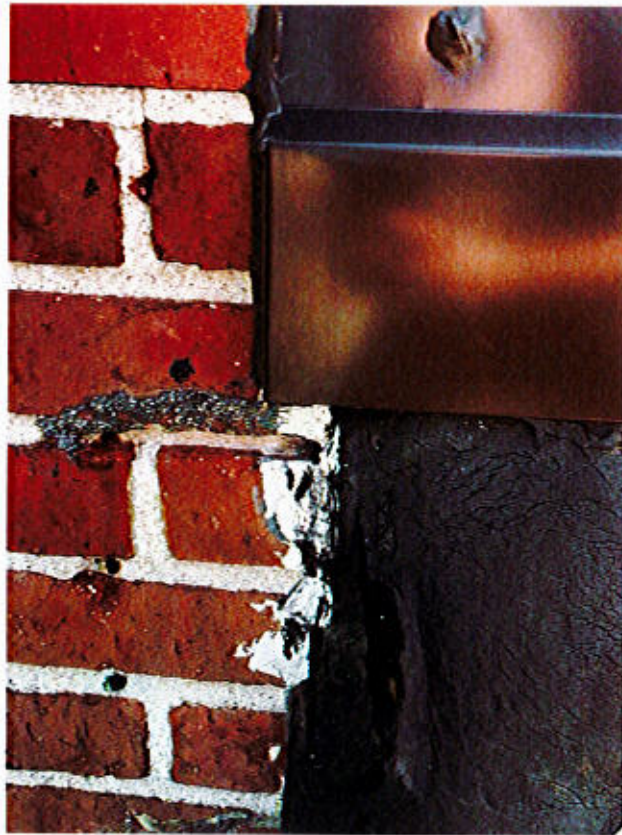
**Roof 2 chimney**

( 1 ), FL, 6, White, gray and brown chimney flashing sealant , 1

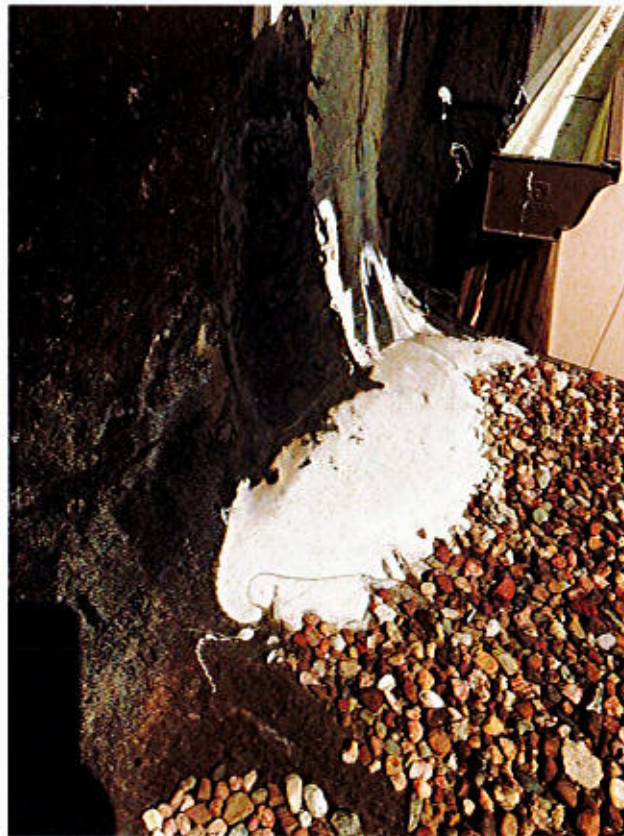
**Roof 2**

**( 1 ), FL, 7, White roof flashing coping sealant , 1**

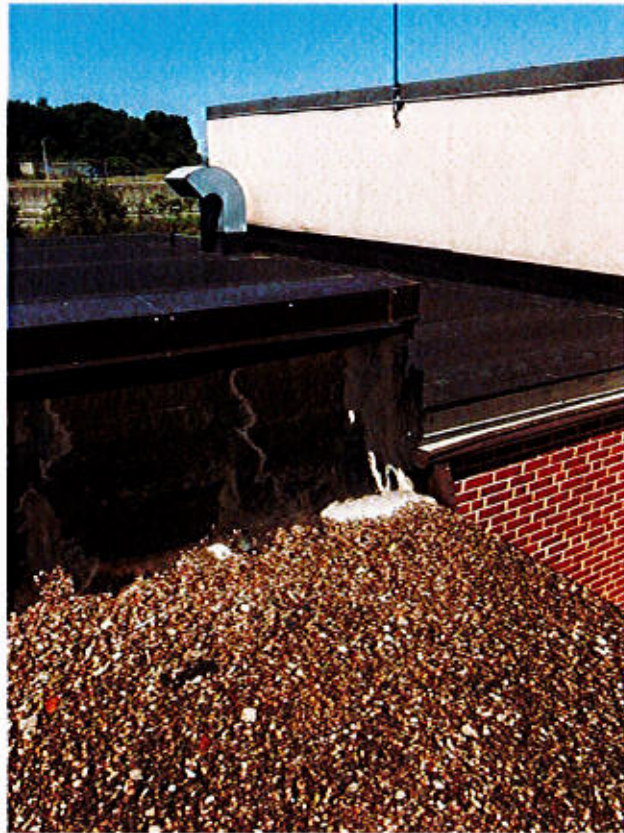
Sample Location	Roof 2
Analyze by Layer	No
Asbestos Bulk Analysis	PLM EPA 600/R93/116
Grab or Composite	Grab
Date	2019-08-15
Time	11:17

Sampled or Assumed?	Sampled
Material Acronym	FL, 7
Material Description	White roof flashing coping sealant
Is Material a Non-Friable Organically Bound (NOB)	Yes
Homogeneous Area	Roof 2
Total Count	( 1 )
Total Count (number only)	1

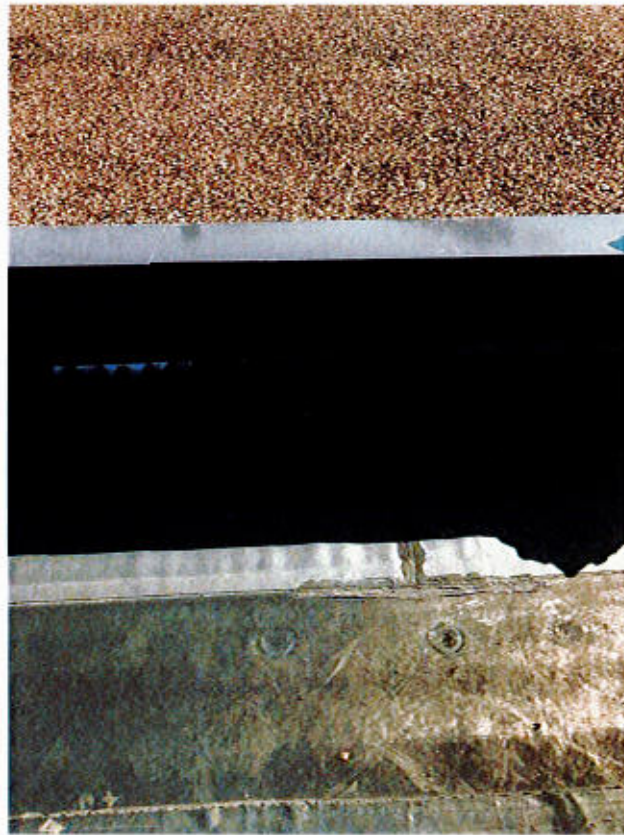
**Roof 1**  
**No**  
**PLM EPA 600/R99/116**  
**Grab**  
**2019-08-15**  
**11:19**

Sampled or Assumed?	Sampled
Material Acronym	FL, 8
Material Description	Black roof flashing sealant
Is Material a Non-Friable Organically Bound (NOB)	Yes
Homogeneous Area	Roof 1
Total Count	( 1 )
Total Count (number only)	1

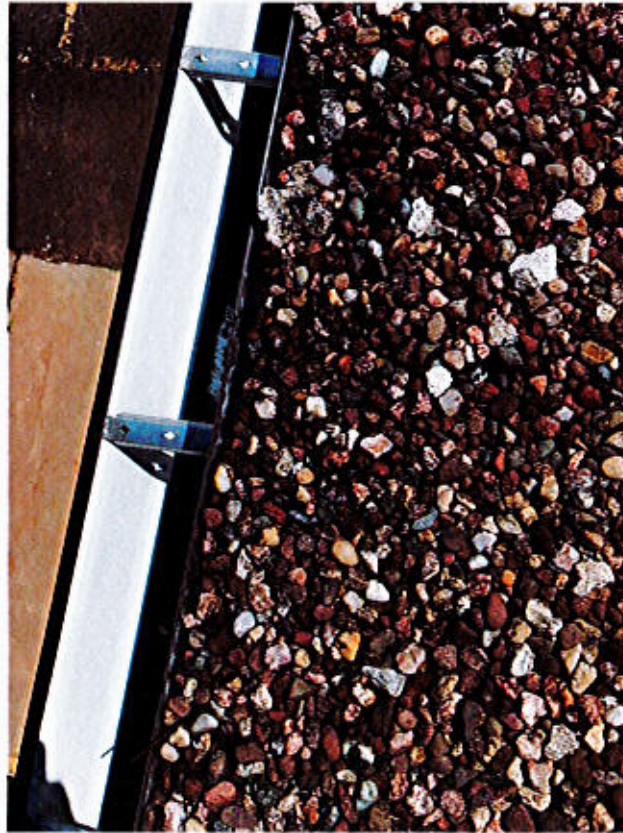
**FL, 9, Black roof edge flashing, 0**

Sampled or Assumed?	Assumed
Accessibility	Accessible
Material Acronym	FL, 9
Material Description	Black roof edge flashing
Is Material a Non-Friable Organically Bound (NOB)	Yes
Homogeneous Area	Roof 2
Total Count (number only)	0

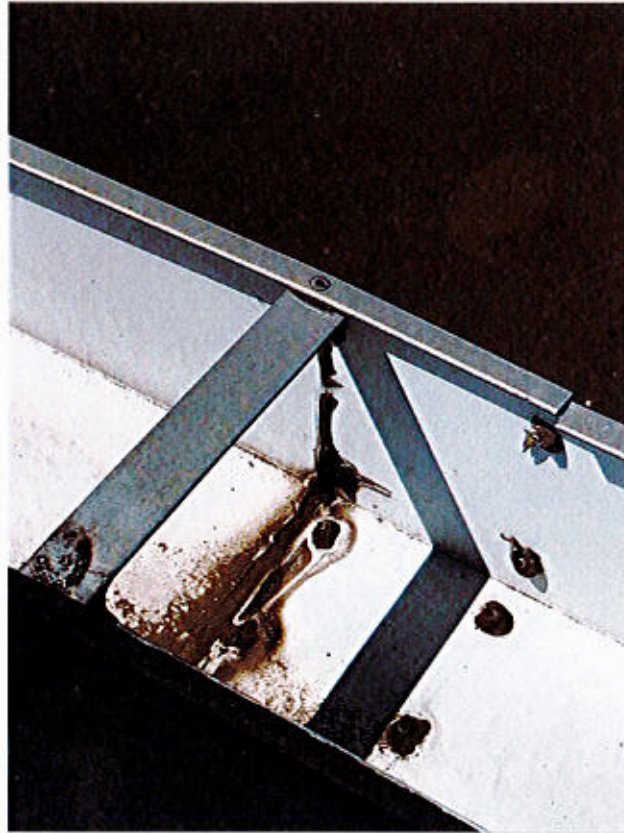
Sample Location	Roof 1
Analyze by Layer	No
Asbestos Bulk Analysis	PLM EPA 600/R93/116
Grab or Composite	Grab
Date	2019-08-15
Time	11:25

Sampled or Assumed?	Sampled
Material Acronym	FL, 10
Material Description	Black gutter sealant
Is Material a Non-Friable Organically Bound (NOB)	Yes
Total Count	( 1 )
Total Count (number only)	1

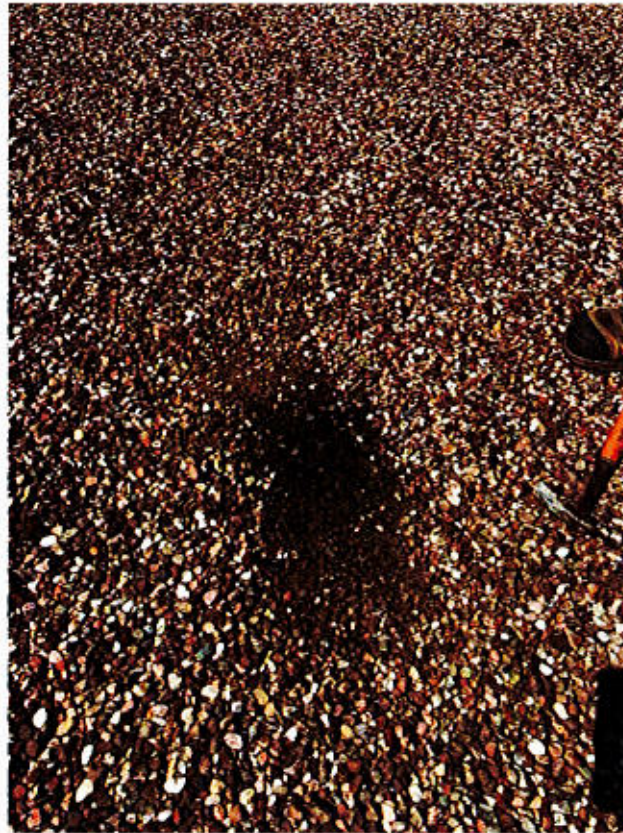
Sample Location	Roof 2
Analyze by Layer	Yes
Asbestos Bulk Analysis	PLM EPA 600/R93/116
Grab or Composite	Grab
Date	2019-08-15
Time	11:39

Sampled or Assumed?	Sampled
Material Acronym	RF, 1
Material Description	Built up roofing, partial board layers with a tar coating over concrete roof base
Is Material a Non-Friable Organically Bound (NOB)	No
Homogeneous Area	Roof 2
Total Count	( 1 )
Total Count (number only)	1
