May 4, 2020

Subject: On-Call Asbestos, Lead, Air Quality & Demolition Compliance
Agreement No.: 8.07-01 (18)
HazMat Inspection – Route 9, 17 & 82 Highway Resigning & Renumbering, Various
Cities/Town, CT
ConnDOT Assignment No. 519-6178
ConnDOT Project No. 172-473
TRC Project No. 289951.6178.0710

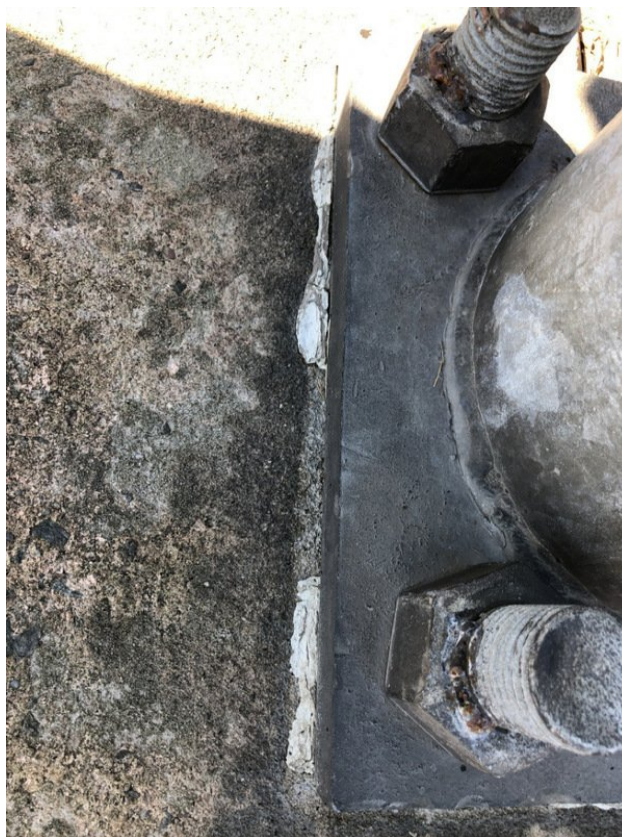
(2), C, 1, Brittle grey caulk, 2

Sample Location	20655
Analyze by Layer	No
Asbestos Bulk Analysis	PLM EPA 600/R93/116
Grab or Composite	Grab
Date	2020-03-16
Time	11:20

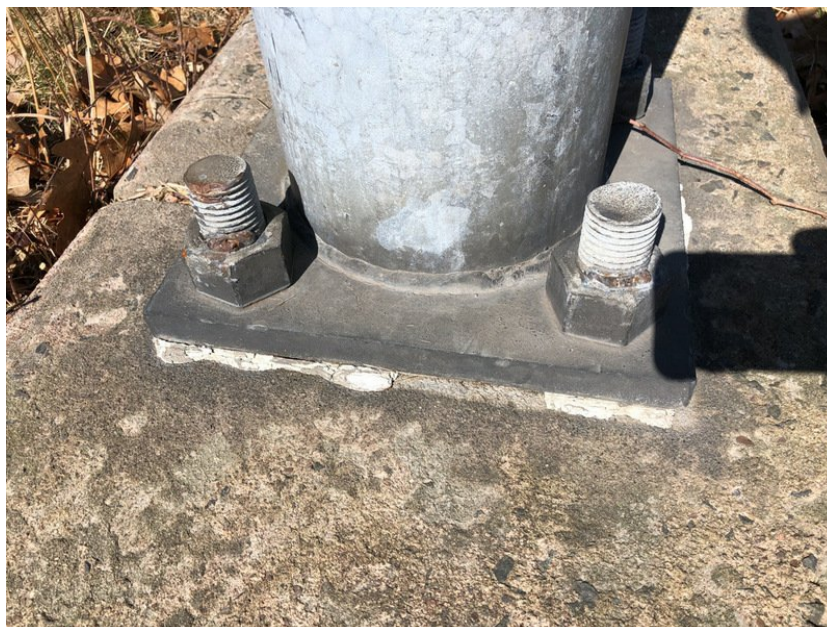
Sample Location	20655
Analyze by Layer	No
Asbestos Bulk Analysis	PLM EPA 600/R93/116
Grab or Composite	Grab
Date	2020-03-16
Time	11:21

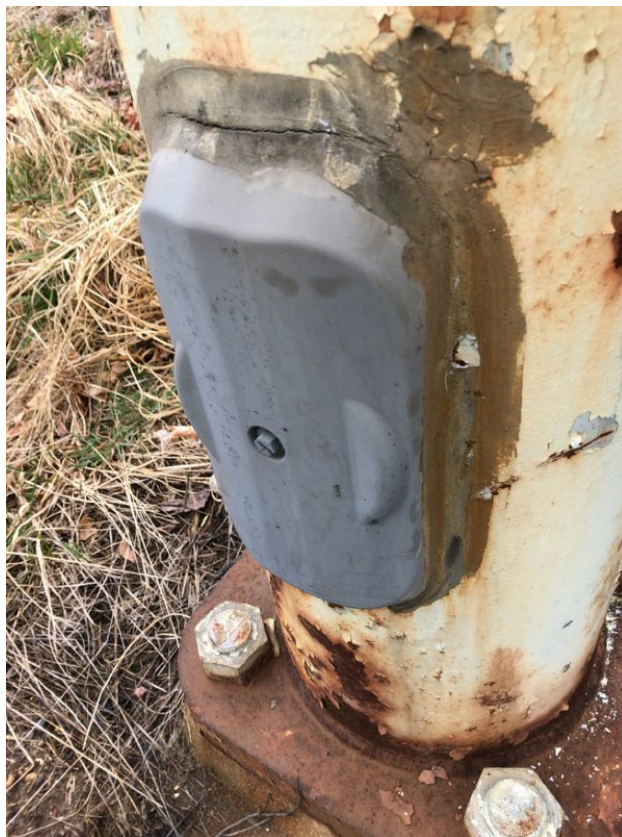
(2), C, 2, Hard grey caulk, 2

Sample Location	20644
Analyze by Layer	No
Asbestos Bulk Analysis	PLM EPA 600/R93/116
