Subject: On-Call Asbestos, Lead, Air Quality & Demolition Compliance
Agreement No. 04.27-01(15)
HazMat Inspection – Sign Supports at Eleven (11) Sites, Statewide, & Sign Support No.
20343, Wallingford, CT
ConnDOT Assignment No. 514-5711
ConnDOT Project No. 170-3447
TRC Project No. 222165.5711.00710

TRC performed a limited survey for hazardous building materials associated with sign support removals at 12 Sites in various locations throughout Connecticut. Results of the survey identified the following on the sign support surfaces at the following Sites:

PROJECT 0170-3447: Statewide Replacement of Overhead Sign Supports at Various Locations

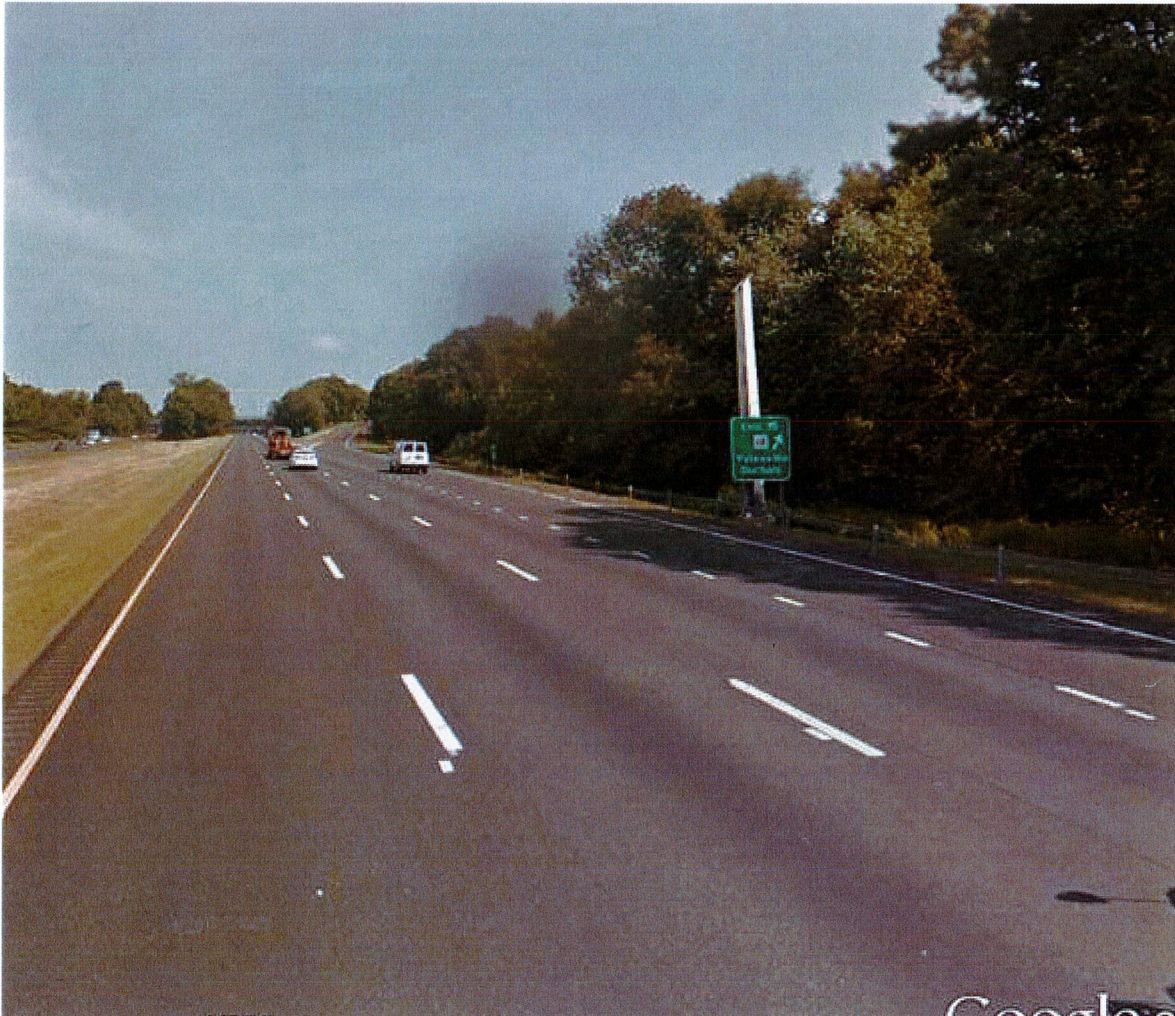
Just received the 60% design package for Project #0170-3447 (5711), and I noticed that a sign post replacement was added back in November, and I don't think that info reached me until now. It was a cantilever sign that was struck by a truck and is now just a vertical post. I know the investigation has been completed and the report is in progress, but if you could please go out and conduct a brief investigation of this post and add it to the report it would be much appreciated.
