Subject: On-Call Asbestos, Lead, Air Quality & Demolition Compliance  
Agreement No. 04.27-01(15)  
HazMat Inspection - Bridge No. 00196 & Traffic Int. Nos. 14-233 & 14-237, Branford, CT  
ConnDOT Assignment No. 514-5692  
ConnDOT Project No. 14-185  
TRC Project No. 222165.5692.0710

TRC performed a limited survey for hazardous building materials associated with the rehabilitation of Bridge No. 00196, I-95 over Route 1, and removal of traffic signals at Int. Nos. 14-233 & 14-237 in Branford, Connecticut. Results of the survey identified lead paint to be present on the structural steel/metal bridge components of Bridge No. 00196. The bridge railings were identified as galvanized (unpainted). Results obtained from TCLP waste stream sampling and analysis for leachable lead from the paint on the structural steel/metal bridge components characterized the paint waste stream at Bridge No. 00196 as CTDEEP/RCRA hazardous waste. At Intersection Nos. 14-233 & 14-237 detectable amounts of lead were identified on the yellow & green traffic signals themselves and crosswalk push buttons. All traffic span poles were either wood or galvanized (unpainted). All crosswalk pedestals were galvanized (u

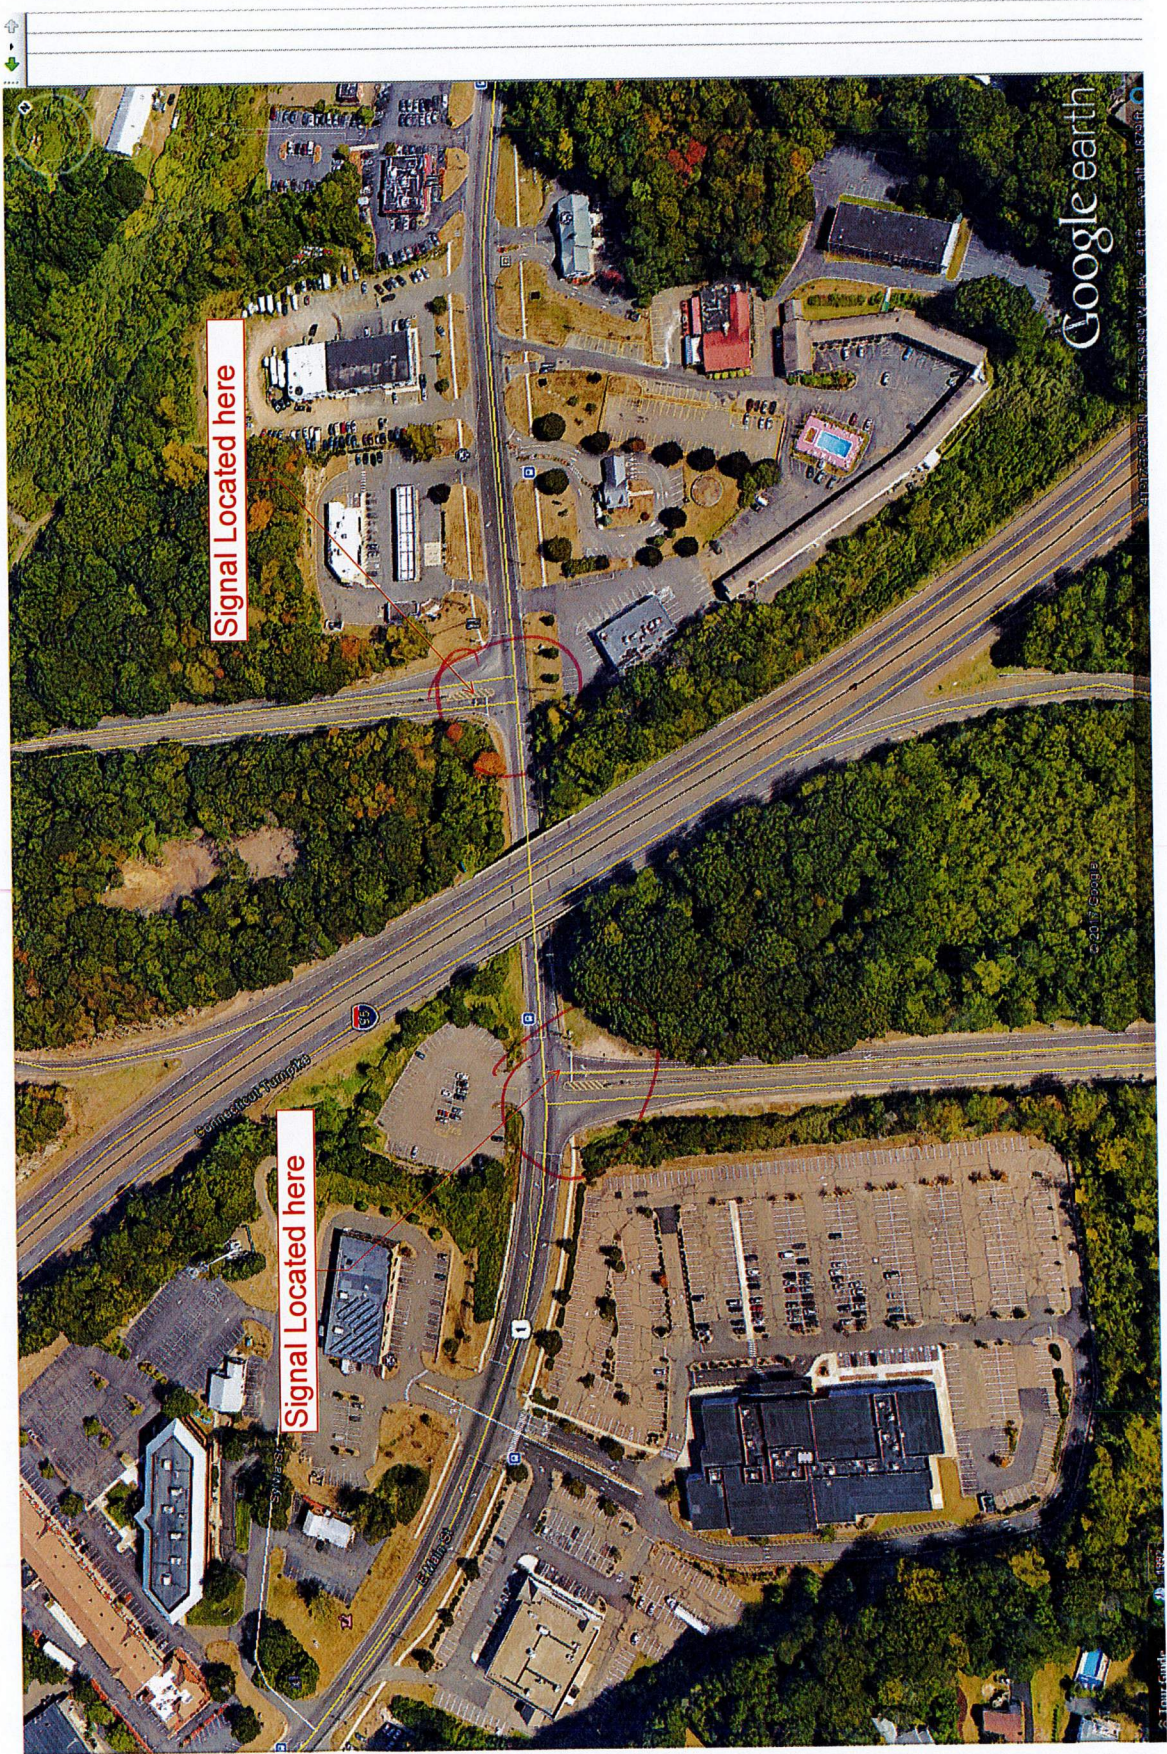
Signal Located here

Attached is a satellite image of the I-95 bridge crossing over Route 1 that is set to be removed. Not sure exactly if both of the signals at the off-ramps are set to be replaced or just one. I tried to contact the designer to get clarification, but they weren't there. If you don't hear from me before you guys head out to do your sampling, assume that we will sample both of them because it won't really cost us much more to do so and will give us the information we need in case they both are planned to be removed.
