Subject: On-Call Asbestos, Lead, Air Quality & Demolition Compliance
Agreement No. 04.27-01(15)
HazMat Inspection - Bridge No. 02295, Route 136 over Norwalk River, Norwalk, CT
ConnDOT Assignment No. 514-5710
ConnDOT Project No. 173-462
TRC Project No. 222165.5710.0710

TRC performed a limited survey for hazardous building materials associated with the rehabilitation of Bridge No. 02295, Route 136 over Norwalk River in Norwalk, Connecticut. TRC's HazMat Inspection letter dated August 30, 2016, indicated that no detectable amounts of lead were present on the metal structural steel/metal bridge components (0.0 mg/cm^2 & $\text{ND} < 0.10\%$ by weight) of the drawbridge portion of the bridge, therefore any paint waste generated would be considered non-RCRA, non-hazardous waste. The rest of the bridge was entirely constructed of unpainted concrete beams with unpainted galvanized metal railing, therefore no lead paint was identified on those components. The black tar paper vapor barrier on the corrugated drain pipes in the abutments and the grey brittle caulk at the deck/concrete support junction were sampled and found to contain asbestos, however they are not expected to be impacted by

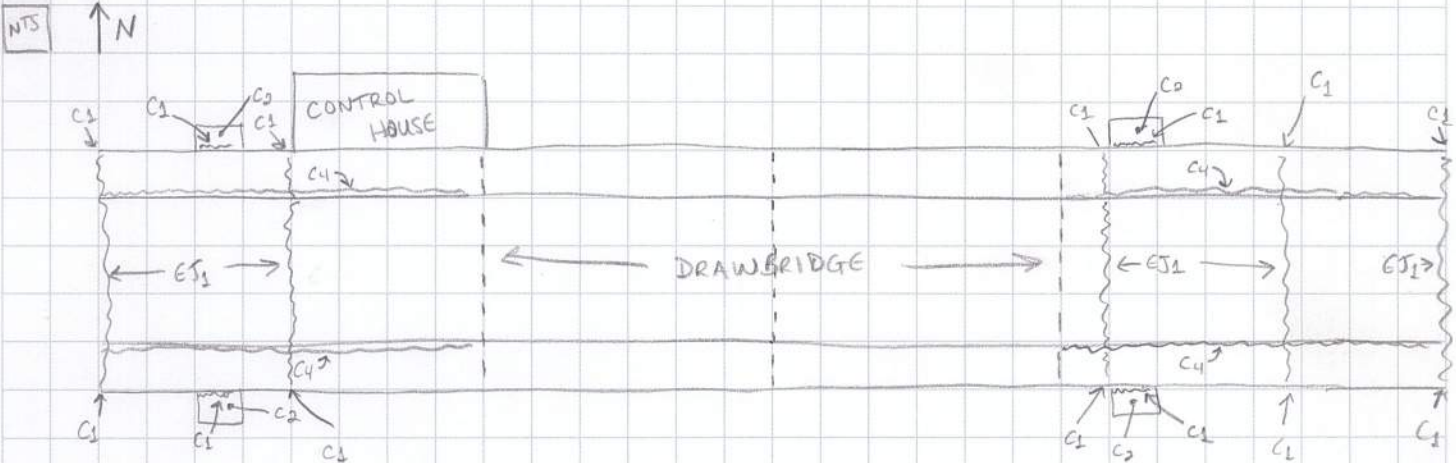
- ① C₁ = Thick Lt. Grey ^{Rubbery} Exp. Jt. Caulk (@ 4 Bridge Jts each side ~ 4 LFea + @ 4 bridge Gates ~ 6 LFea = around Ctrl. House ~ 30 LFe)
- ② C₂ = Grey Rubbery Caulk (@ base of drawbridge arms) (~ 12 LF x 4)
- ③ EJ₁ = Black Tar Expansion Jt.
- ④ VB₁ = Tar paper Vapor Barrier on corrugated drain pipe below bridge (~ 20 SF)
- ⑤ C₃ = Grey Brittle Caulk @ deck/conc. support junction (on o/s beams across entire span minus drawbridge)
- ⑥ GBP₁ = Cloth Guardrail Base Pads (~ 250 @ .5 SF ea)
- ⑦ C₄ = Black Sidewalk Caulk (where sidewalk meets curb) (entire span (-) drawbridge)
