**PRE-RENOVATION  
INVESTIGATIVE SURVEY FOR  
HAZARDOUS BUILDING MATERIALS  
DOT GENERATOR INSTALLATION/  
REPLACEMENT PROJECTS  
EAST HAVEN, EAST LYME, EAST WINDSOR,  
HADDAM, HARTFORD, MANSFIELD & ROCKY  
HILL, CONNECTICUT  
Project No. 170-3476**

**PRE-RENOVATION  
INVESTIGATIVE SURVEY FOR  
HAZARDOUS BUILDING MATERIALS**

**GENERATOR INSTALLATION/  
REPLACEMENTS**  
**EAST HAVEN, EAST LYME, EAST WINDSOR,  
HADDAM, HARTFORD, MANSFIELD &  
ROCKY HILL, CONNECTICUT**  
Project No. 170-3476

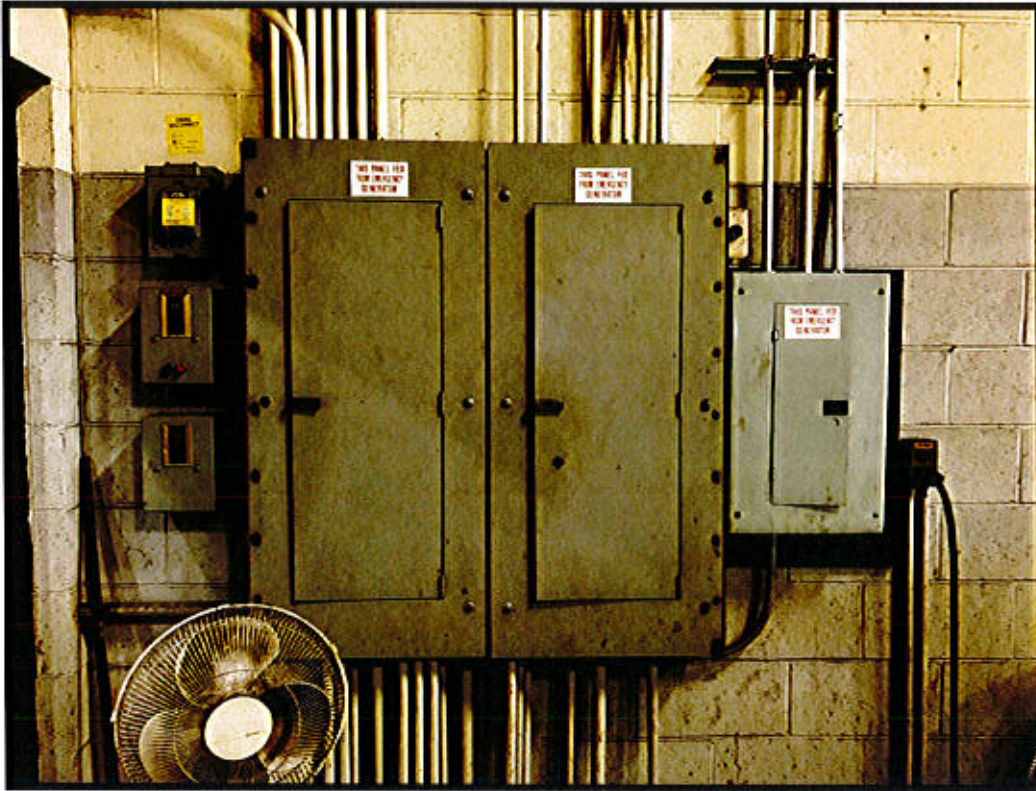
Photo 1. East Haven Repair Facility – 2100 N. High Street, East Haven, CT.  
Generator Electrical Panel.

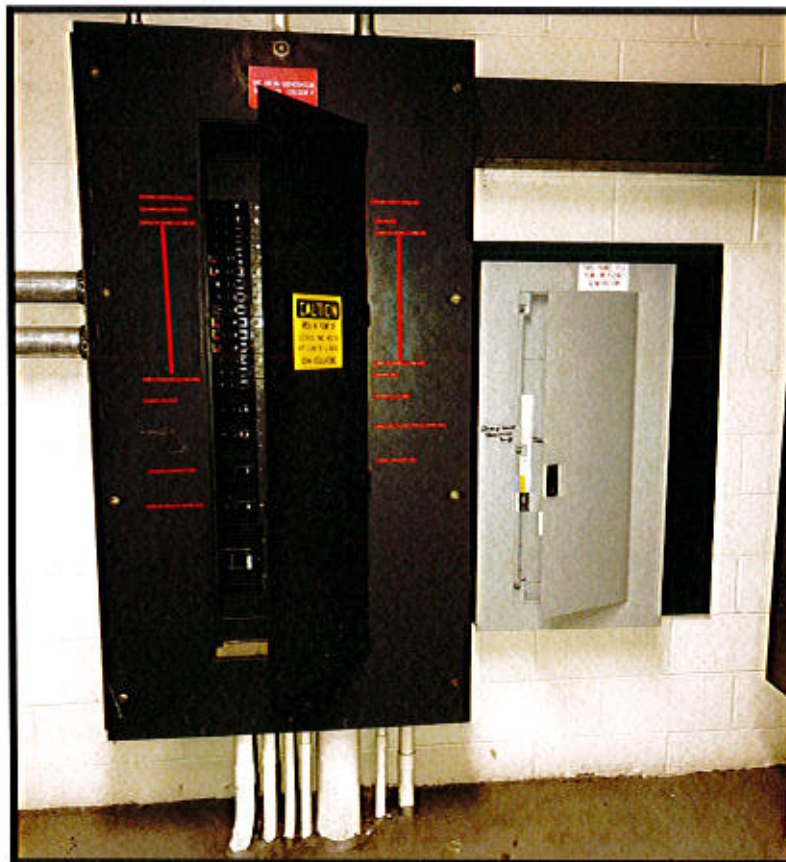
Photo 2. East Haven Repair Facility –  
2100 N. High Street, East Haven, CT.  
Electrical Panels.

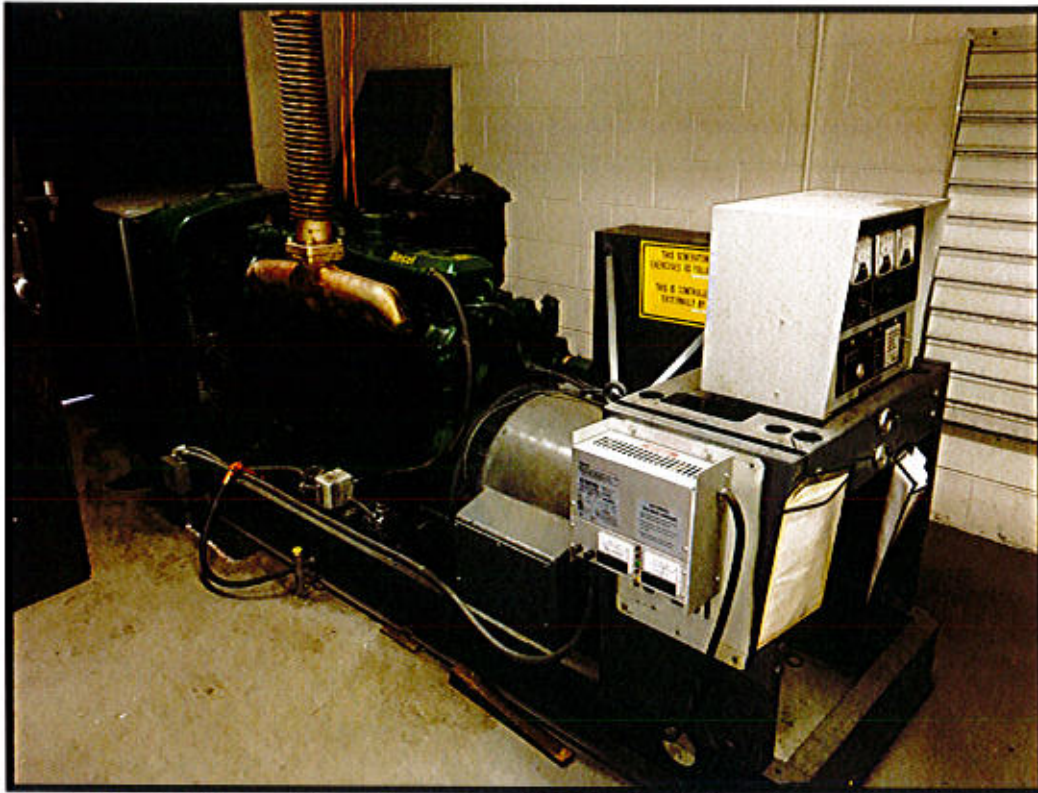
Photo 3. East Haven Repair Facility – 2100 N. High Street, East Haven, CT.  
Generator.

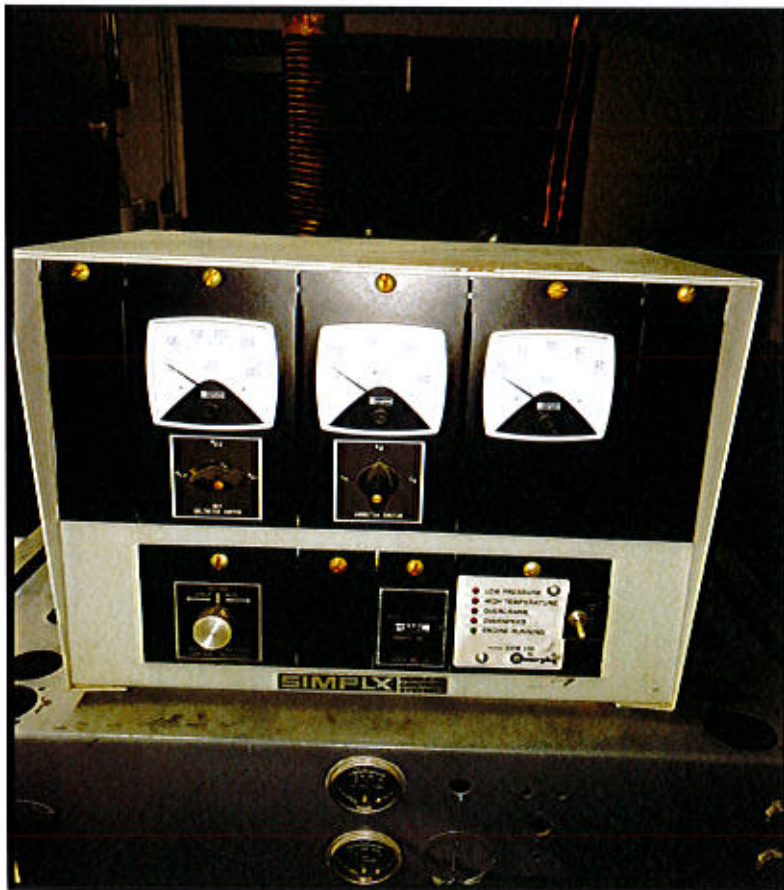
Photo 4. East Haven Repair Facility –  
2100 N. High Street, East Haven, CT.  
Generator Control.

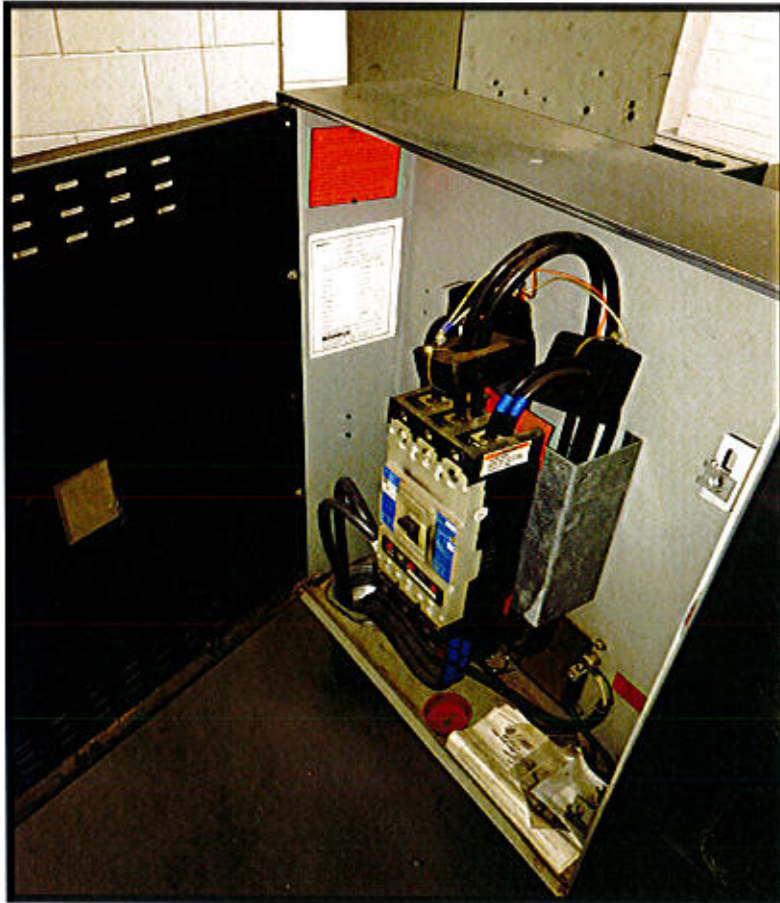
Photo 5.  
East Haven Repair  
Facility –  
2100 N. High Street,  
East Haven, CT.  
Inside Panel.

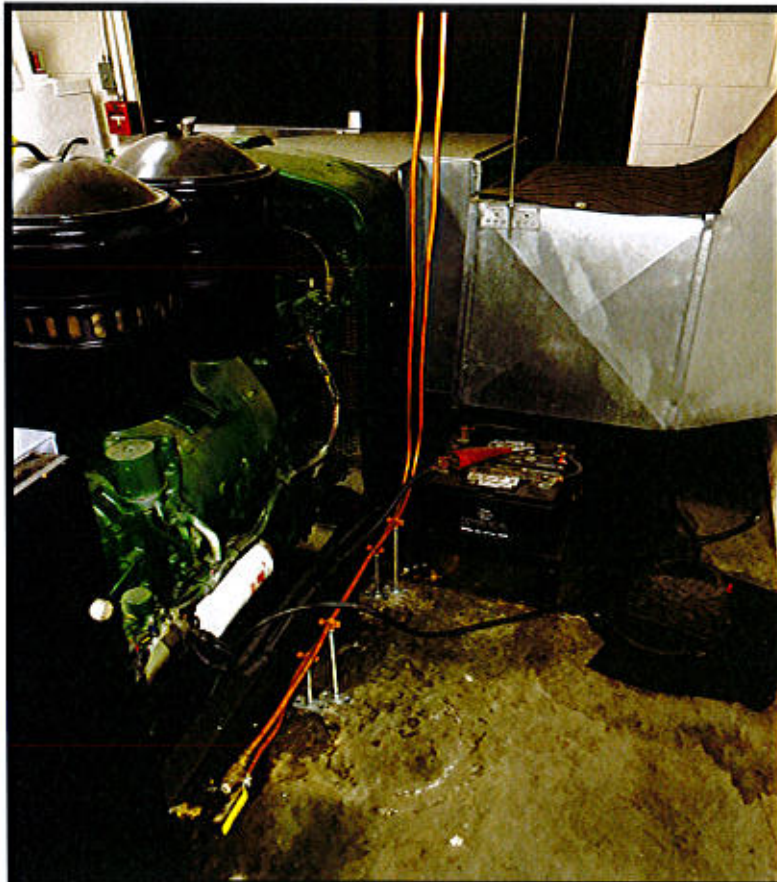
Photo 6.  
East Haven Repair Facility –  
2100 N. High Street,  
East Haven, CT.  
Generator.

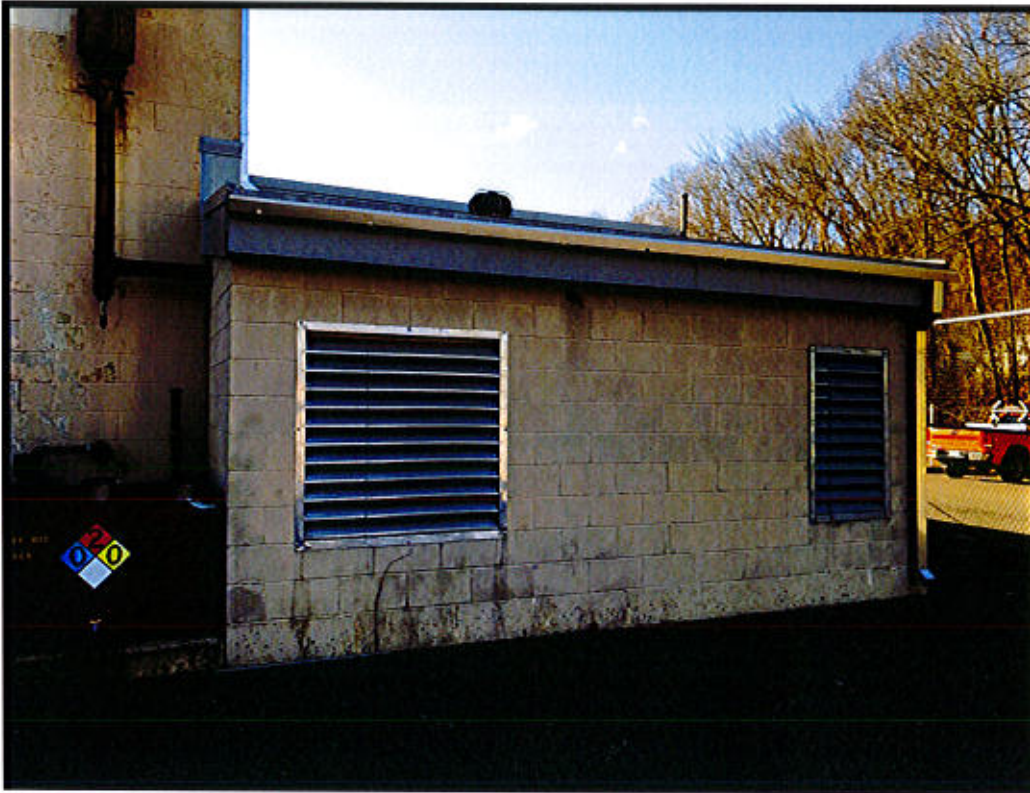
Photo 7. East Haven Repair Facility – 2100 N. High Street, East Haven, CT.  
Generator Vents.

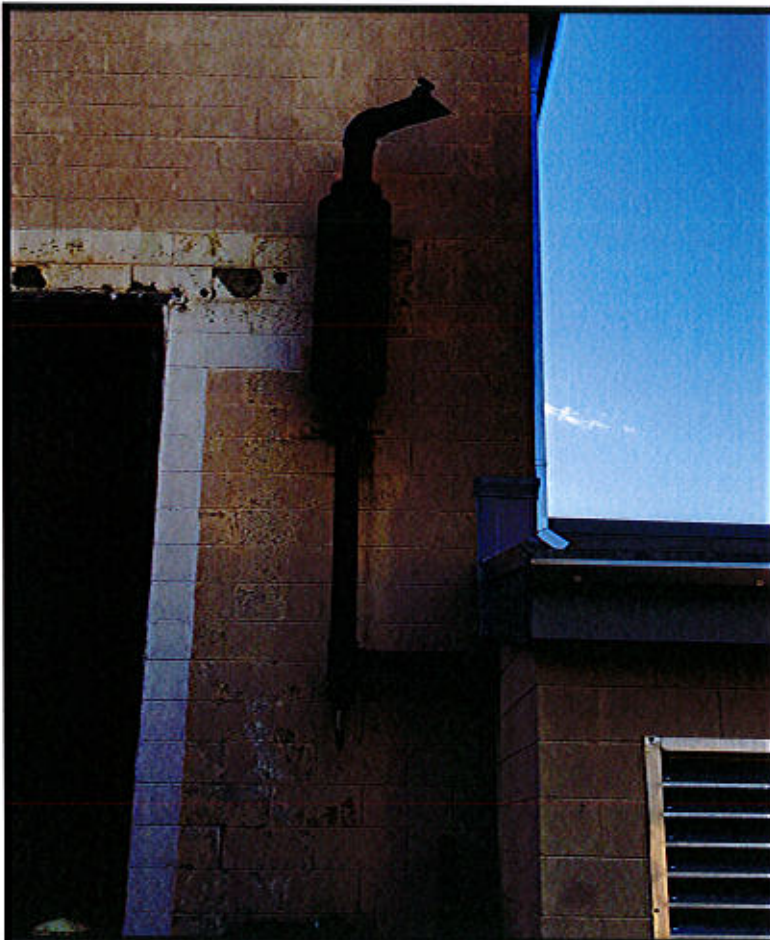
Photo 8.  
East Haven Repair Facility –  
2100 N. High Street,  
East Haven, CT.  
Generator Exhaust.

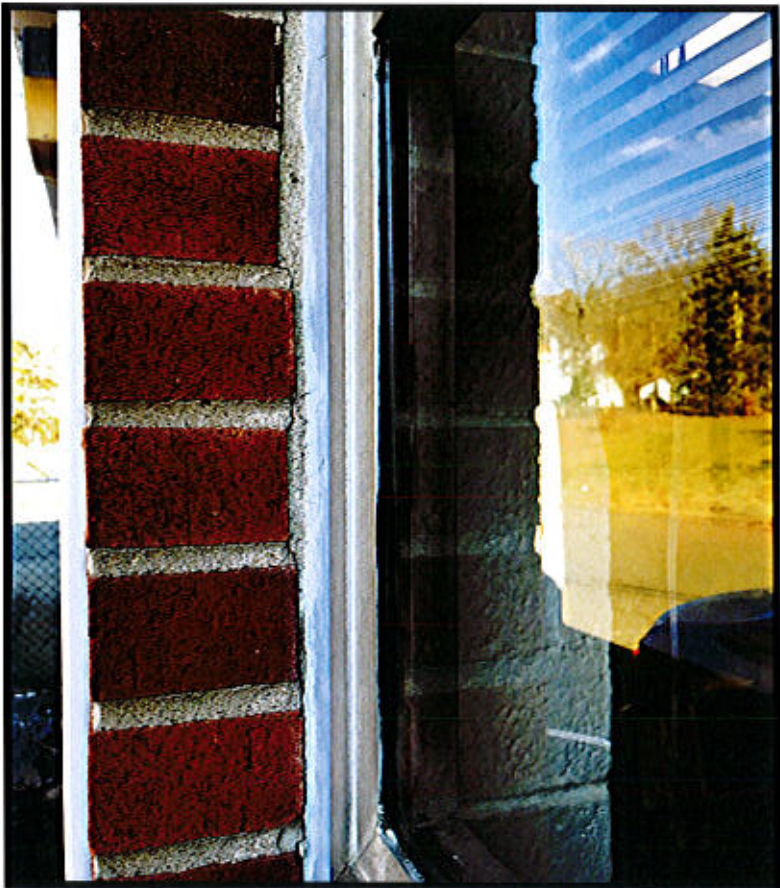
Photo 9.  
East Haven Repair Facility –  
2100 N. High Street,  
East Haven, CT.  
Brick/CMU Wall.

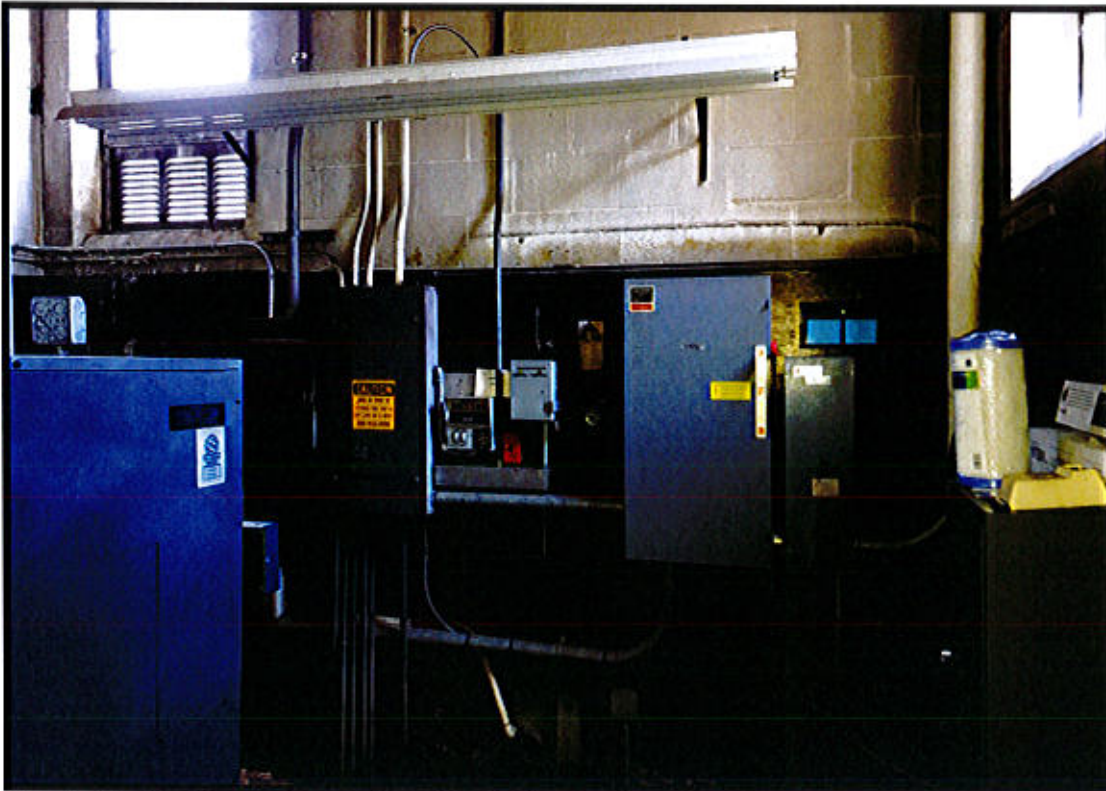
Photo 11. East Lyme Property & Facilities Region 2 Facility – Rt. 156, East Lyme, CT. Electrical Panels.

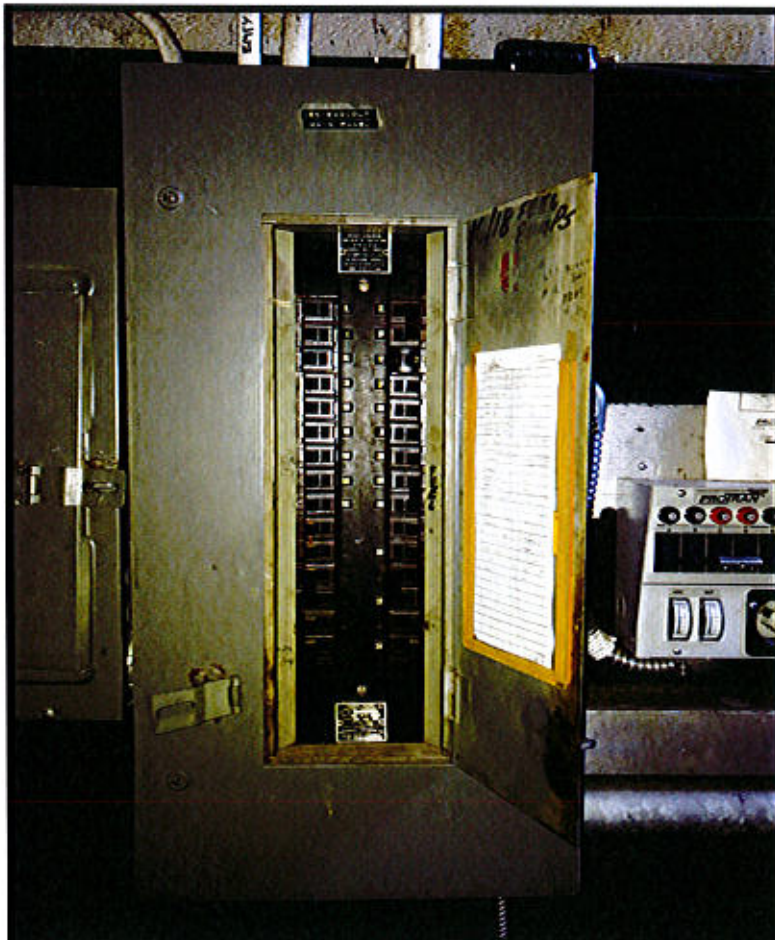
Photo 12.  
East Lyme Property & Facilities Region 2 Facility – Rt. 156, East Lyme, CT. Electrical Panel.

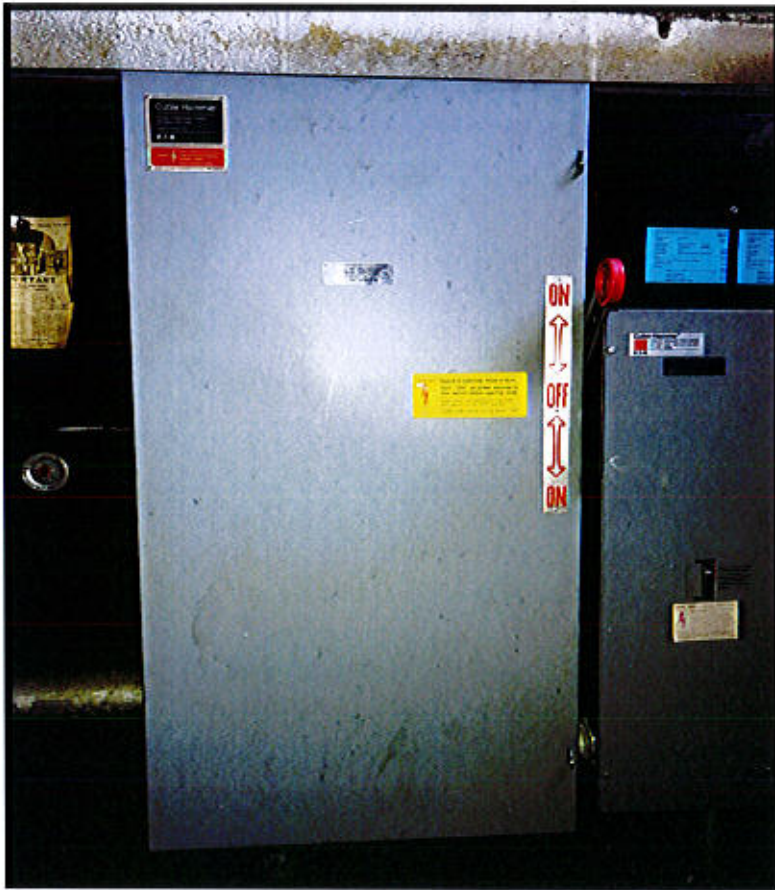
Photo 13.  
East Lyme Property & Facilities Region 2 Facility – Rt. 156, East Lyme, CT.  
Electrical Panel.

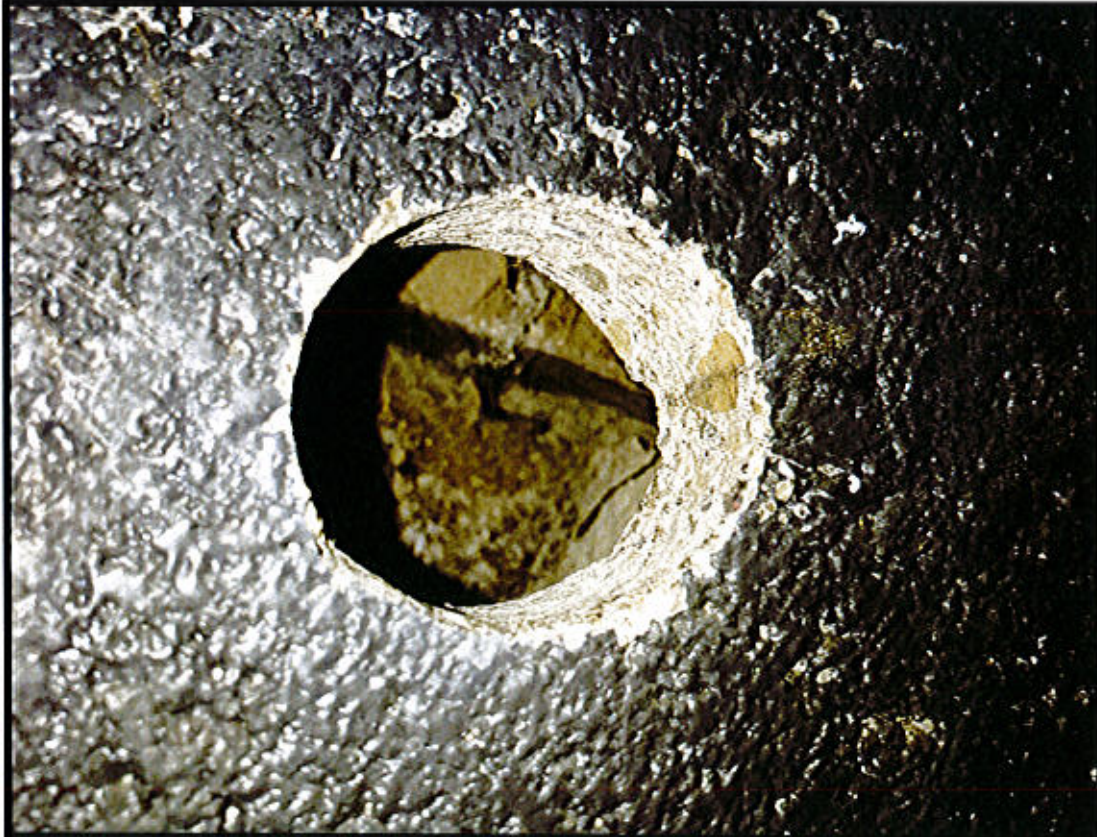
Photo 14. East Lyme Property & Facilities Region 2 Facility – Rt. 156, East Lyme, CT.  
Wall Penetration.

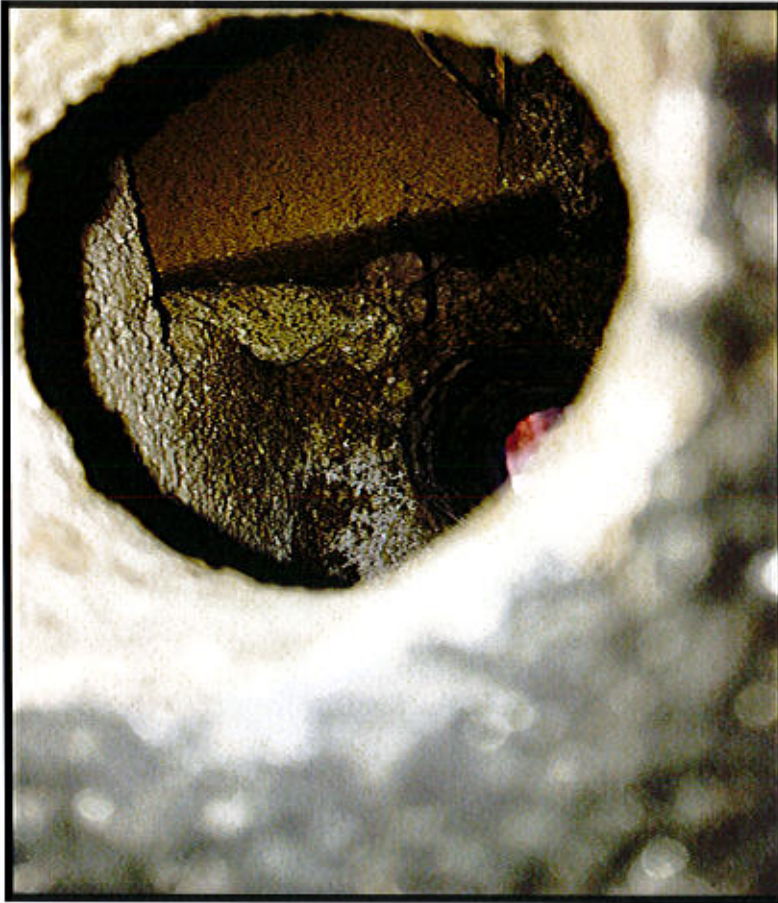
**Photo 15.**  
East Lyme Property &  
Facilities Region 2 Facility –  
Rt. 156, East Lyme, CT.  
Wall Penetration.

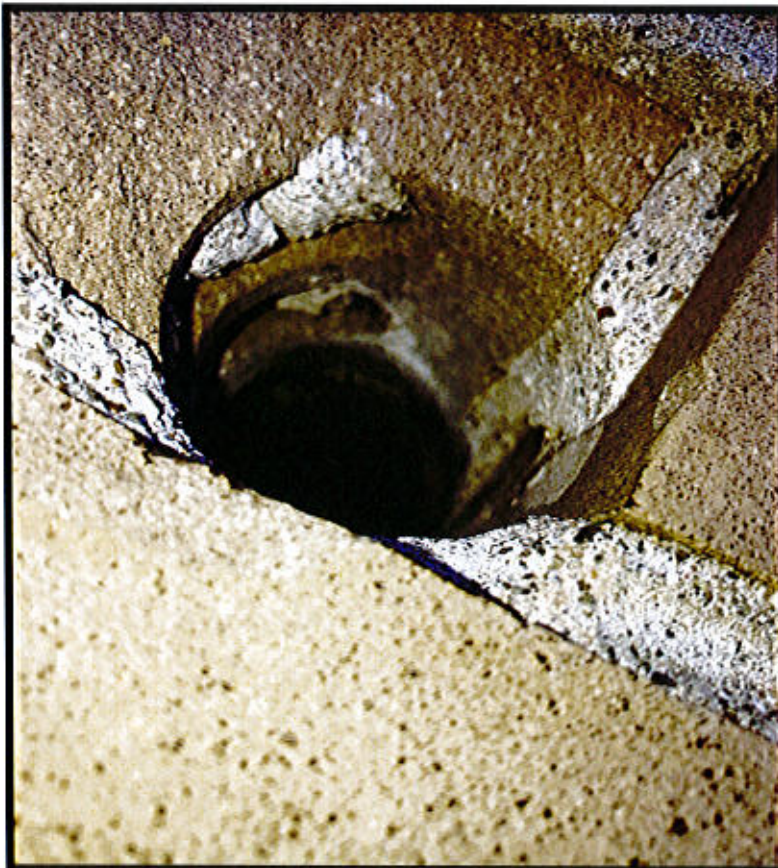
**Photo 16.**  
East Lyme Property &  
Facilities Region 2 Facility –  
Rt. 156, East Lyme, CT.  
Wall Penetration.

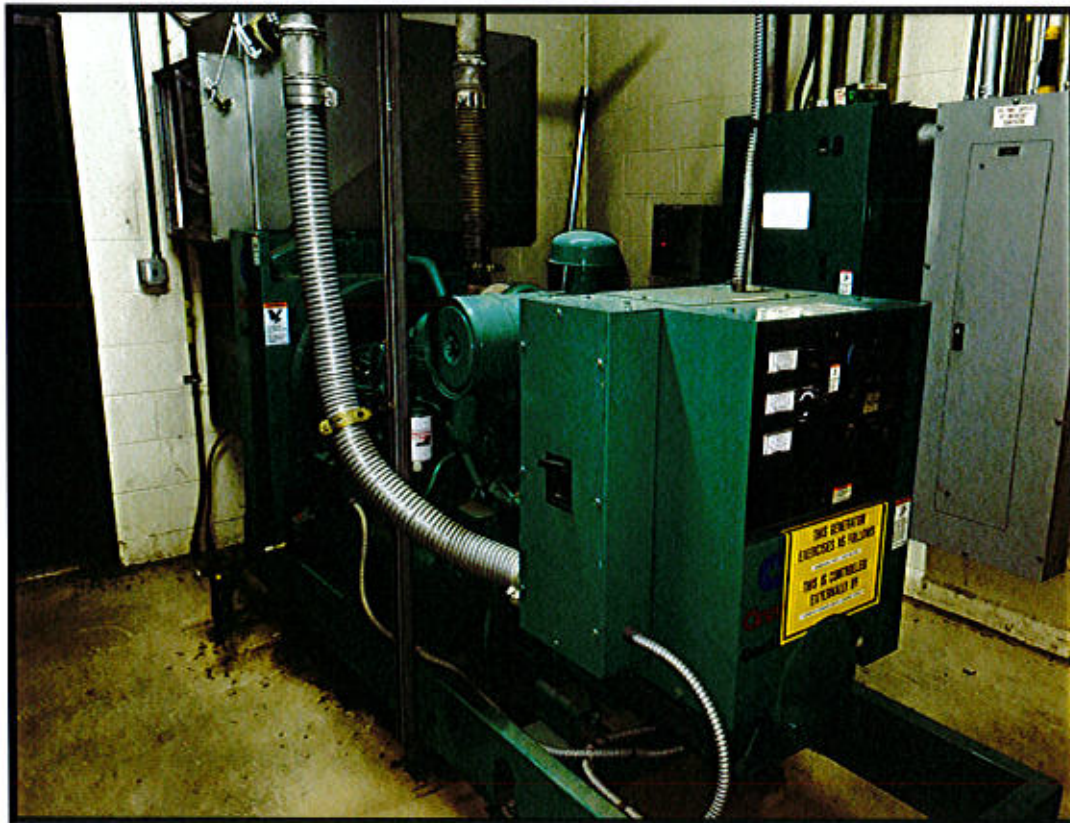
Photo 24. East Windsor Maintenance Facility –  
Prospect Hill Road, East Windsor, CT.  
Generator.

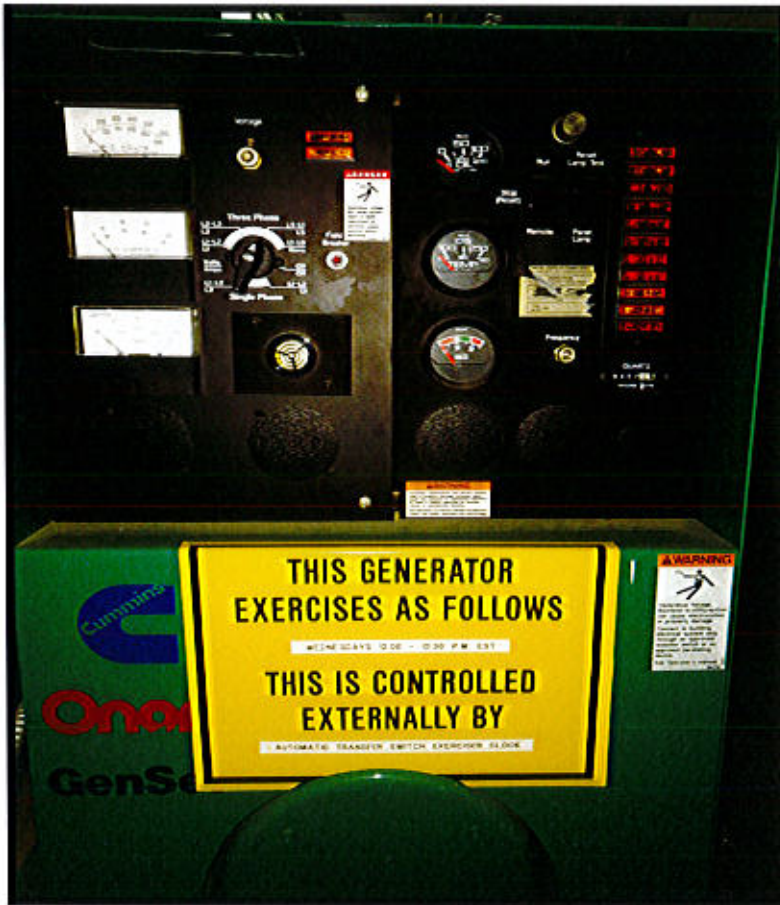
Photo 25.  
 East Windsor Maintenance Facility – Prospect Hill Road, East Windsor, CT.  
 Generator Control.

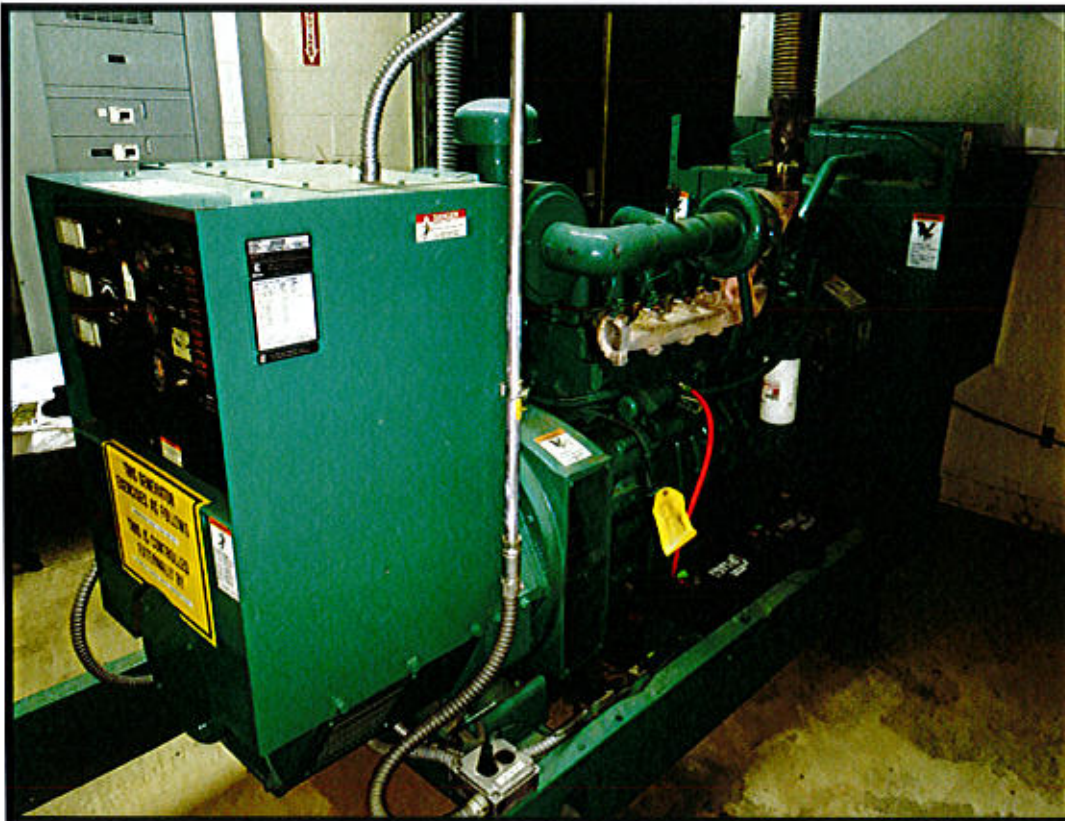
Photo 26. East Windsor Maintenance Facility – Prospect Hill Road, East Windsor, CT.  
 Generator.

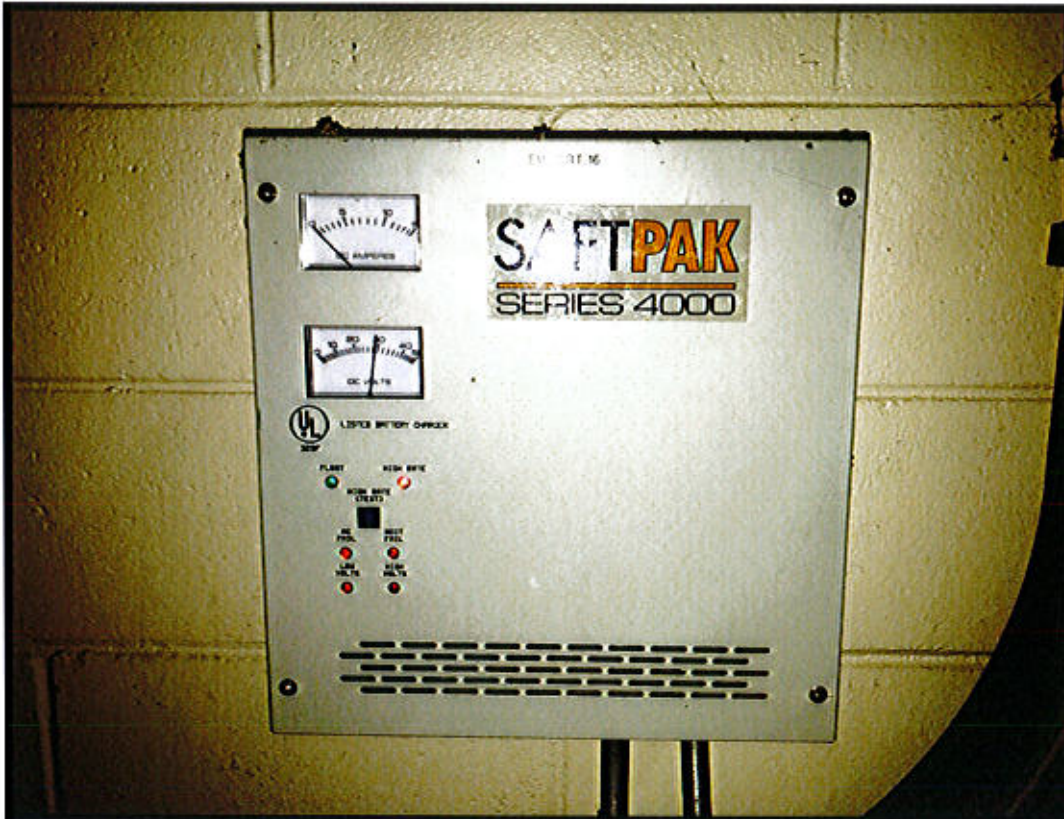
Photo 27. East Windsor Maintenance Facility –  
Prospect Hill Road, East Windsor, CT.  
Control Panel.

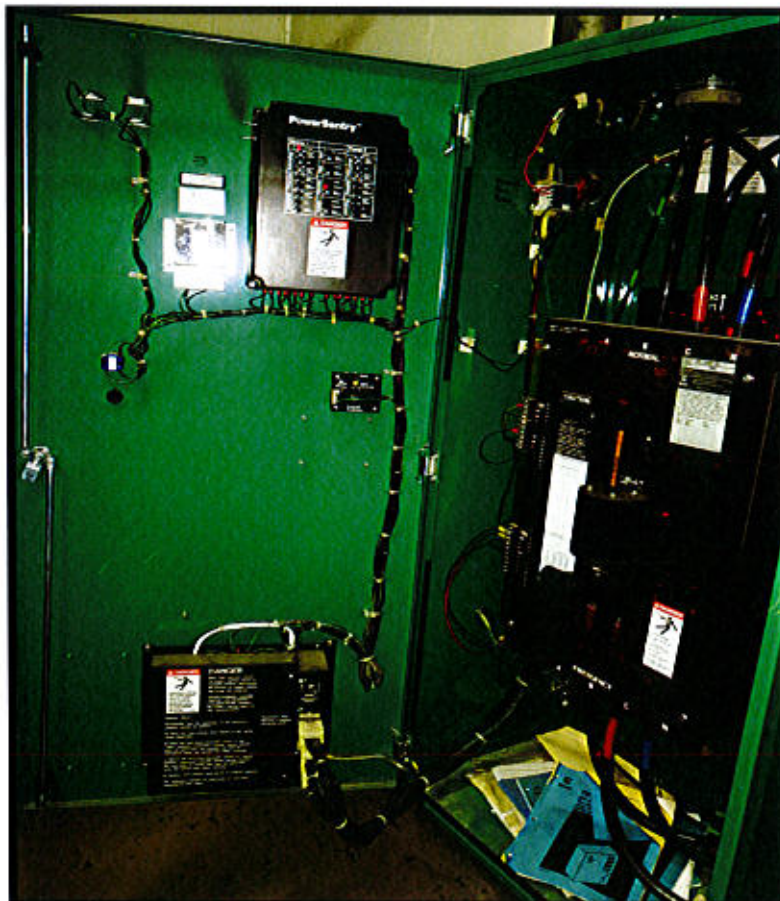
Photo 28.  
East Lyme Property &  
Facilities Region 2 Facility –  
Rt. 156, East Lyme, CT.  
Inside Generator Control.

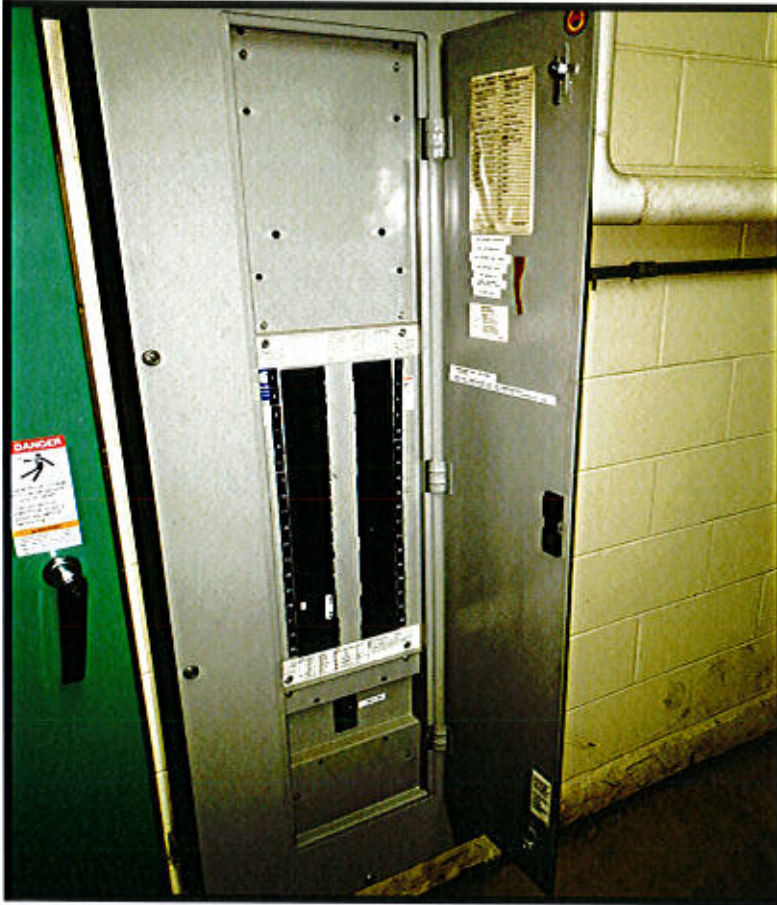
**Photo 29.**  
East Windsor Maintenance  
Facility – Prospect Hill Road,  
East Windsor, CT.  
Electrical Panel.

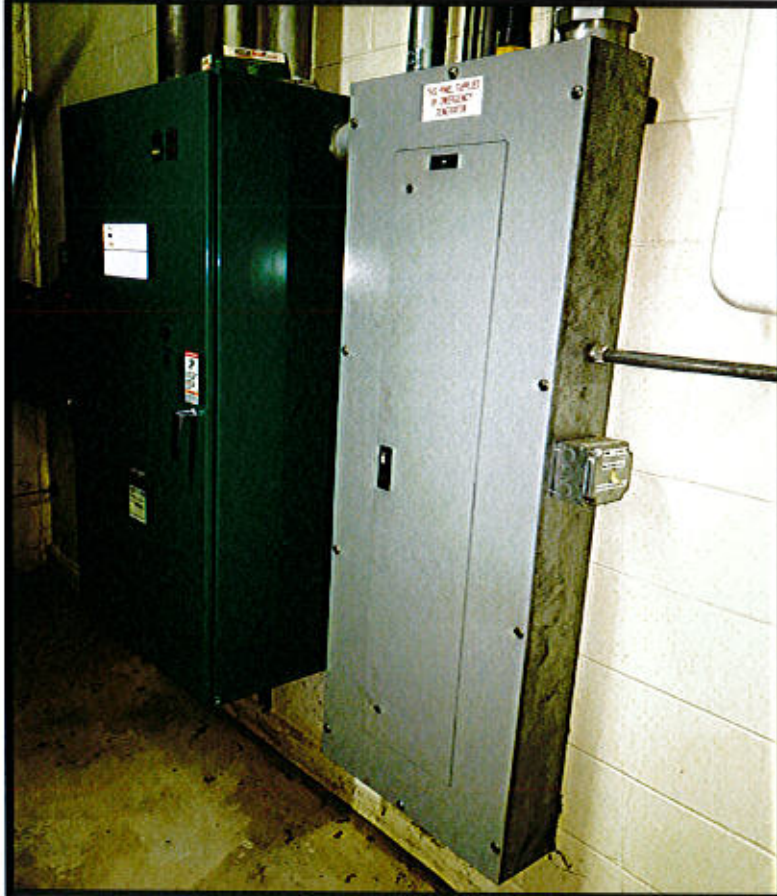
**Photo 30.**  
East Windsor Maintenance  
Facility – Prospect Hill Road,  
East Windsor, CT.  
Generator & Electrical Box.

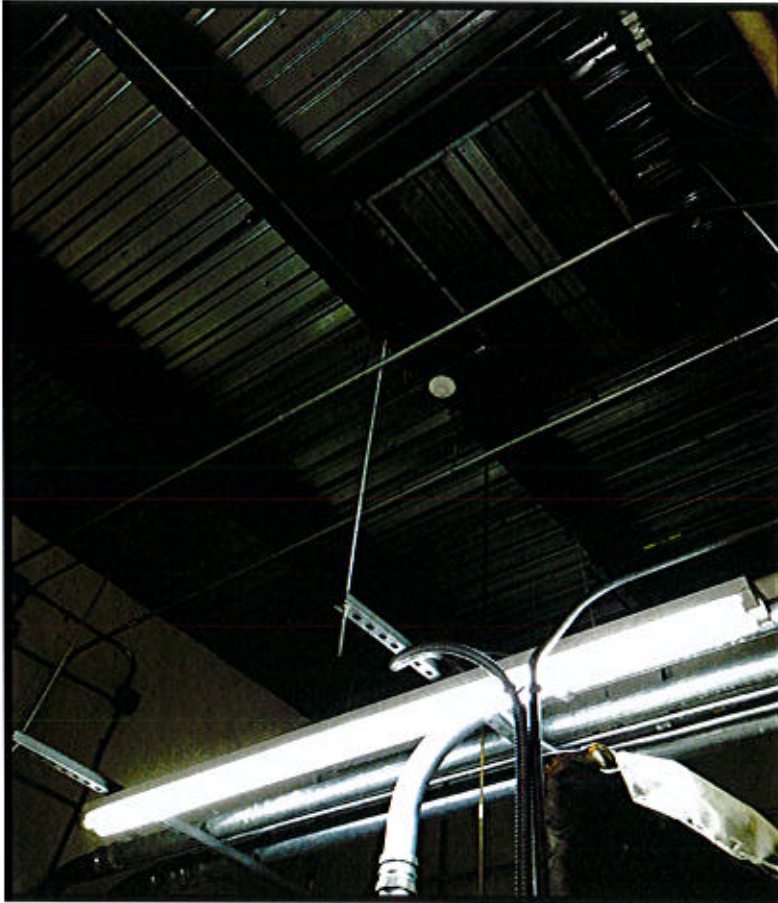
**Photo 31.**  
East Windsor Maintenance  
Facility – Prospect Hill Road,  
East Windsor, CT.  
Generator Room Ceiling.

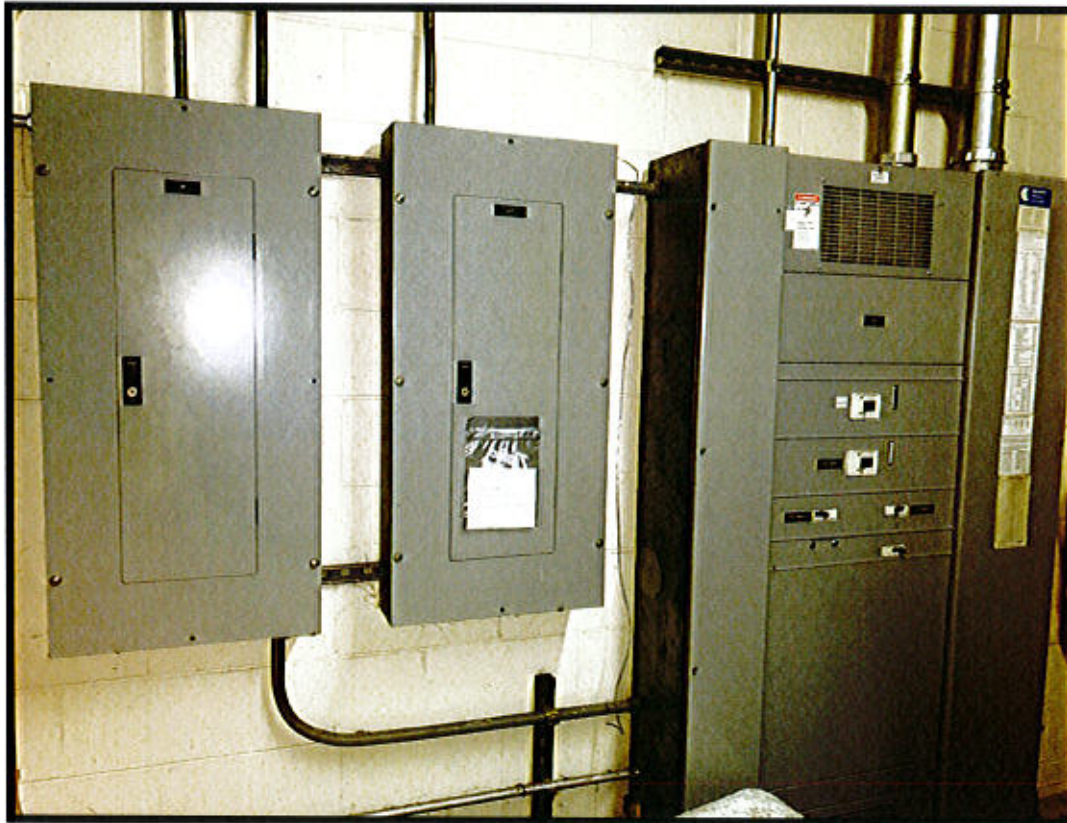
**Photo 32.** East Windsor Maintenance Facility –  
Prospect Hill Road, East Windsor, CT.  
Electrical Panels

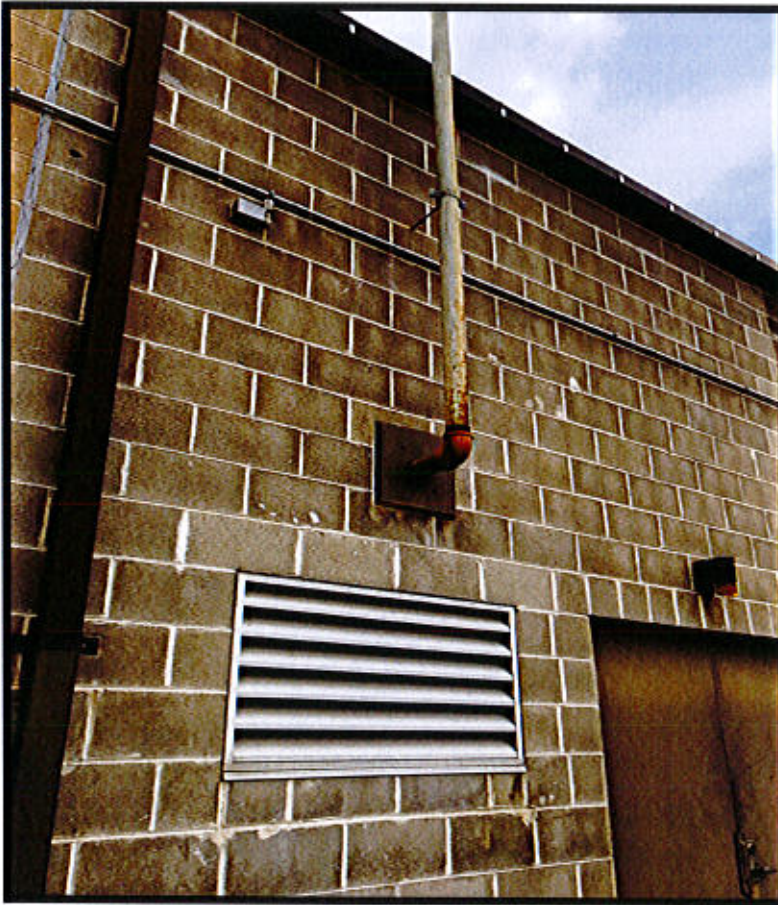
**Photo 33.**  
**East Windsor Maintenance Facility – Prospect Hill Road, East Windsor, CT.**  
Generator Room Vent and Generator Exhaust.

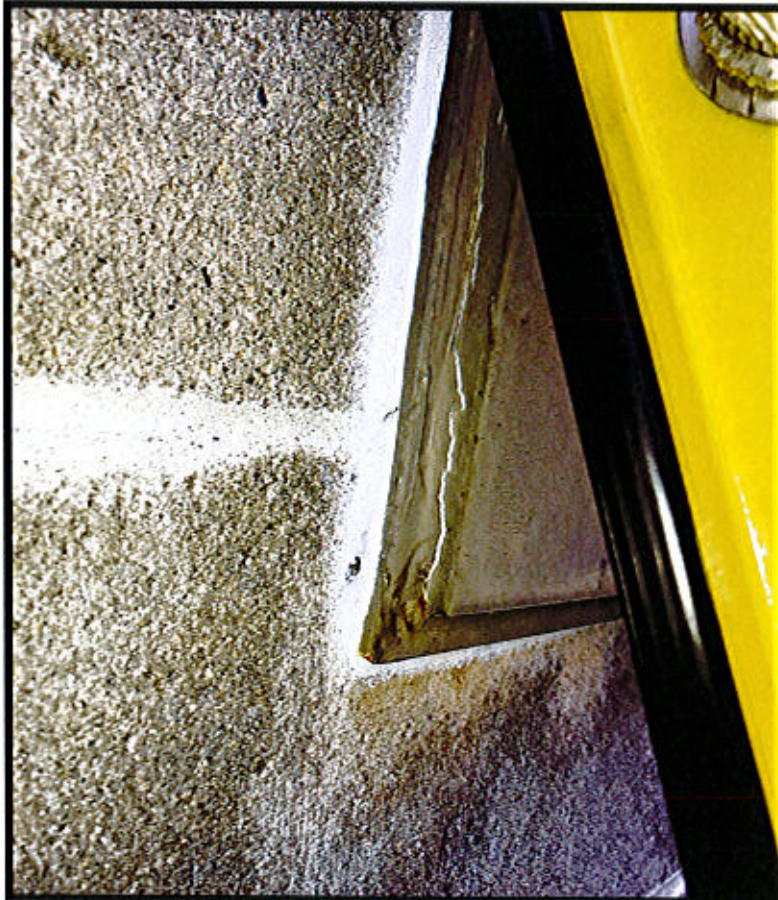
**Photo 34.**  
**East Windsor Maintenance Facility – Prospect Hill Road, East Windsor, CT.**  
Generator Exhaust Caulk.

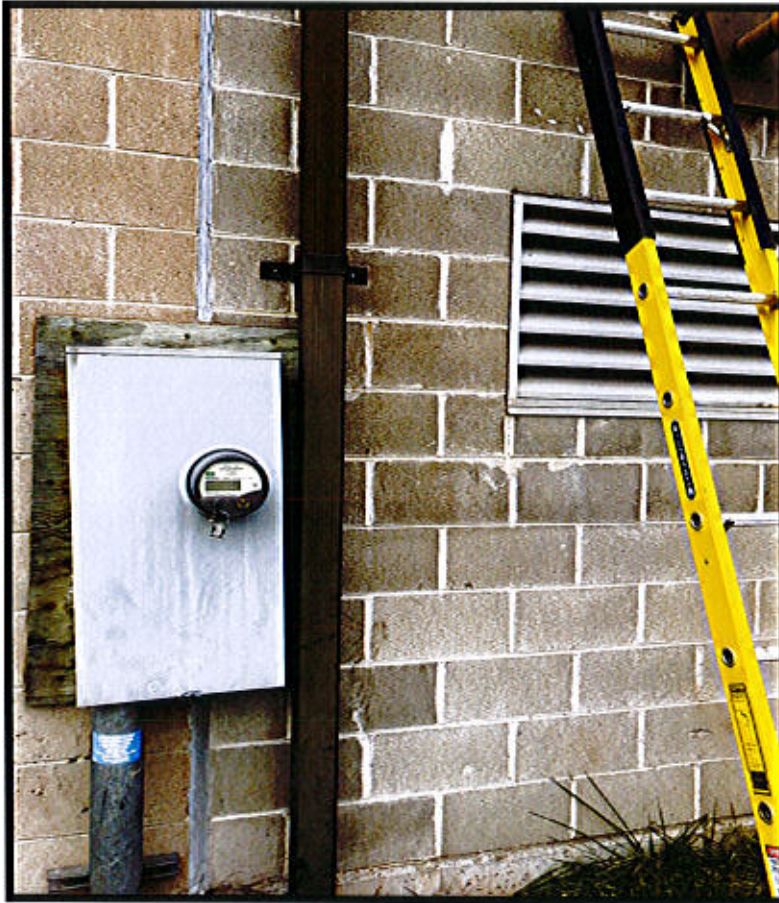
Photo 35.  
East Windsor Maintenance  
Facility – Prospect Hill Road,  
East Windsor, CT.  
Electrical Meter.

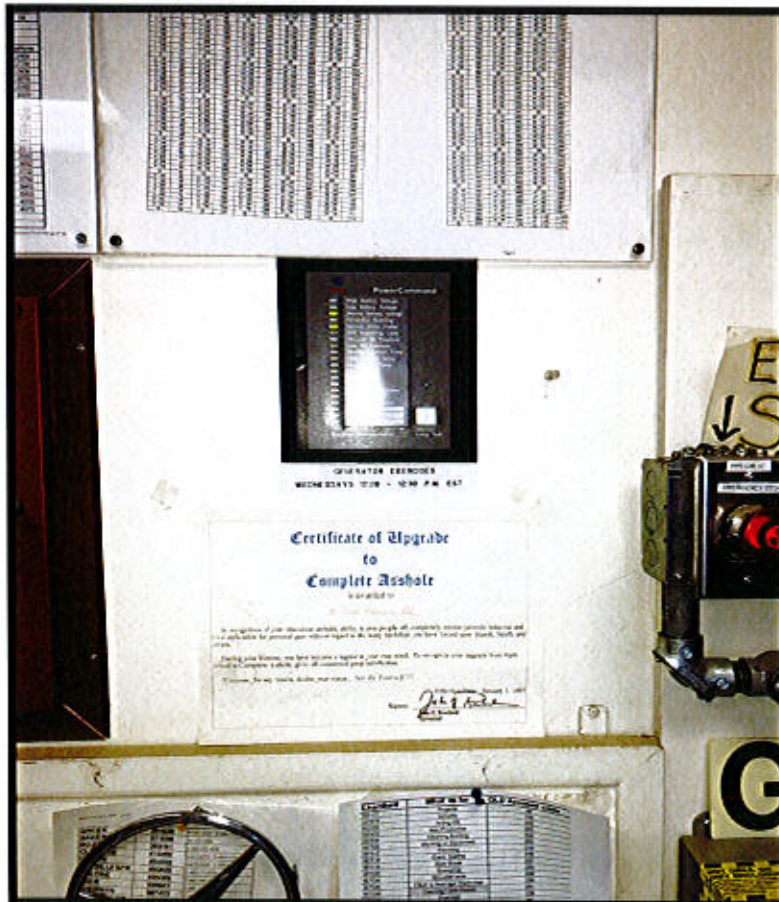
Photo 36.  
East Windsor Maintenance  
Facility – Prospect Hill Road,  
East Windsor, CT.  
Tank Monitoring System.

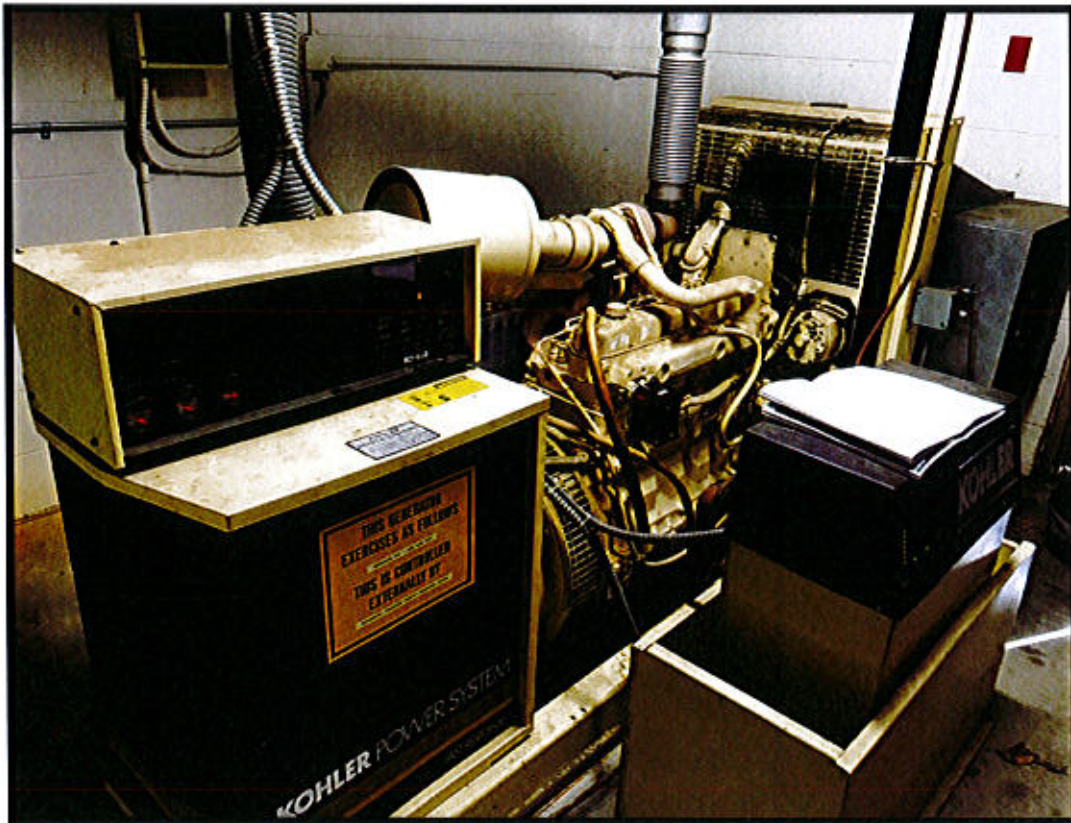
Photo 38. Haddam Maintenance Facility – Saybrook Road, Haddam, CT.  
Generator.
