**PRE-RENOVATION  
INVESTIGATIVE SURVEY FOR  
HAZARDOUS BUILDING MATERIALS  
DOT GENERATOR INSTALLATION/  
REPLACEMENT PROJECTS  
EAST HAVEN, EAST LYME, EAST WINDSOR,  
HADDAM, HARTFORD, MANSFIELD & ROCKY  
HILL, CONNECTICUT  
Project No. 170-3476**

**PRE-RENOVATION  
INVESTIGATIVE SURVEY FOR  
HAZARDOUS BUILDING MATERIALS**

**GENERATOR INSTALLATION/  
REPLACEMENTS**  
**EAST HAVEN, EAST LYME, EAST WINDSOR,  
HADDAM, HARTFORD, MANSFIELD &  
ROCKY HILL, CONNECTICUT**  
Project No. 170-3476

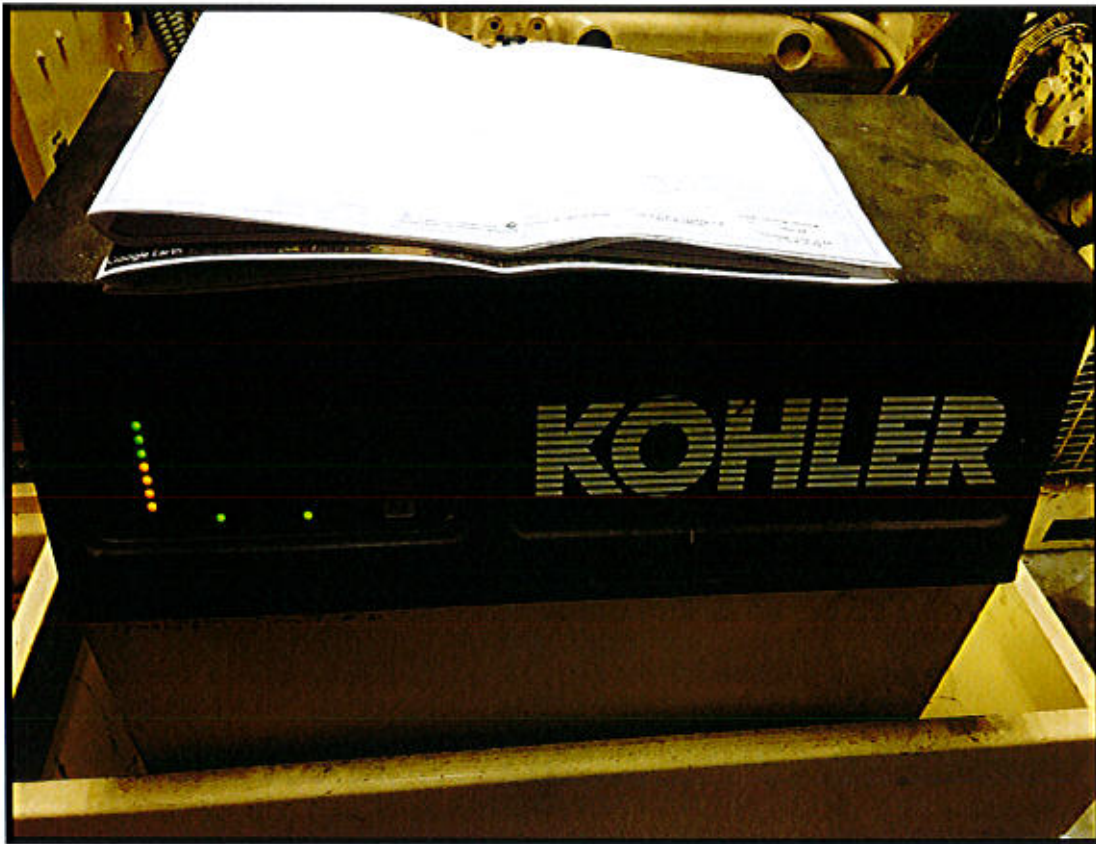
Photo 39. Haddam Maintenance Facility – Saybrook Road, Haddam, CT.  
Generator Control.

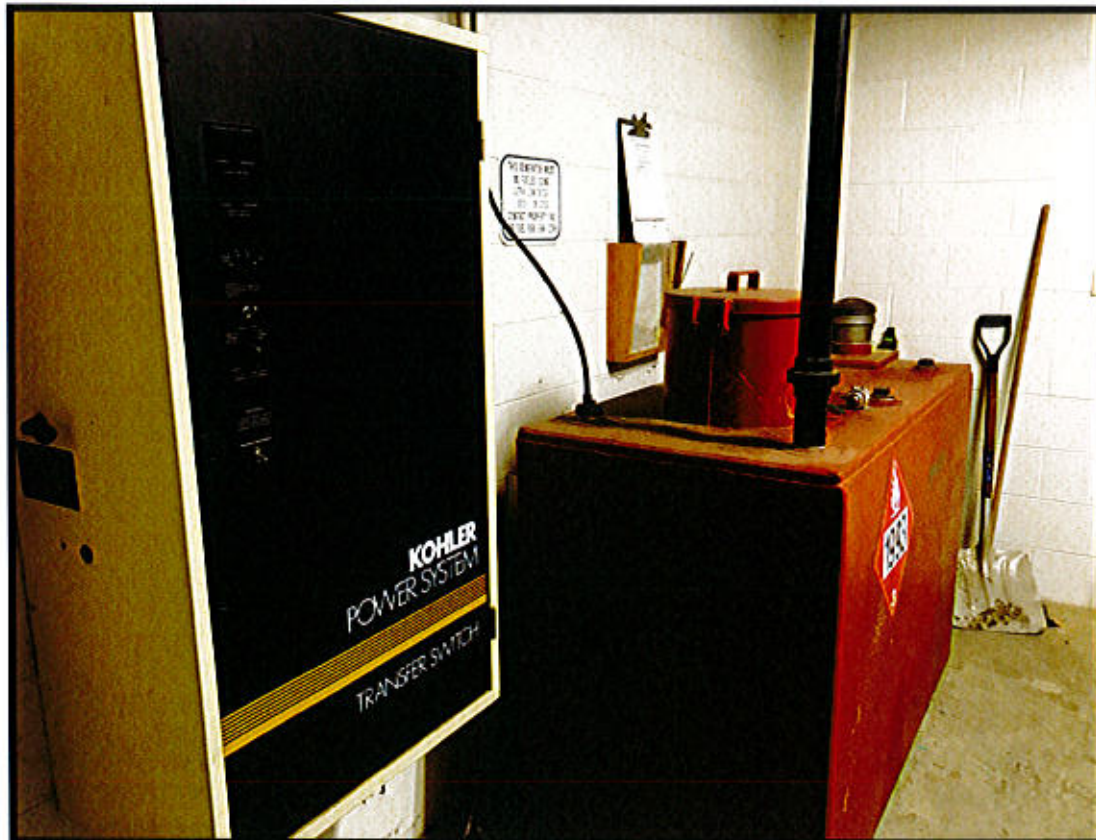
Photo 40. Haddam Maintenance Facility – Saybrook Road, Haddam, CT.  
Generator Transfer and Fuel Tank.

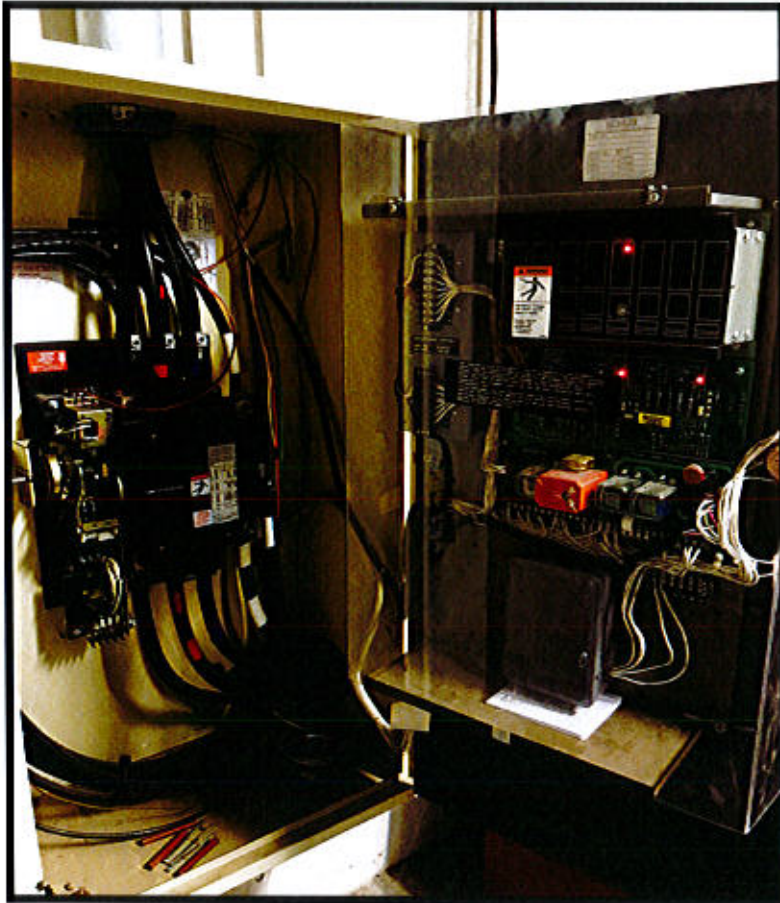
Photo 41.  
Haddam Maintenance Facility –  
Saybrook Road, Haddam, CT.  
Inside Generator Transfer.

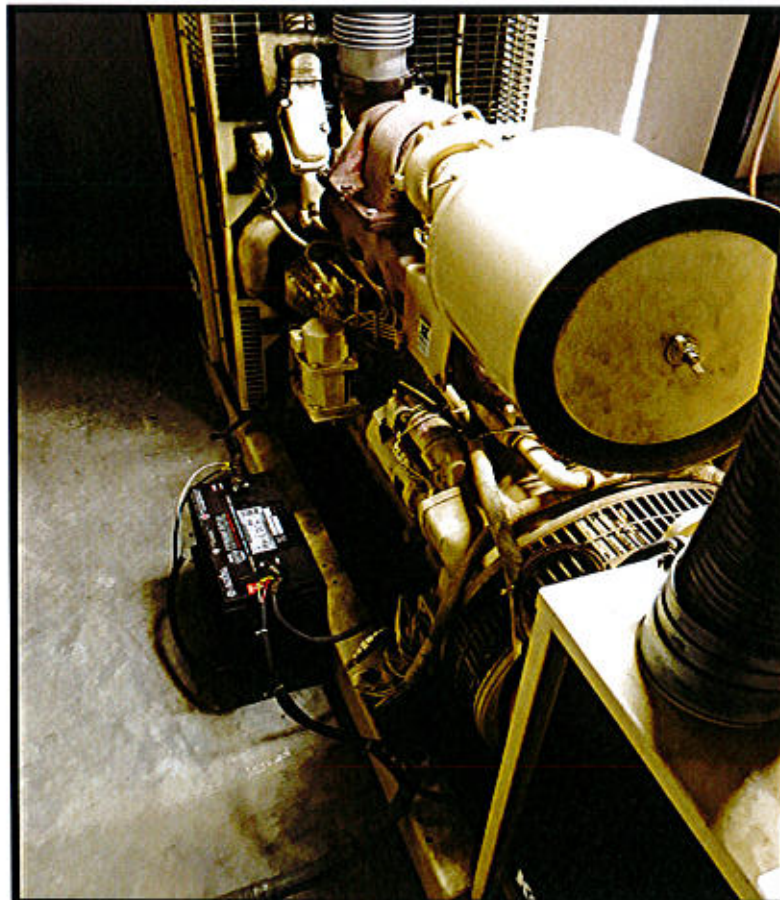
Photo 42.  
Haddam Maintenance Facility –  
Saybrook Road, Haddam, CT.  
Generator.

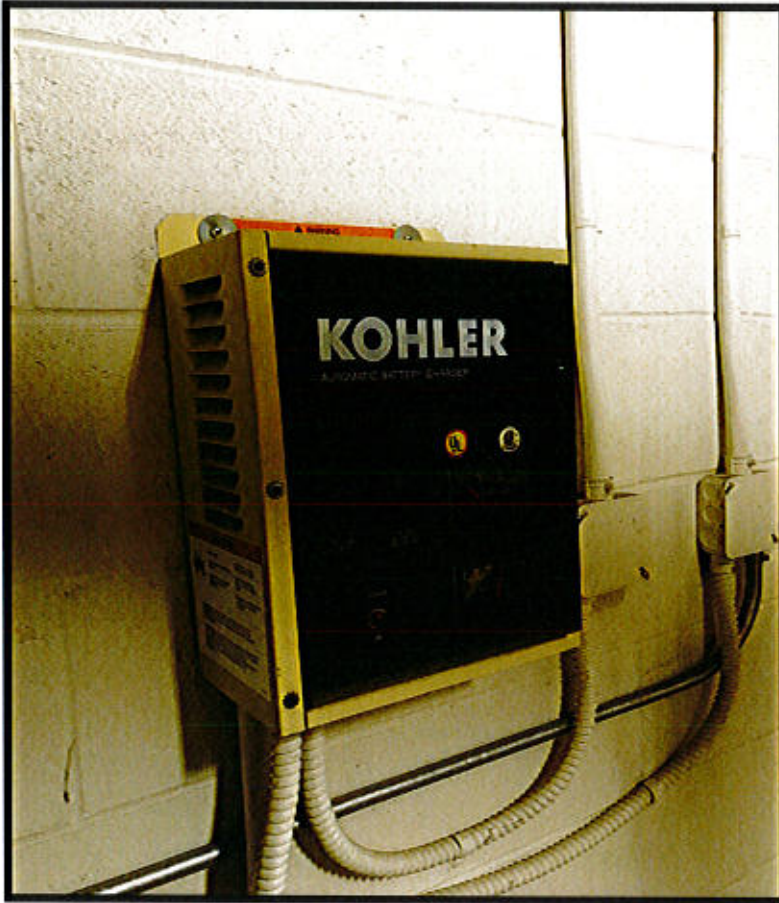
Photo 43.  
Haddam Maintenance  
Facility – Saybrook Road,  
Haddam, CT.  
Generator Battery Charger.

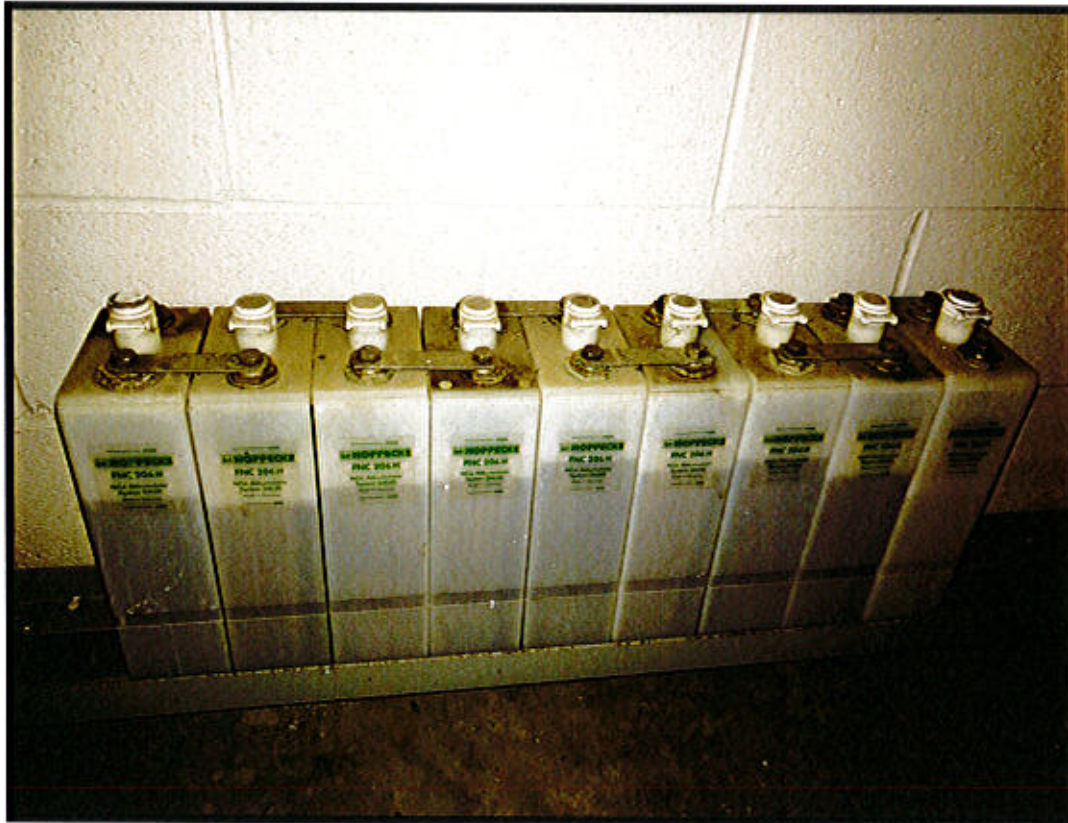
Photo 44. Haddam Maintenance Facility – Saybrook Road, Haddam, CT.  
Batteries.

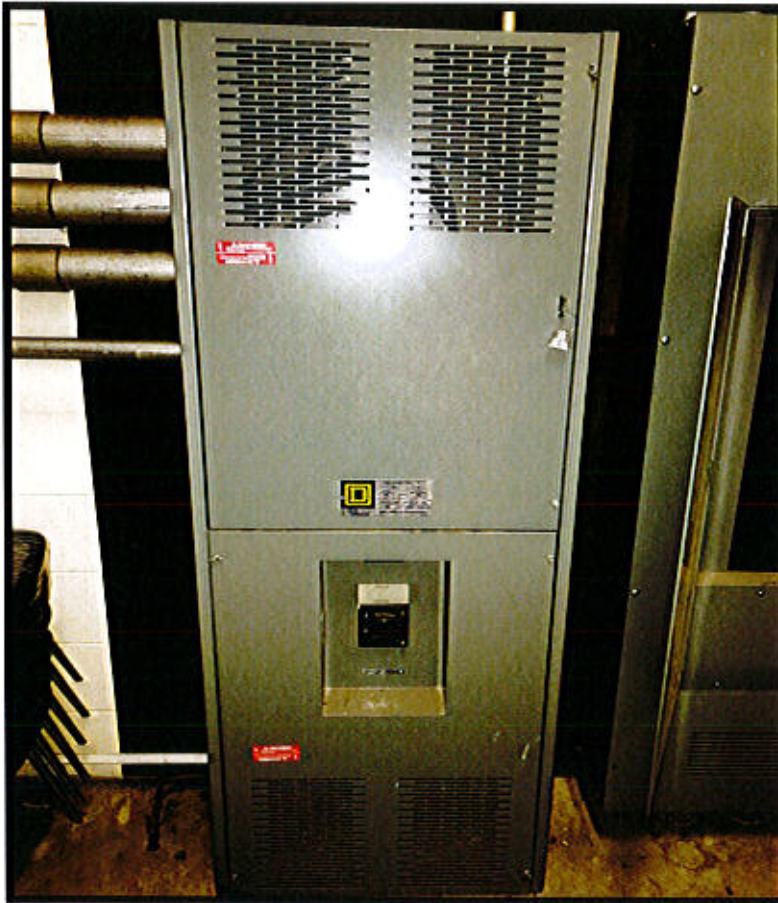
Photo 45.  
 Hartford Bridge & Electrical  
 Maintenance Facility –  
 49 Jennings Road, Hartford, CT  
 Generator Room Panel.

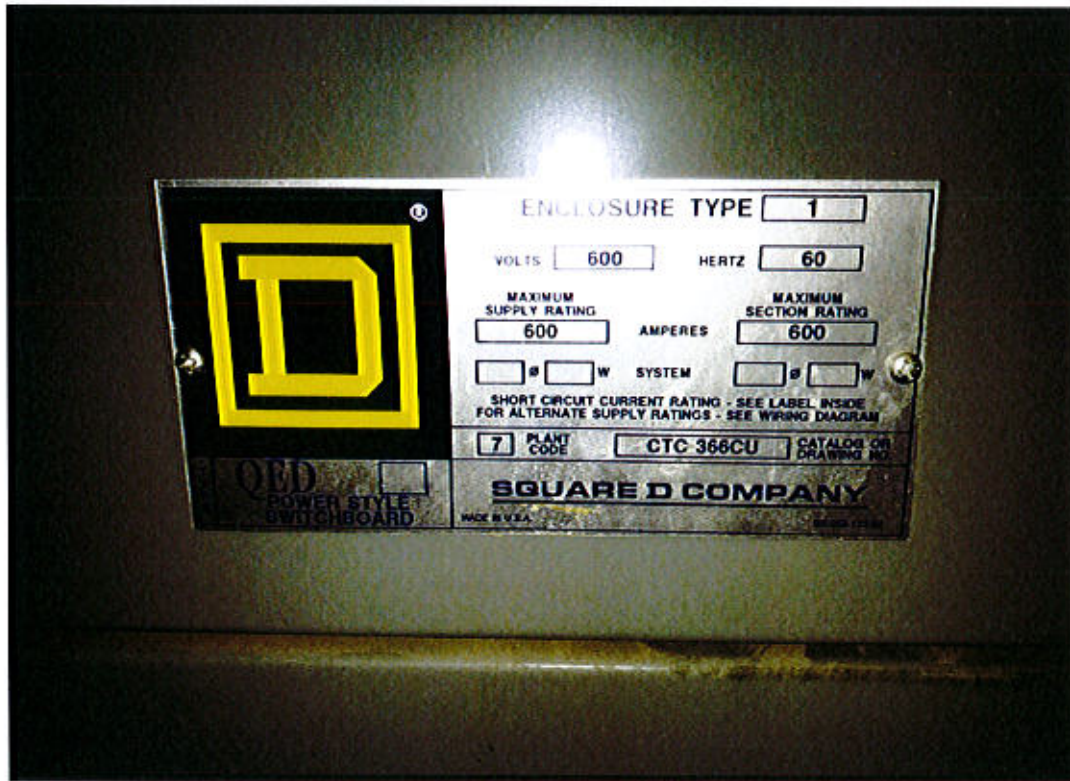
Photo 46. Hartford Bridge & Electrical Maintenance Facility –  
 49 Jennings Road, Hartford, CT  
 Generator Room Panel Label.

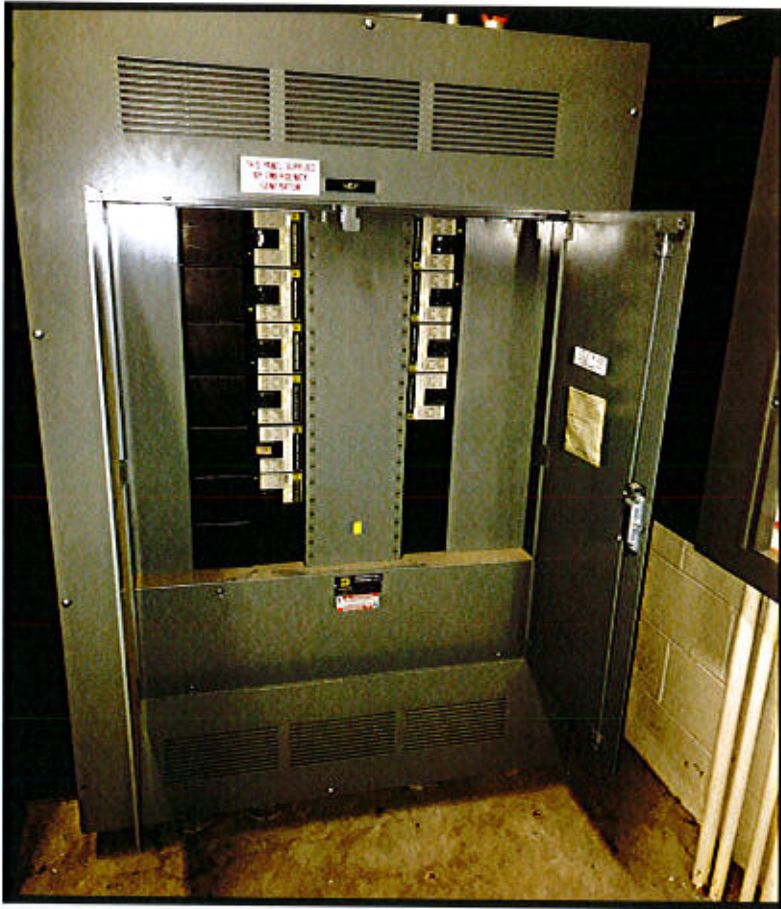
Photo 47.  
Hartford Bridge & Electrical  
Maintenance Facility –  
49 Jennings Road, Hartford, CT  
Generator Panel.

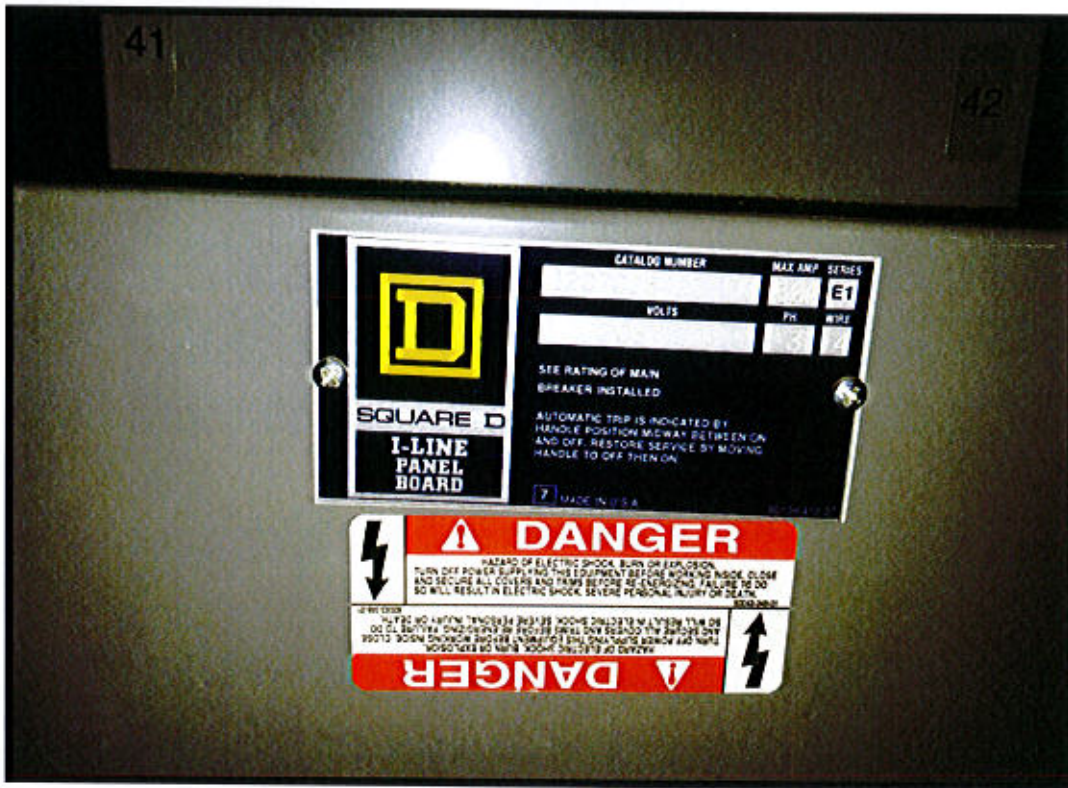
Photo 48. Hartford Bridge & Electrical Maintenance Facility –  
49 Jennings Road, Hartford, CT  
Generator Panel Label.

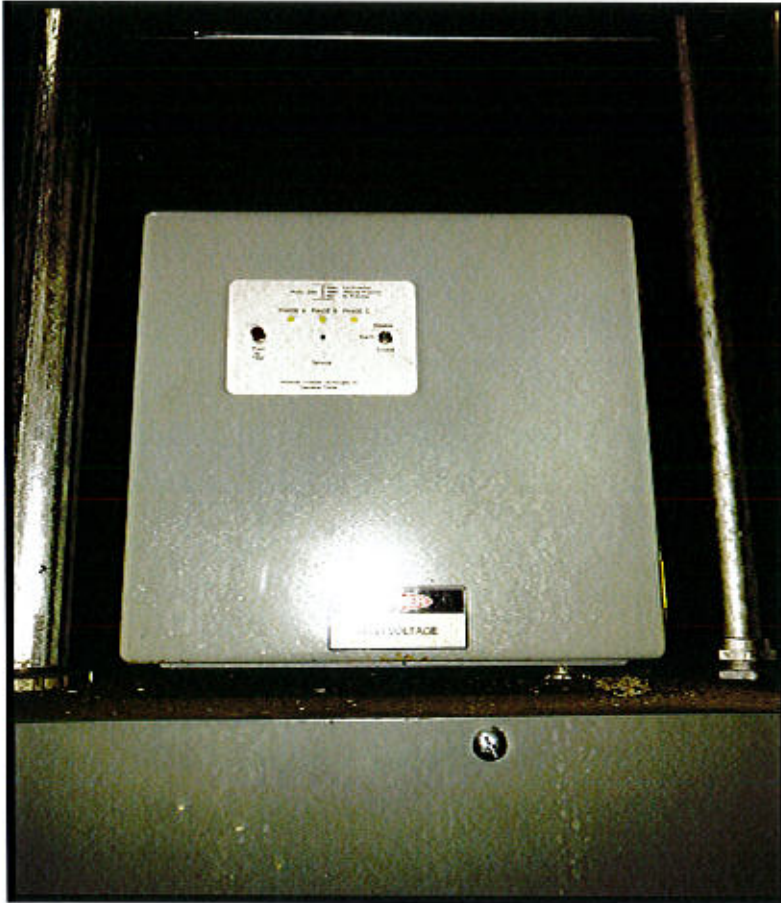
Photo 49.  
Hartford Bridge & Electrical  
Maintenance Facility –  
49 Jennings Road, Hartford, CT  
Generator Room Panel.

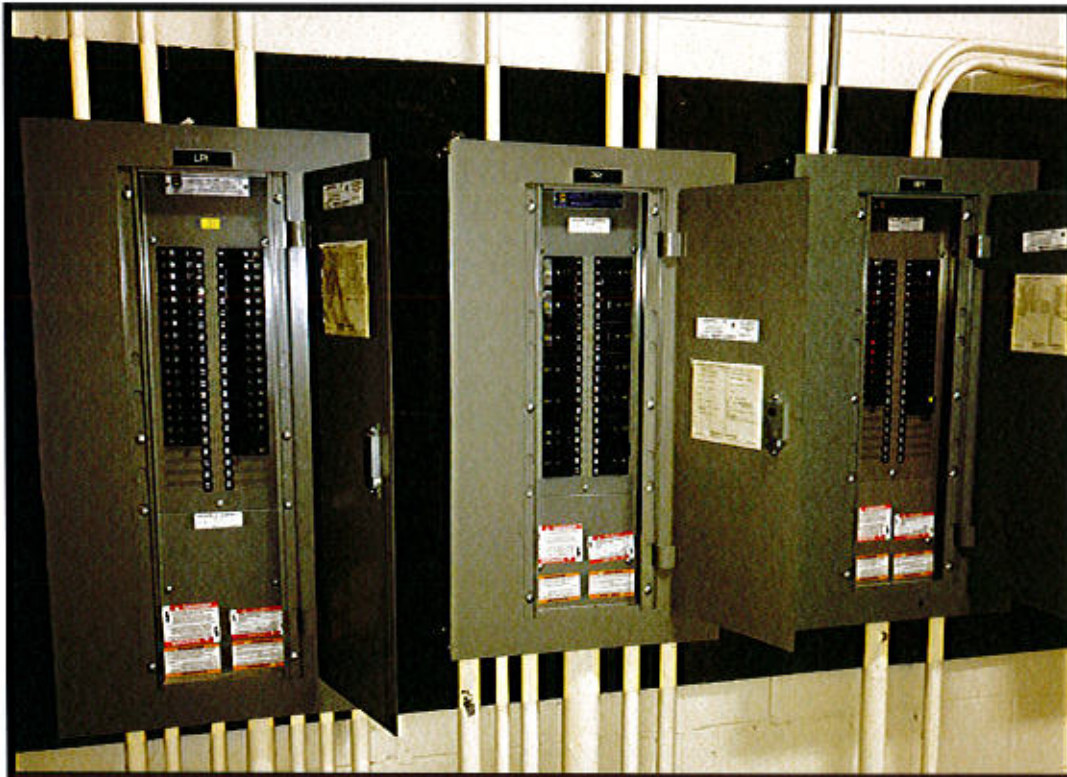
Photo 50. Hartford Bridge & Electrical Maintenance Facility –  
49 Jennings Road, Hartford, CT.  
Generator Room Electrical Panel

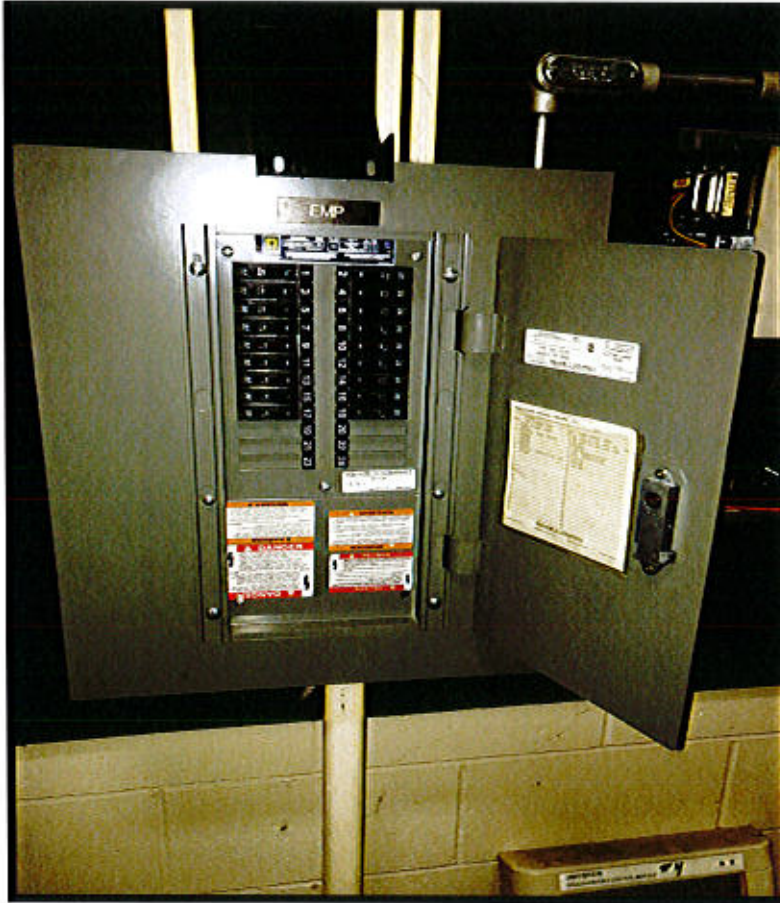
Photo 51.  
Hartford Bridge & Electrical  
Maintenance Facility –  
49 Jennings Road, Hartford, CT  
Generator Room Electrical Panel.

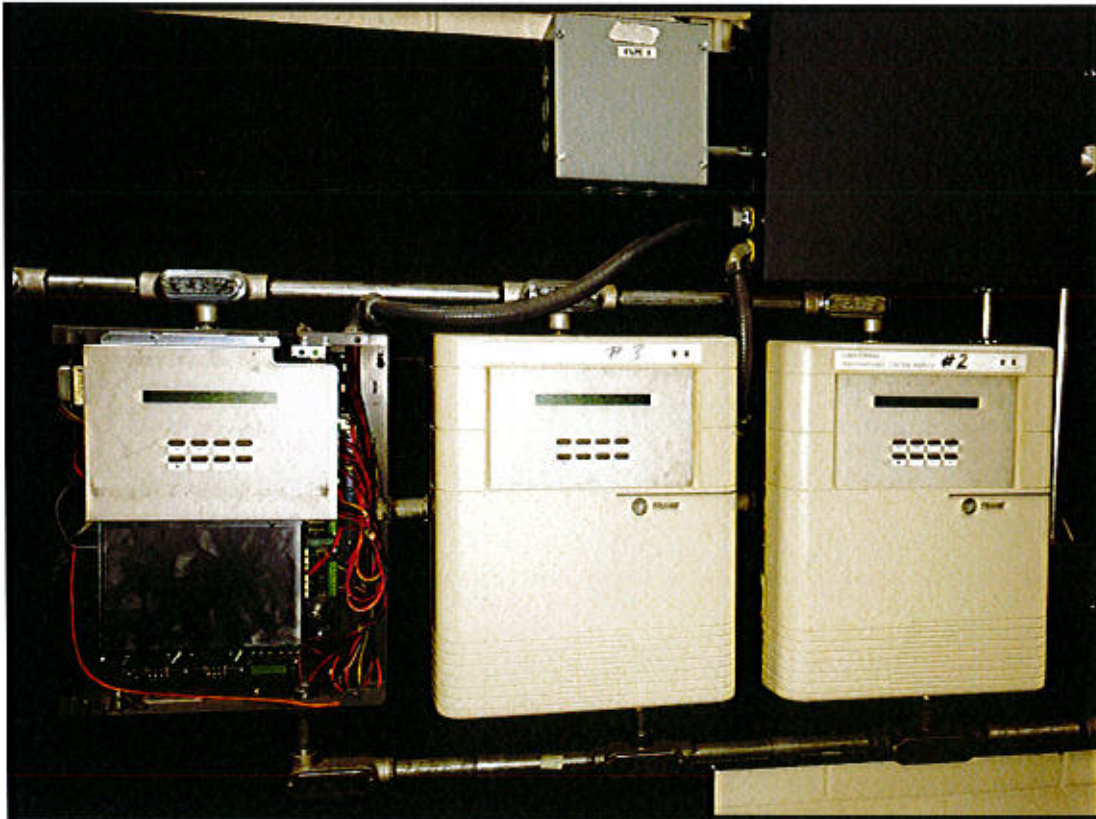
Photo 52. Hartford Bridge & Electrical Maintenance Facility –  
49 Jennings Road, Hartford, CT  
Trane Control Boxes.

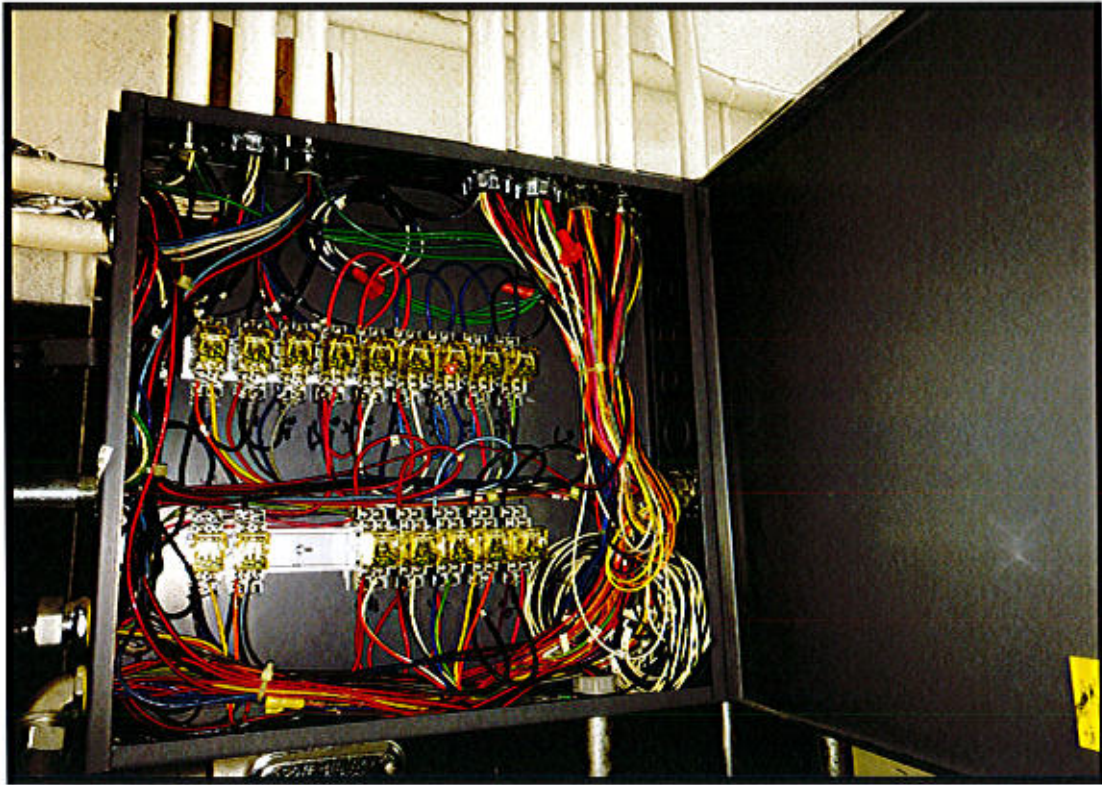
Photo 53. Hartford Bridge & Electrical Maintenance Facility –  
49 Jennings Road, Hartford, CT.  
Control Box.

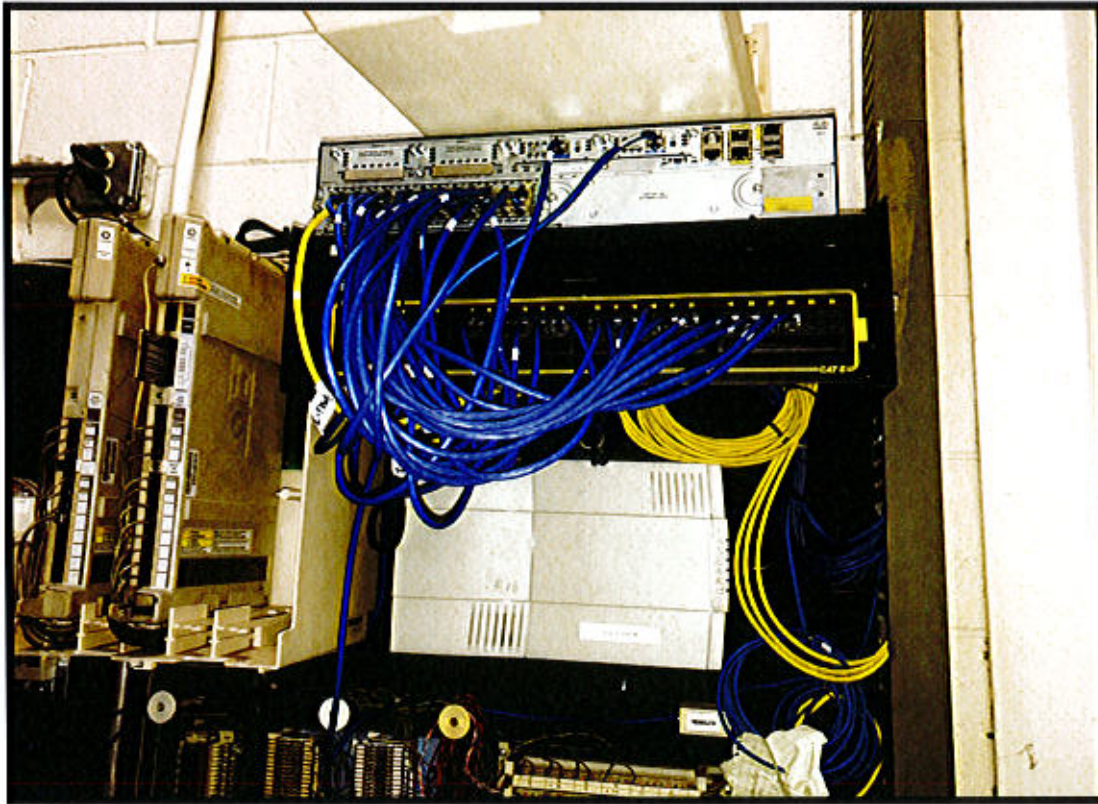
Photo 54. Hartford Bridge & Electrical Maintenance Facility –  
49 Jennings Road, Hartford, CT.  
Various Controls.

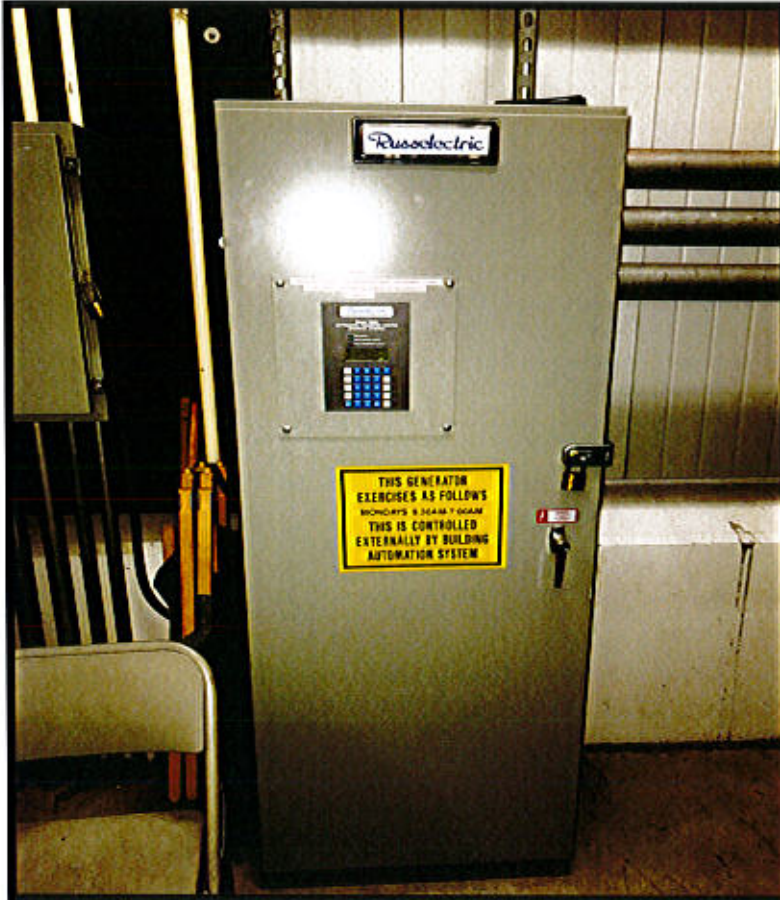
Photo 55.  
Hartford Bridge & Electrical  
Maintenance Facility –  
49 Jennings Road, Hartford, CT  
Generator Control Box.

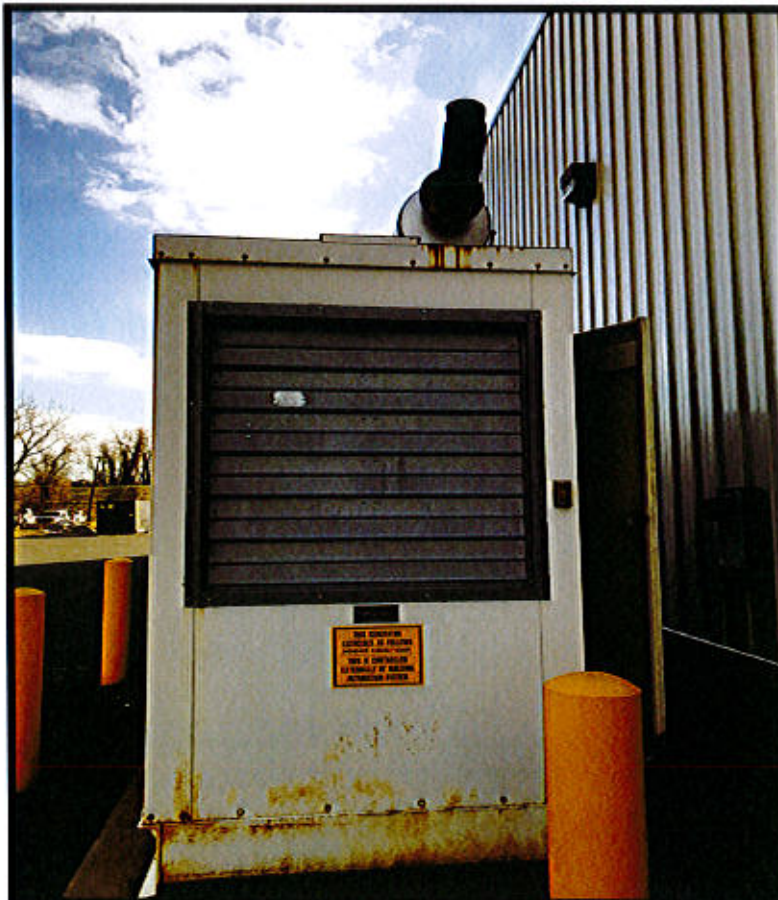
Photo 56.  
Hartford Bridge & Electrical  
Maintenance Facility –  
49 Jennings Road, Hartford, CT  
Generator.

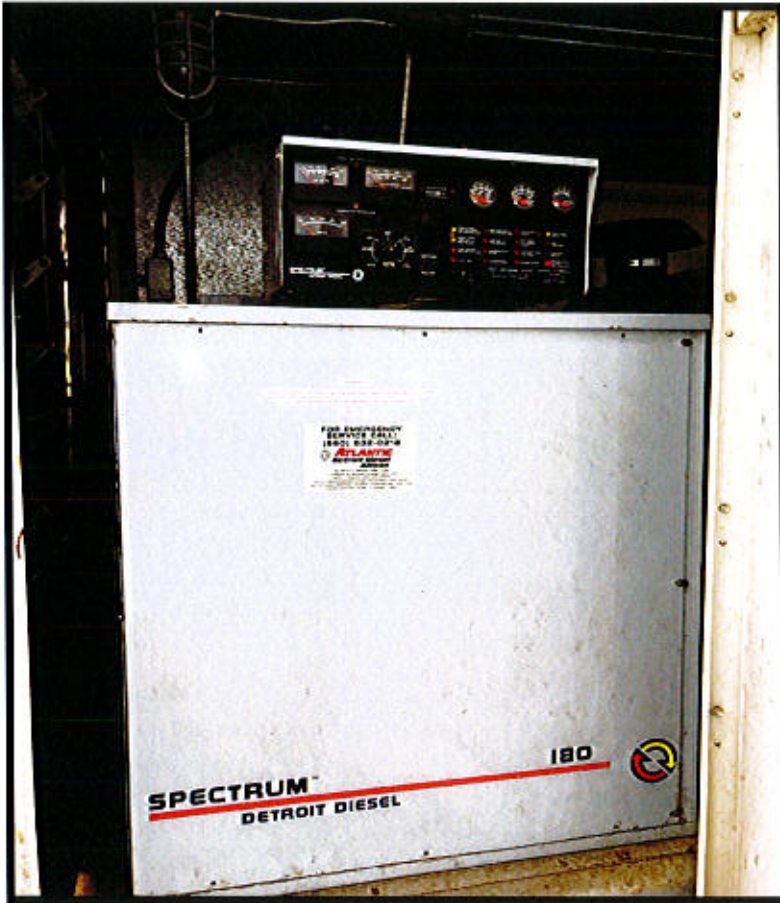
Photo 57.  
Hartford Bridge & Electrical  
Maintenance Facility –  
49 Jennings Road, Hartford, CT  
Inside Generator.

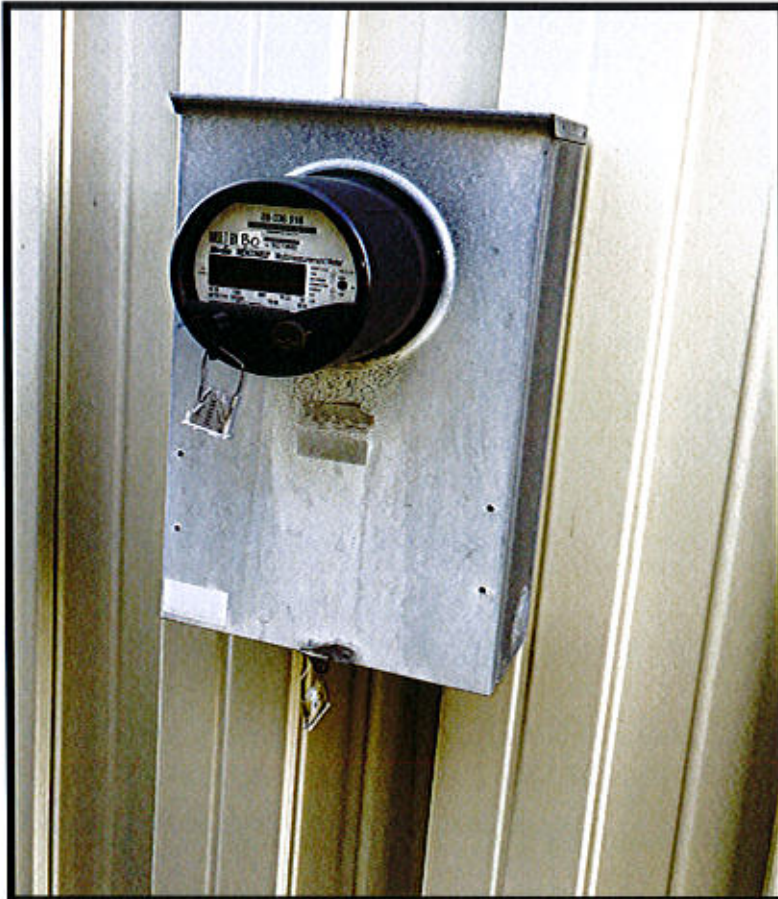
Photo 58.  
Hartford Bridge & Electrical  
Maintenance Facility –  
49 Jennings Road, Hartford, CT  
Electrical Meter.

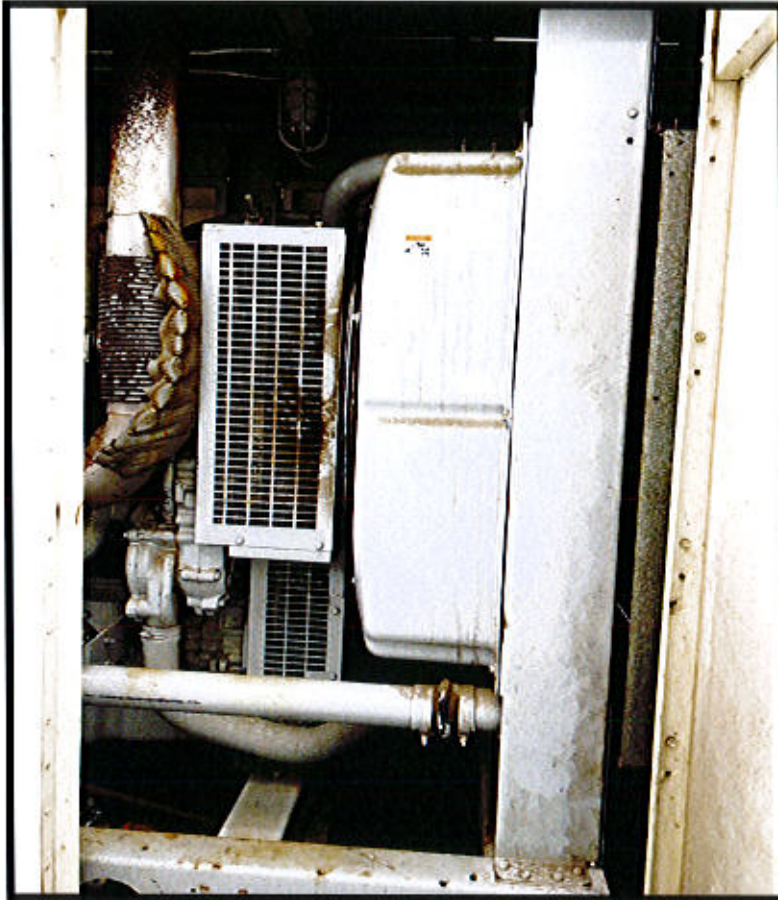
Photo 59.  
Hartford Bridge & Electrical  
Maintenance Facility –  
49 Jennings Road, Hartford, CT  
Inside Generator.

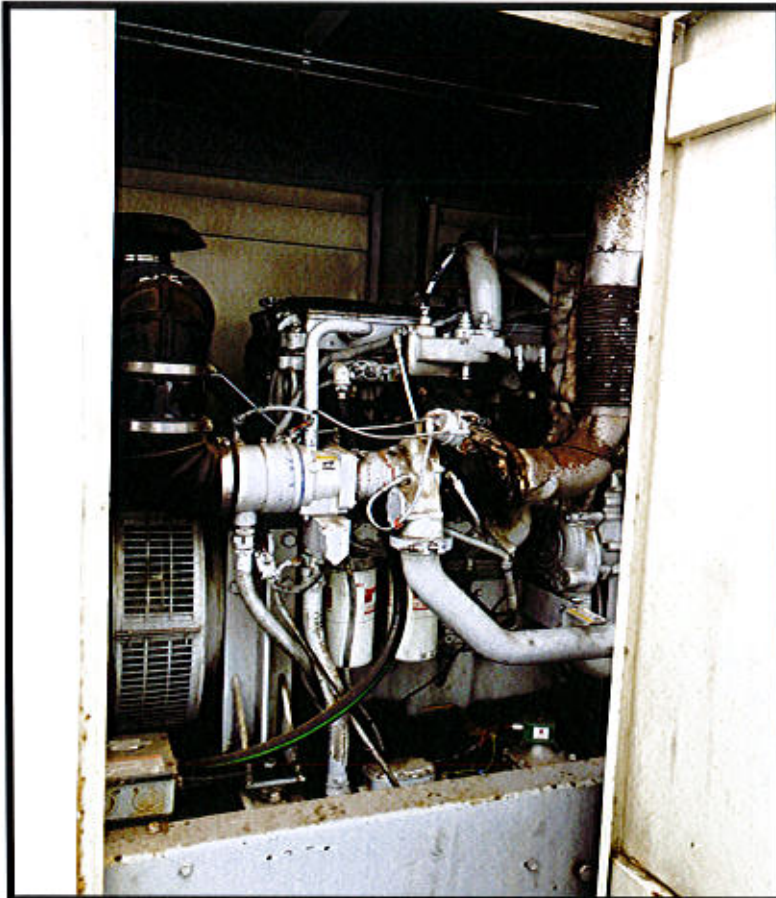
Photo 60.  
Hartford Bridge & Electrical  
Maintenance Facility –  
49 Jennings Road, Hartford, CT  
Inside Generator.

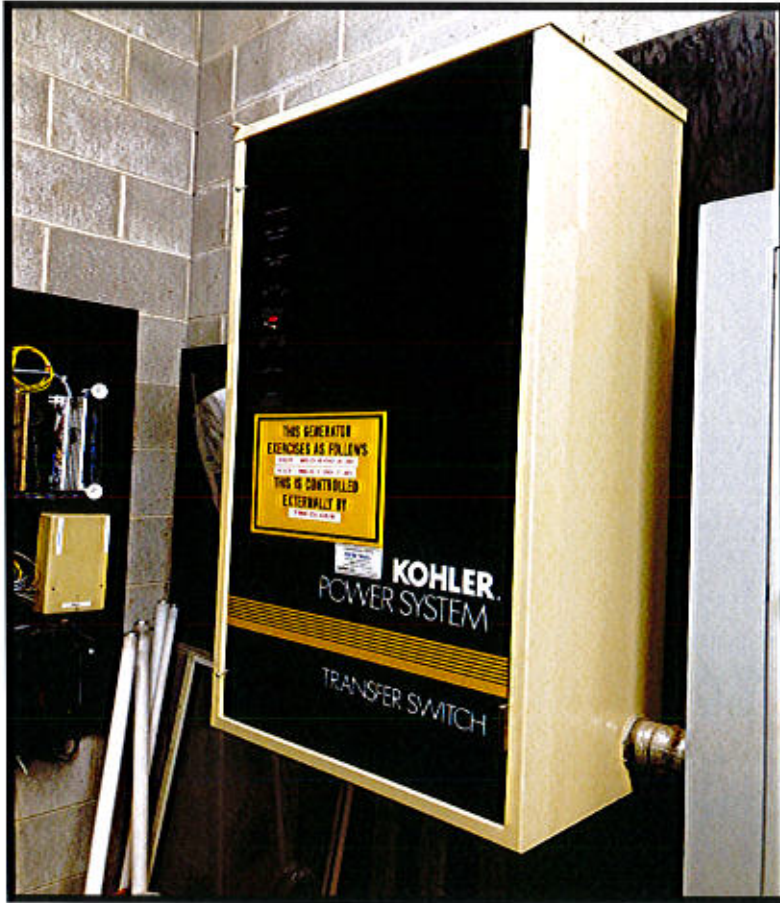
Photo 61.  
Mansfield Maintenance  
Facility – 100 N. Frontage Road,  
Mansfield, CT.  
Generator Transfer Switch.

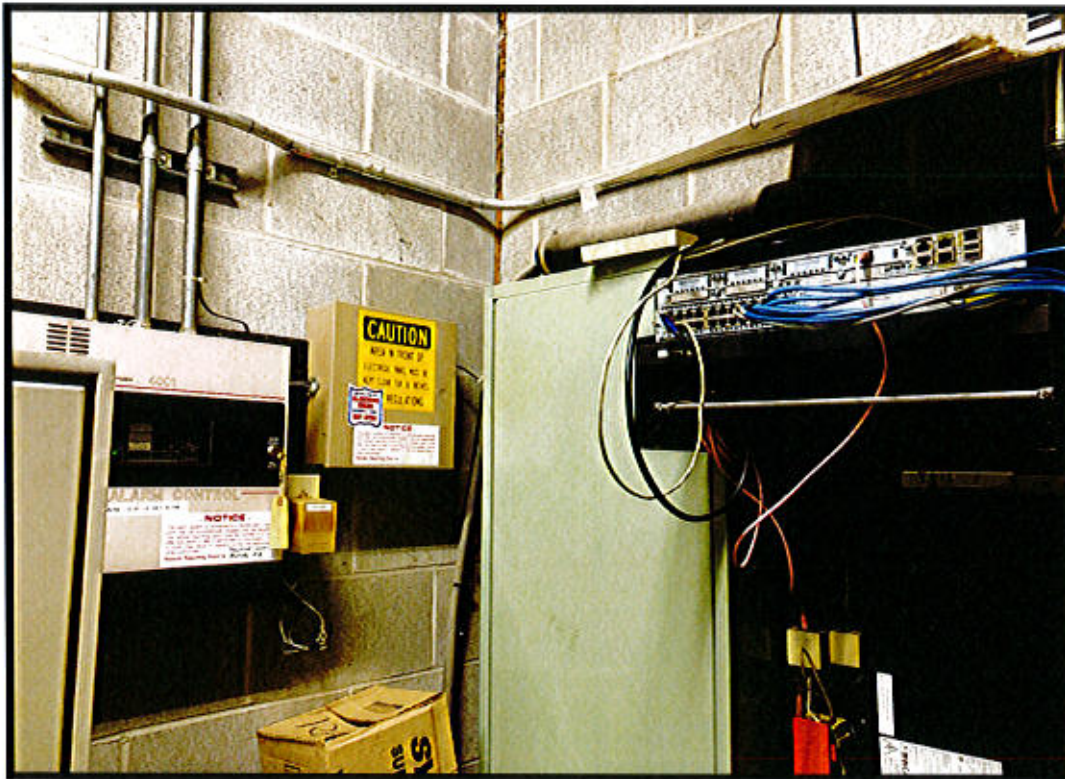
Photo 62. Mansfield Maintenance Facility – 100 N. Frontage Road, Mansfield, CT.  
Alarm Control.

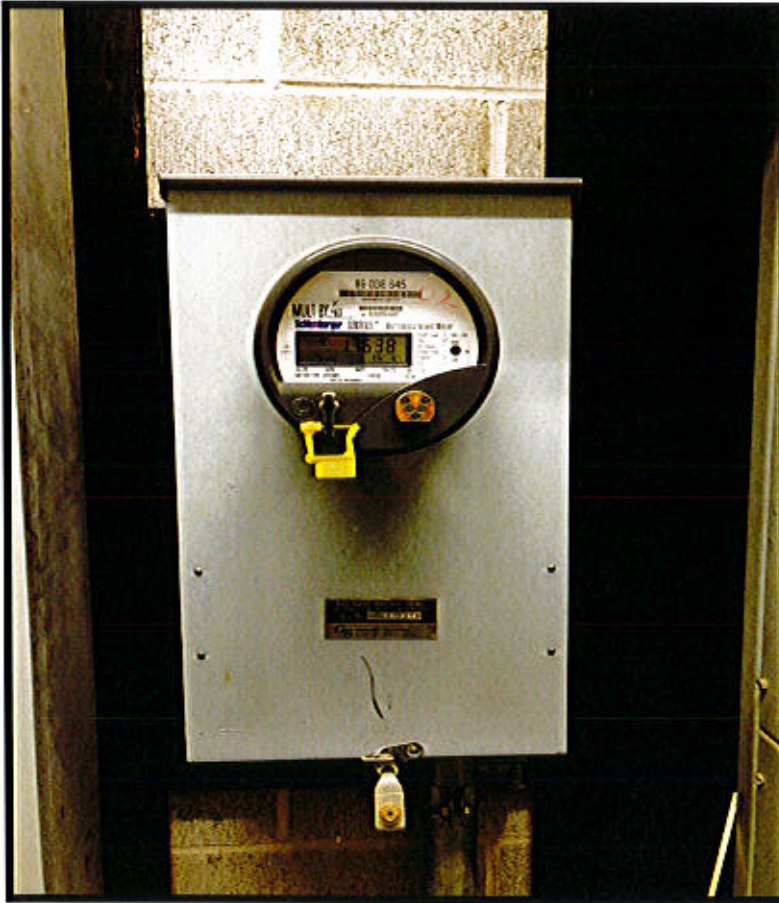
Photo 63.  
Mansfield Maintenance  
Facility – 100 N. Frontage  
Road, Mansfield, CT.  
Electrical Meter.

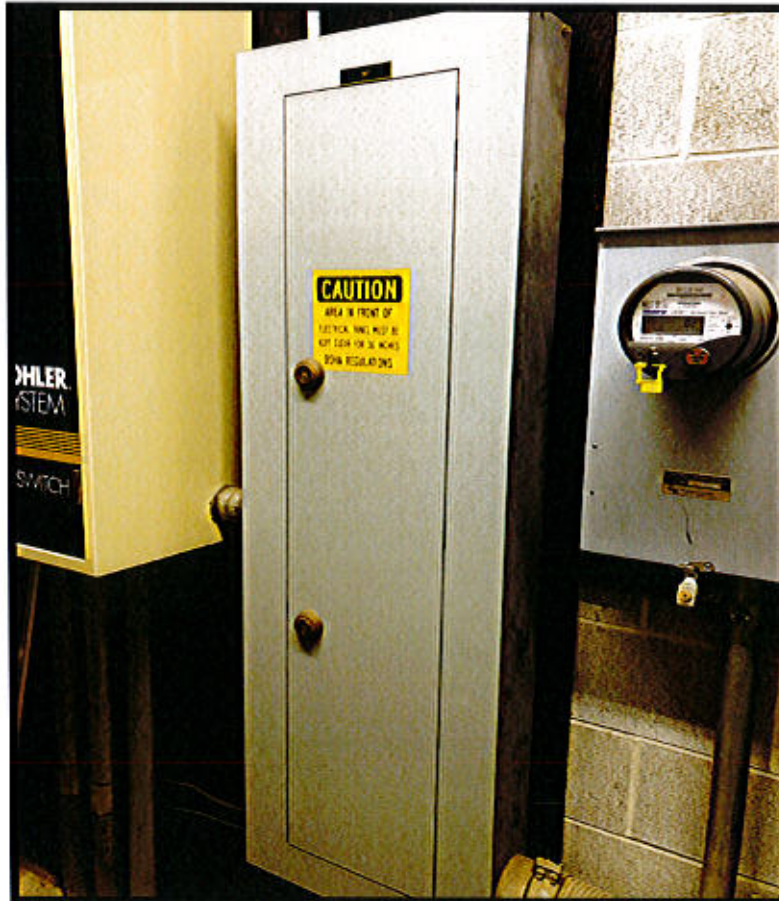
Photo 64.  
Mansfield Maintenance  
Facility – 100 N. Frontage  
Road, Mansfield, CT.  
Electrical Panel.

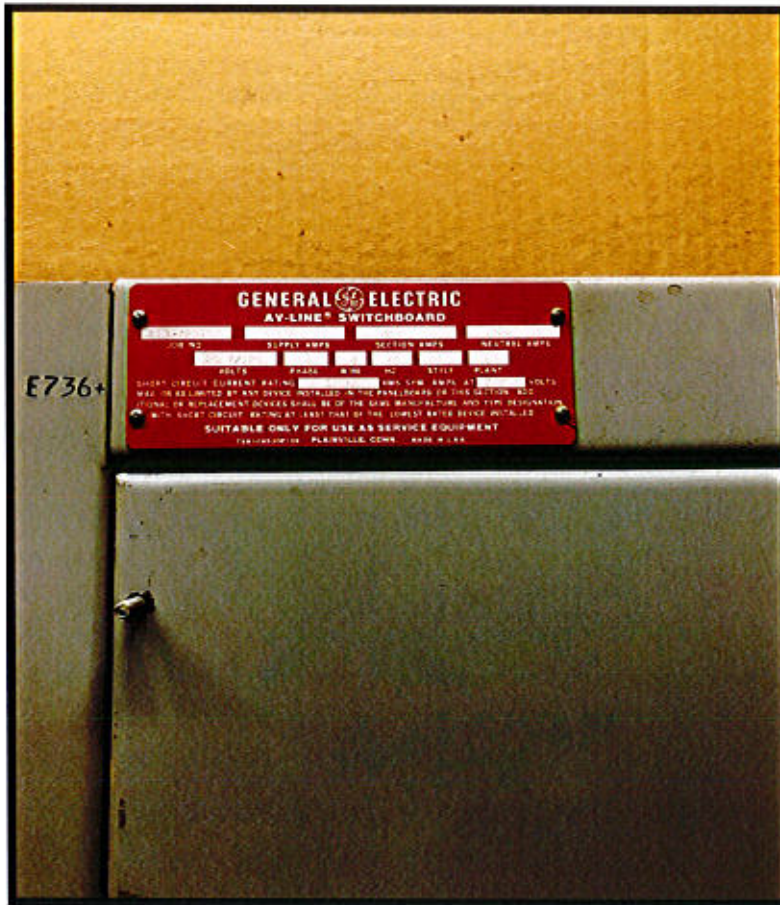
**Photo 65.**  
**Mansfield Maintenance Facility – 100 N. Frontage Road, Mansfield, CT.**  
 Electrical Panel Label.

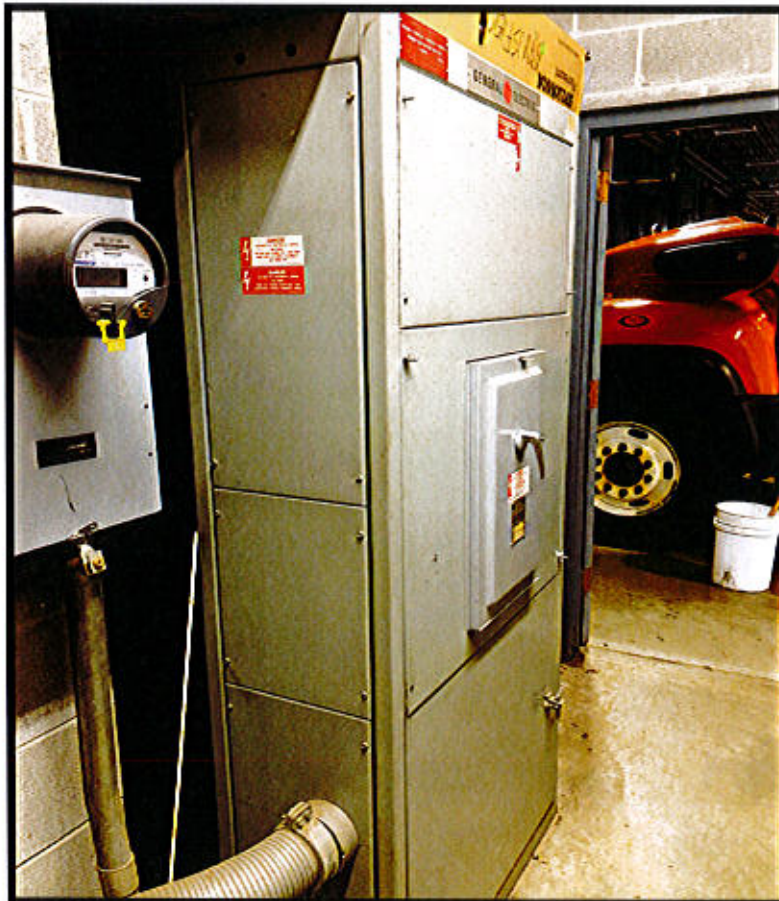
**Photo 66.**  
**Mansfield Maintenance Facility – 100 N. Frontage Road, Mansfield, CT.**  
 Transfer switch Q.

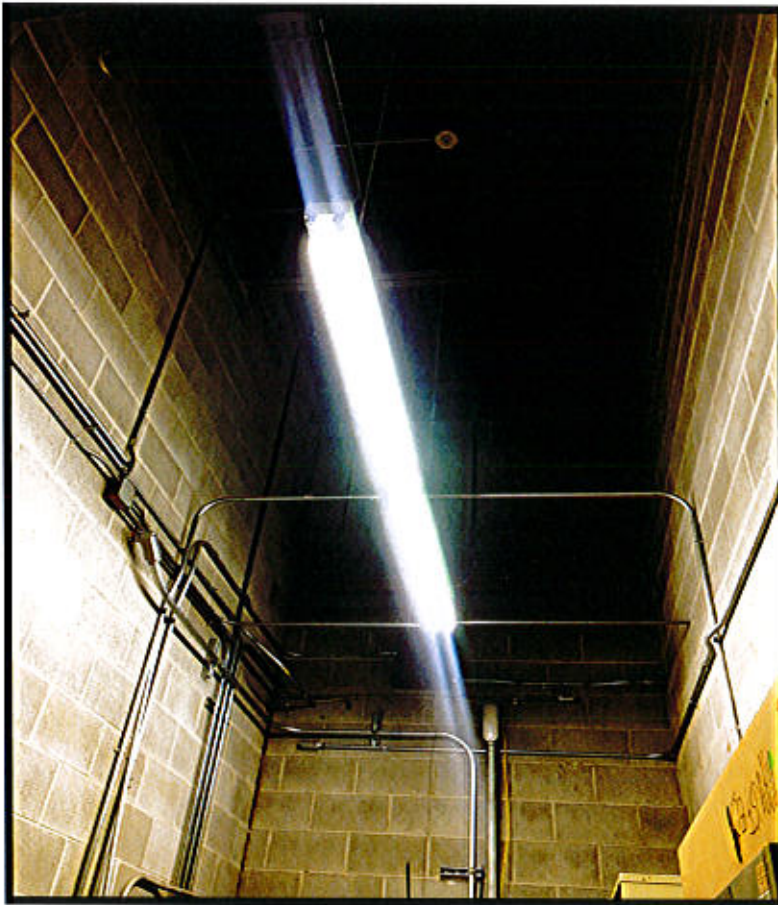
**Photo 67.**  
**Mansfield Maintenance Facility – 100 N. Frontage Road, Mansfield, CT.**  
Generator Room Ceiling.
