**PRE-RENOVATION  
INVESTIGATIVE SURVEY FOR  
HAZARDOUS BUILDING MATERIALS  
DOT GENERATOR INSTALLATION/  
REPLACEMENT PROJECTS  
EAST HAVEN, EAST LYME, EAST WINDSOR,  
HADDAM, HARTFORD, MANSFIELD & ROCKY  
HILL, CONNECTICUT  
Project No. 170-3476**

**PRE-RENOVATION  
INVESTIGATIVE SURVEY FOR  
HAZARDOUS BUILDING MATERIALS**

**GENERATOR INSTALLATION/  
REPLACEMENTS**  
**EAST HAVEN, EAST LYME, EAST WINDSOR,  
HADDAM, HARTFORD, MANSFIELD &  
ROCKY HILL, CONNECTICUT**  
Project No. 170-3476

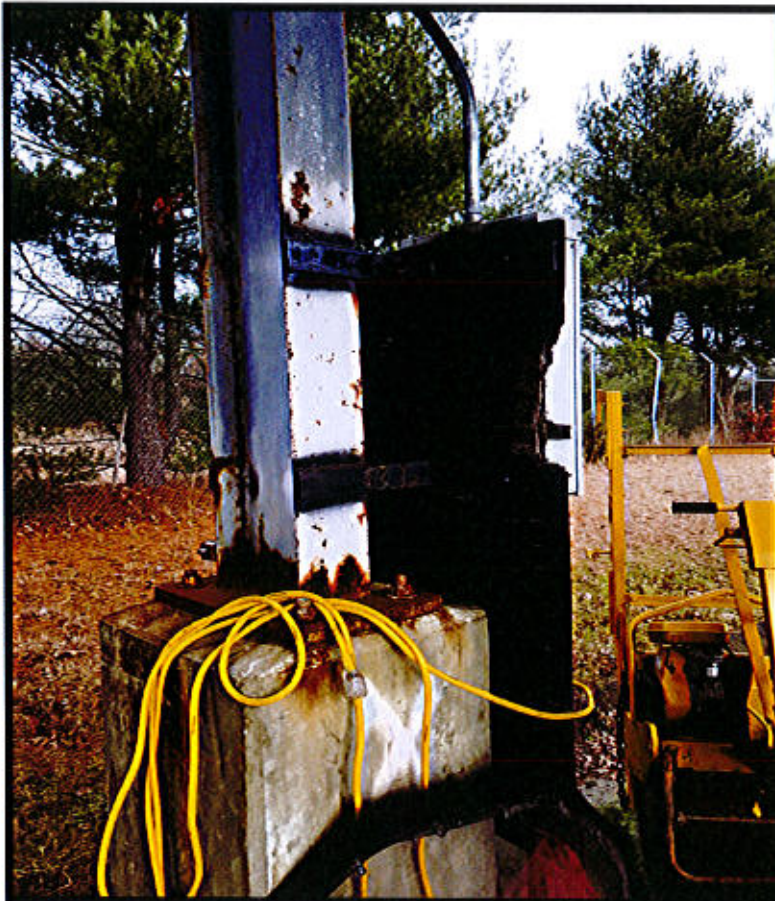
**Photo 68.**  
**Mansfield Maintenance Facility – 100 N. Frontage Road, Mansfield, CT.**  
Generator Electrical Panel.

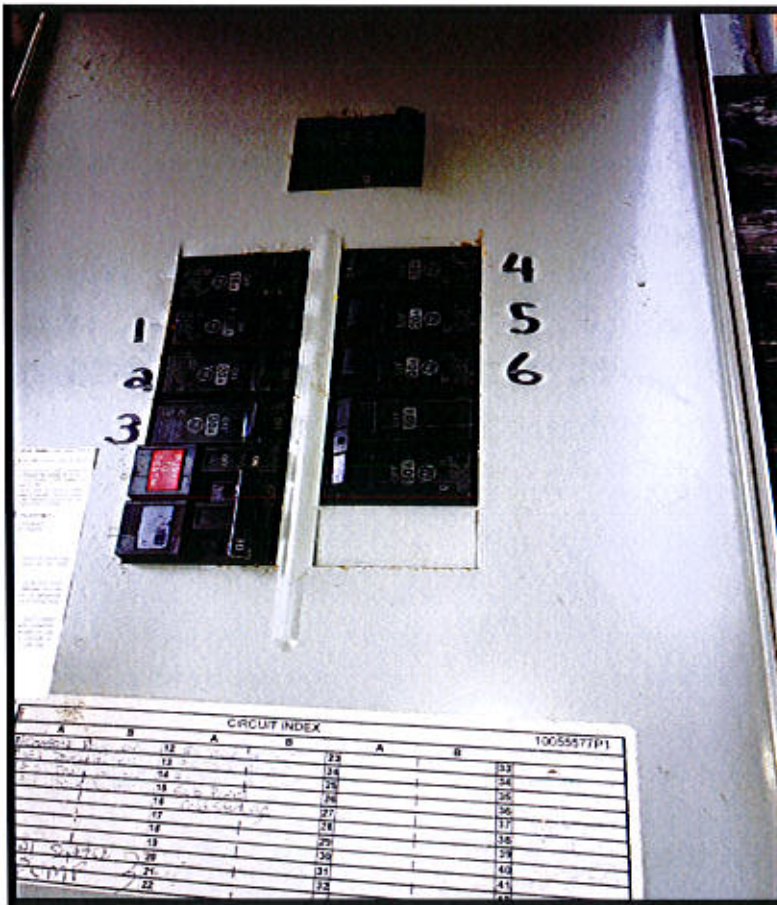
Photo 69.  
 Mansfield Maintenance  
 Facility – 100 N. Frontage  
 Road, Mansfield, CT.  
 Generator Electrical Panel.

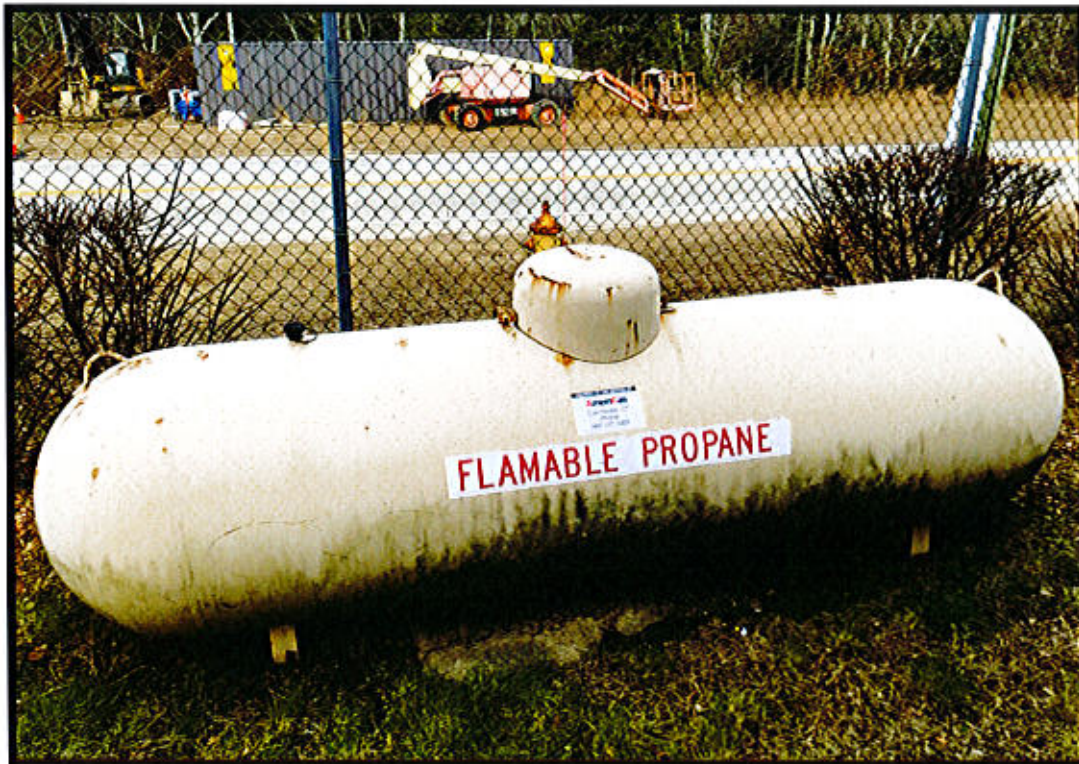
Photo 70. Mansfield Maintenance Facility – 100 N. Frontage Road, Mansfield, CT.  
 Propane Tank.

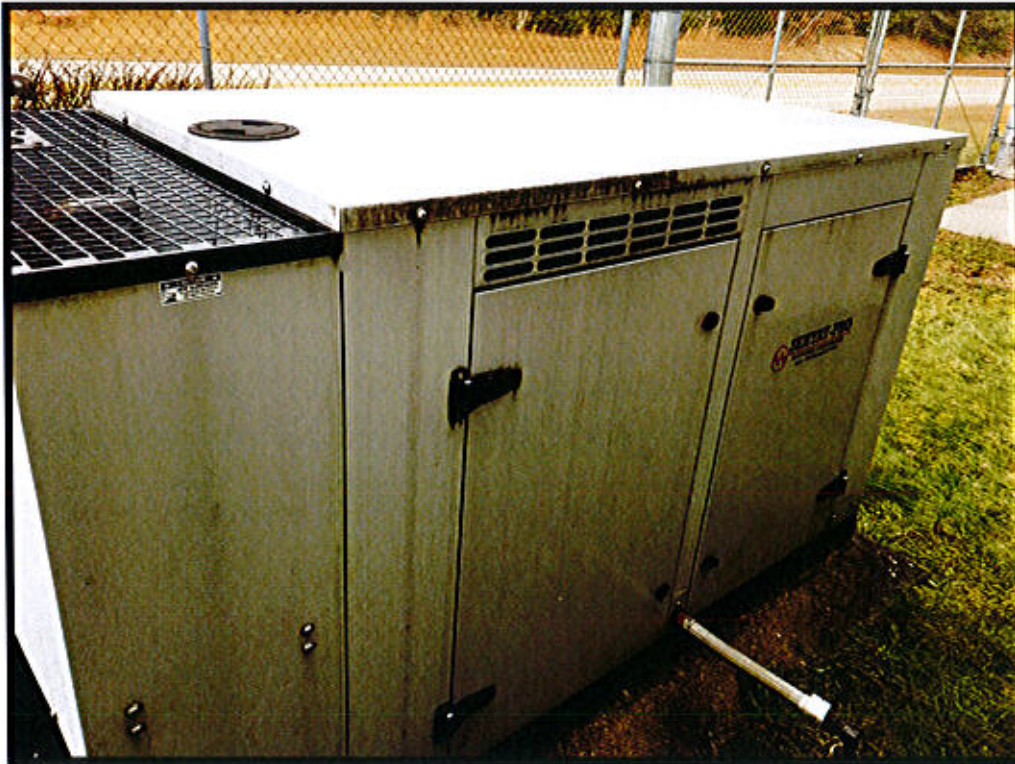
**Photo 71. Mansfield Maintenance Facility – 100 N. Frontage Road, Mansfield, CT.  
Generator.**

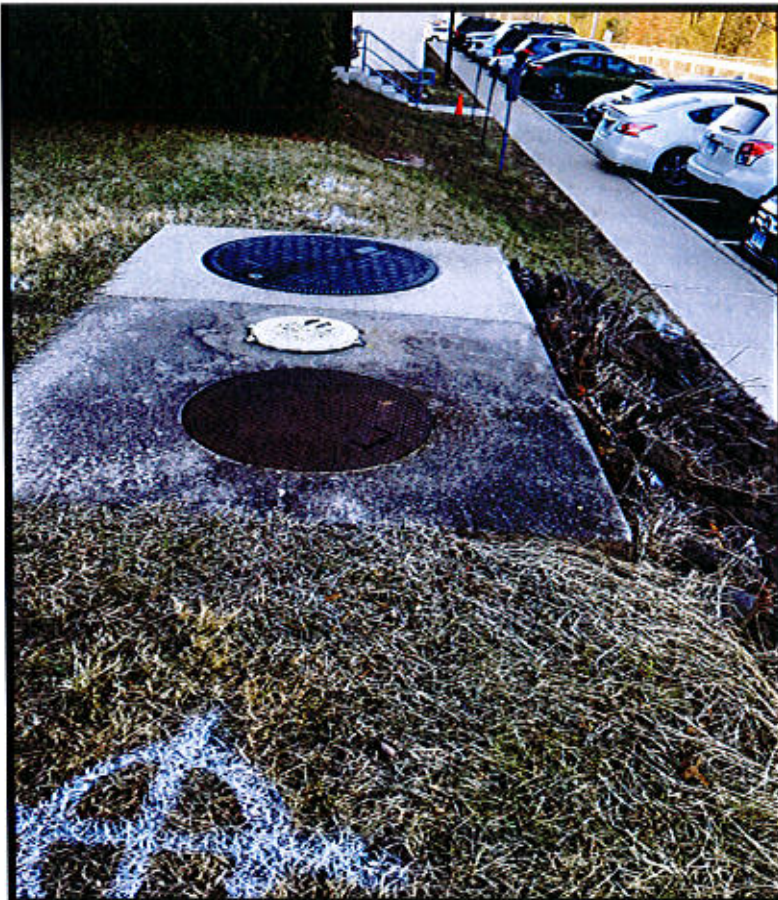
**Photo 72.  
Mansfield Maintenance  
Facility – 100 N. Frontage  
Road, Mansfield, CT.  
UST Covers.**

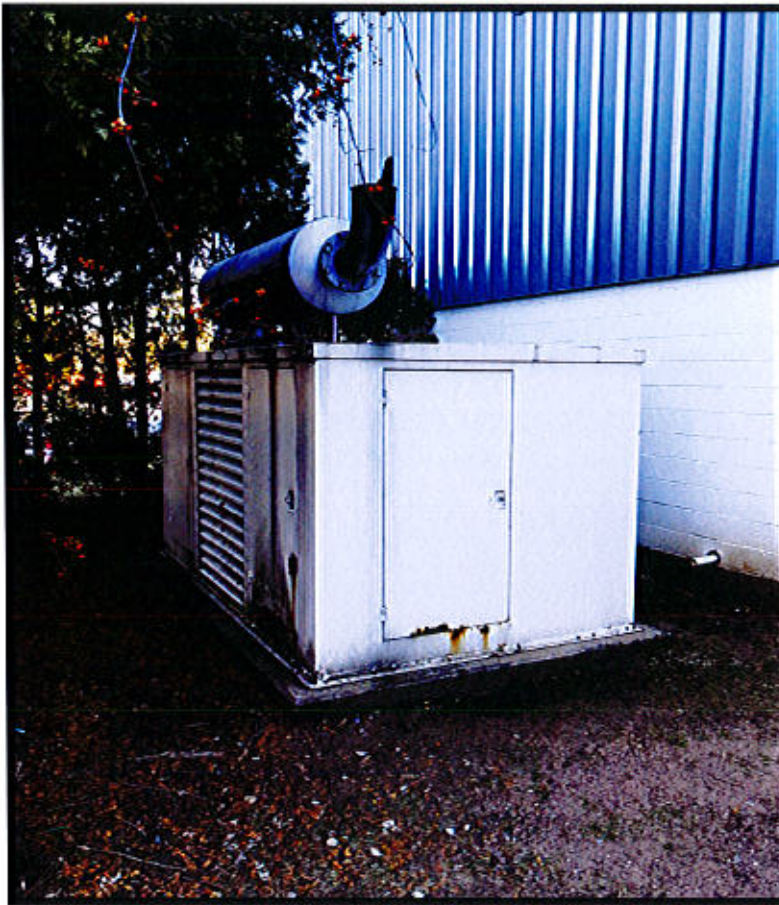
Photo 73.  
Mansfield Maintenance  
Facility – 100 N. Frontage  
Road, Mansfield, CT.  
Generator.

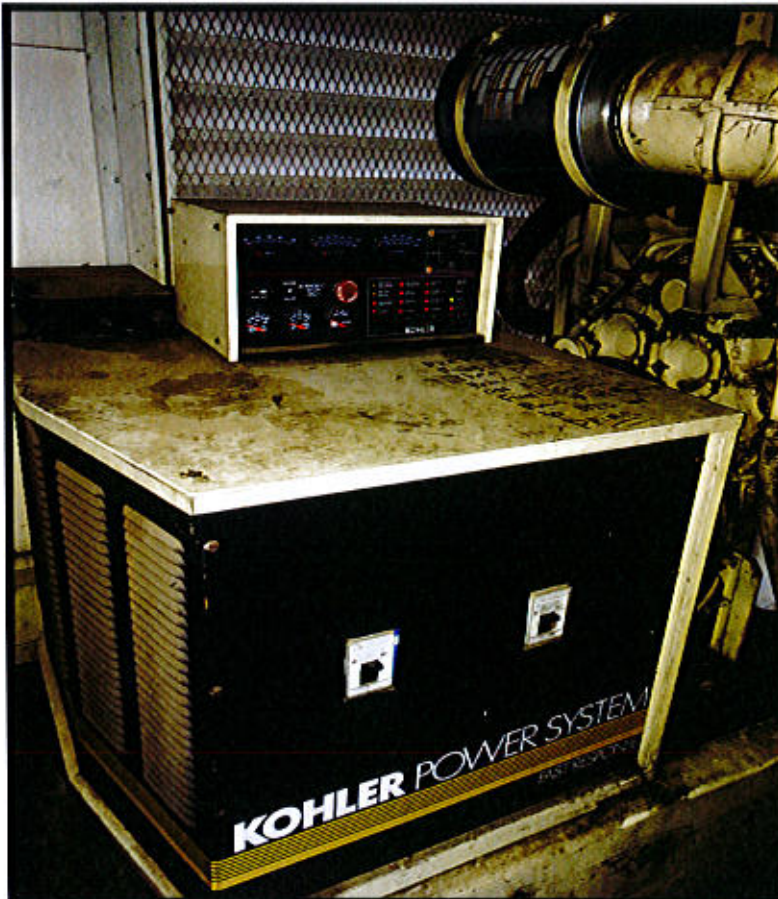
Photo 74.  
Mansfield Maintenance  
Facility – 100 N. Frontage  
Road, Mansfield, CT.  
Inside Generator.

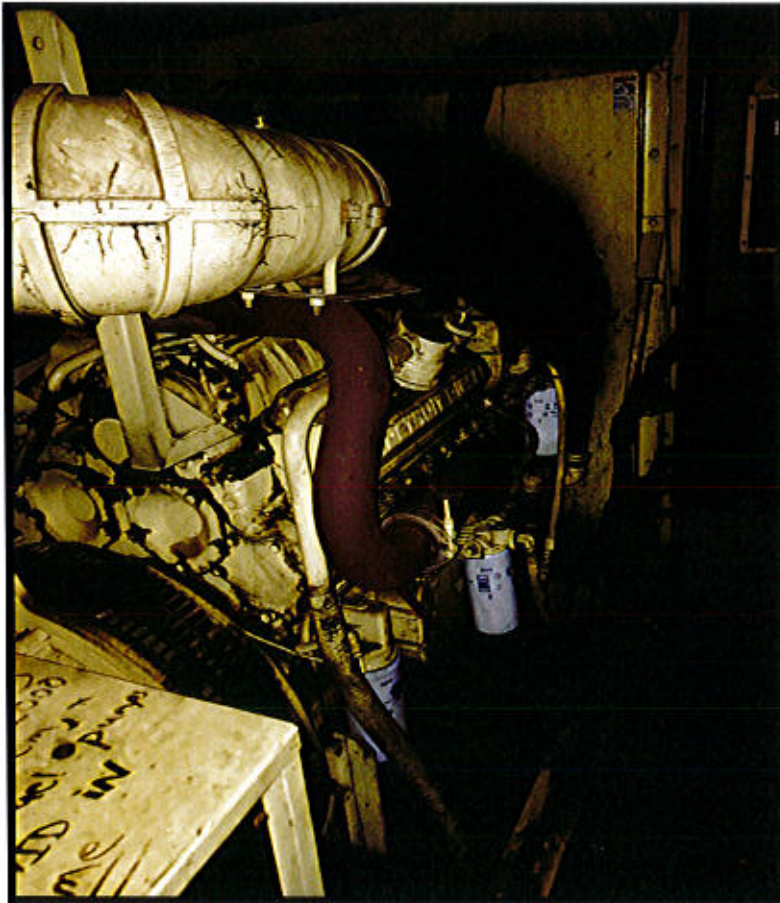
Photo 75.  
Mansfield Maintenance  
Facility – 100 N. Frontage  
Road, Mansfield, CT.  
Inside Generator.

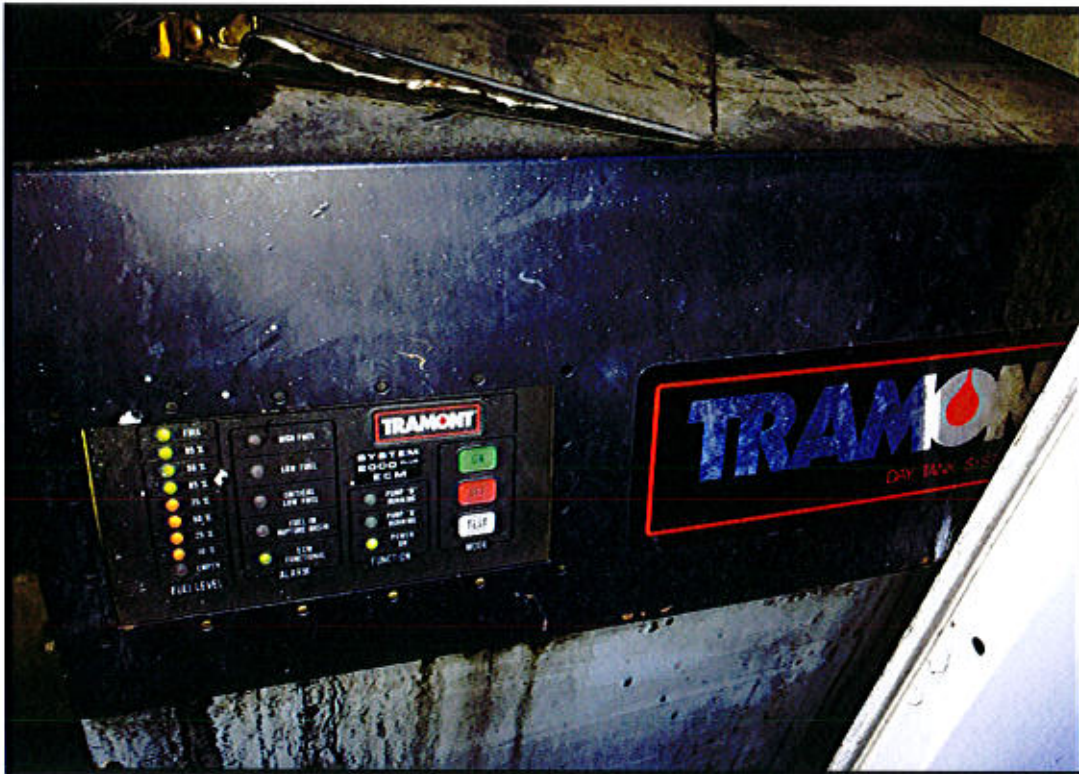
Photo 77. Mansfield Maintenance Facility – 100 N. Frontage Road, Mansfield, CT.  
Inside Generator Control.

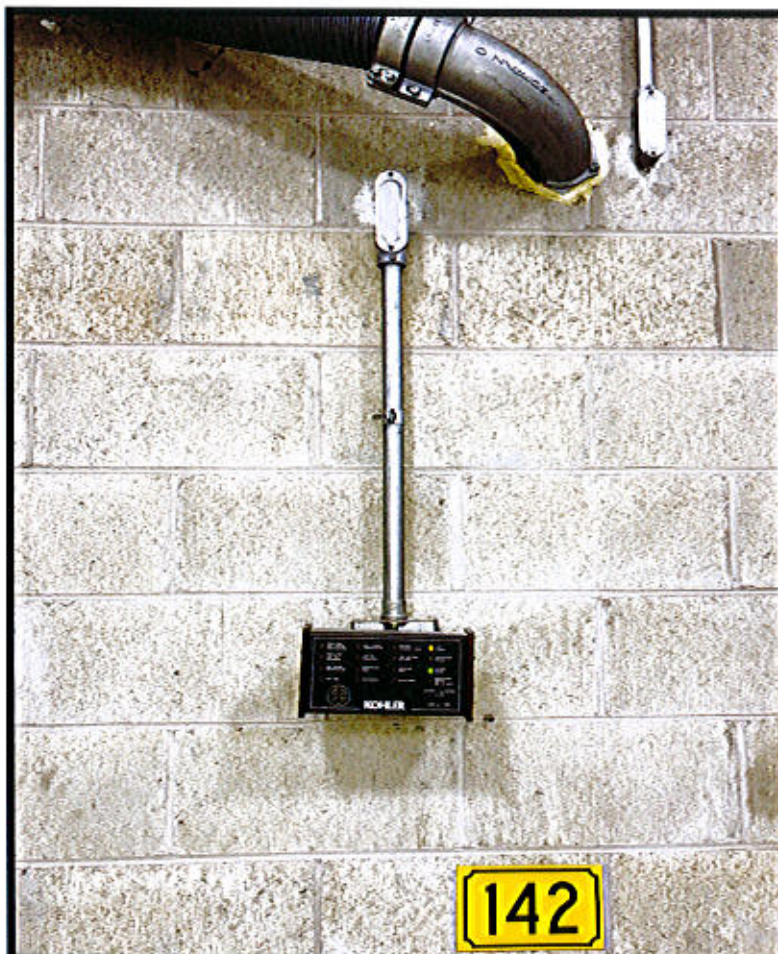
Photo 78.  
Rocky Hill Central Warehouse  
Facility – 600 Broad Street,  
Rocky Hill, CT.  
Generator Annunciator.

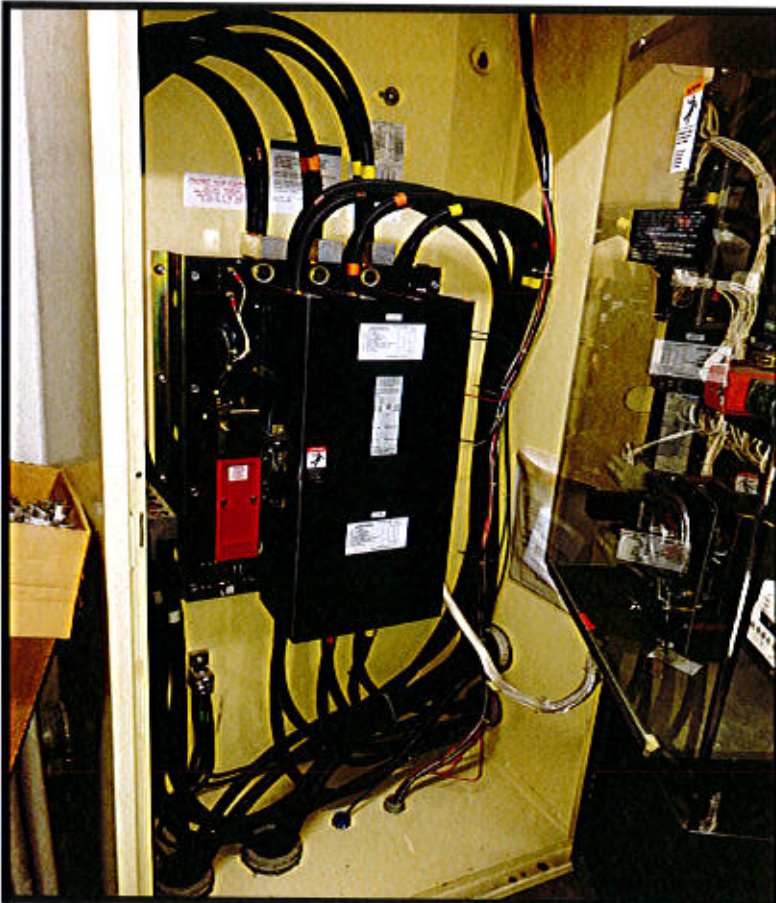
Photo 80.  
Rocky Hill Central Warehouse  
Facility – 600 Broad Street,  
Rocky Hill, CT.  
Generator Transfer.

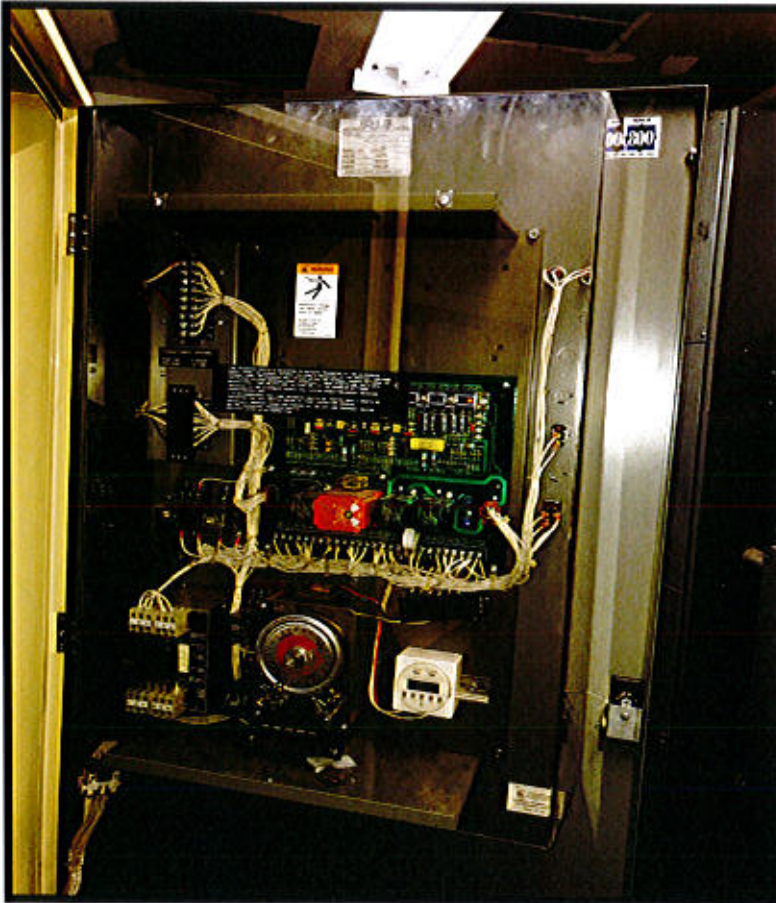
Photo 81.  
 Rocky Hill Central Warehouse  
 Facility – 600 Broad Street,  
 Rocky Hill, CT.  
 Inside Generator Transfer.

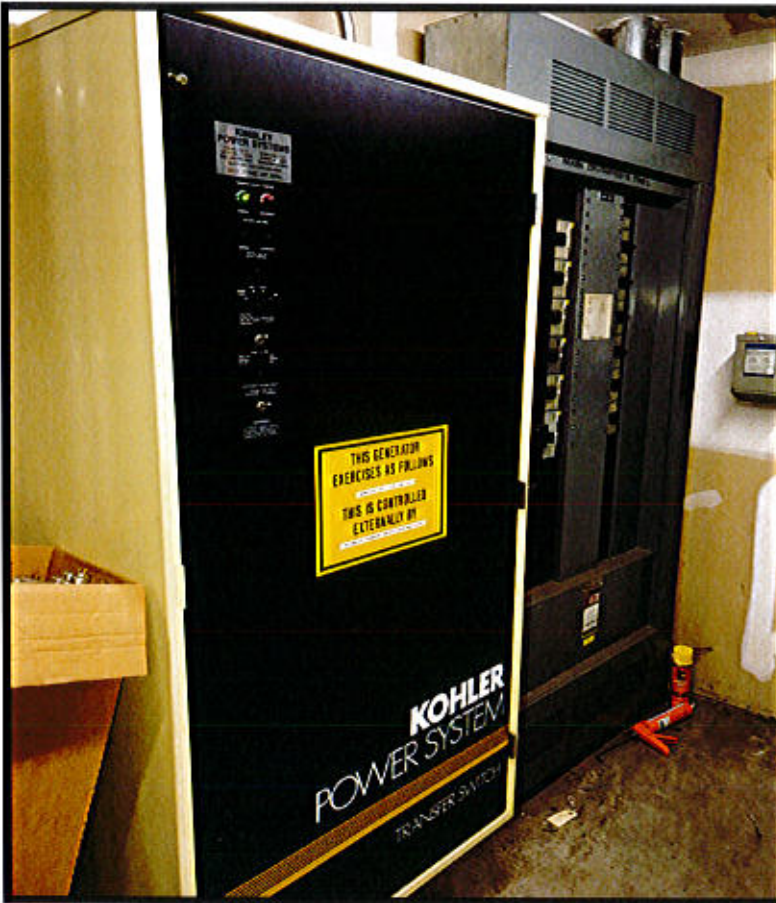
Photo 83.  
Rocky Hill Central Warehouse  
Facility – 600 Broad Street,  
Rocky Hill, CT.  
Generator Transfer.

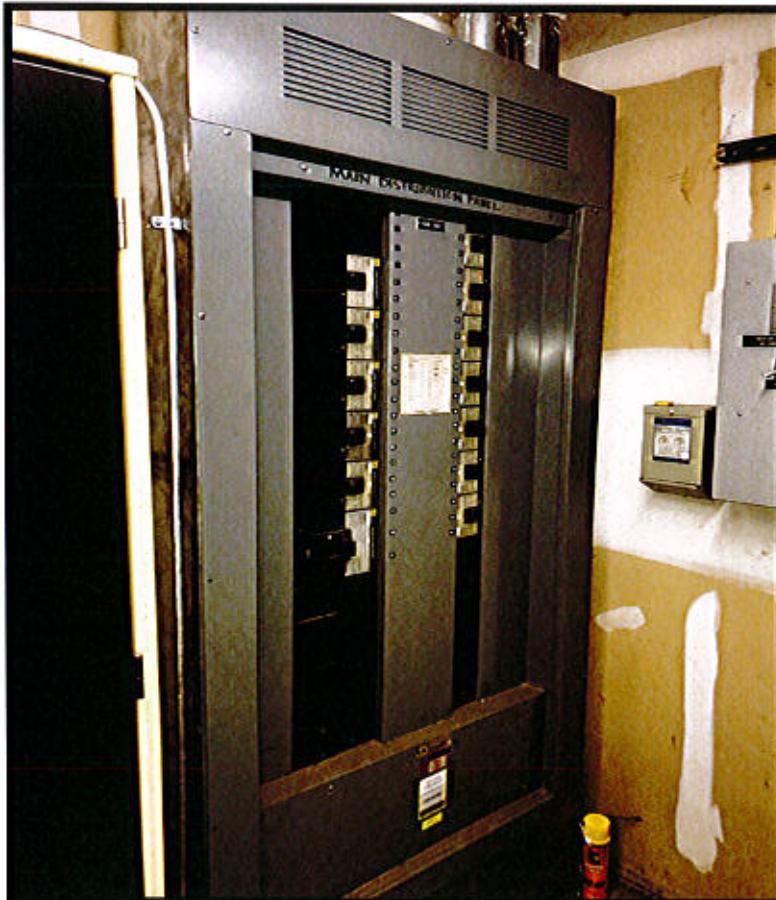
Photo 84.  
Rocky Hill Central Warehouse  
Facility – 600 Broad Street,  
Rocky Hill, CT.  
Electrical Panel.

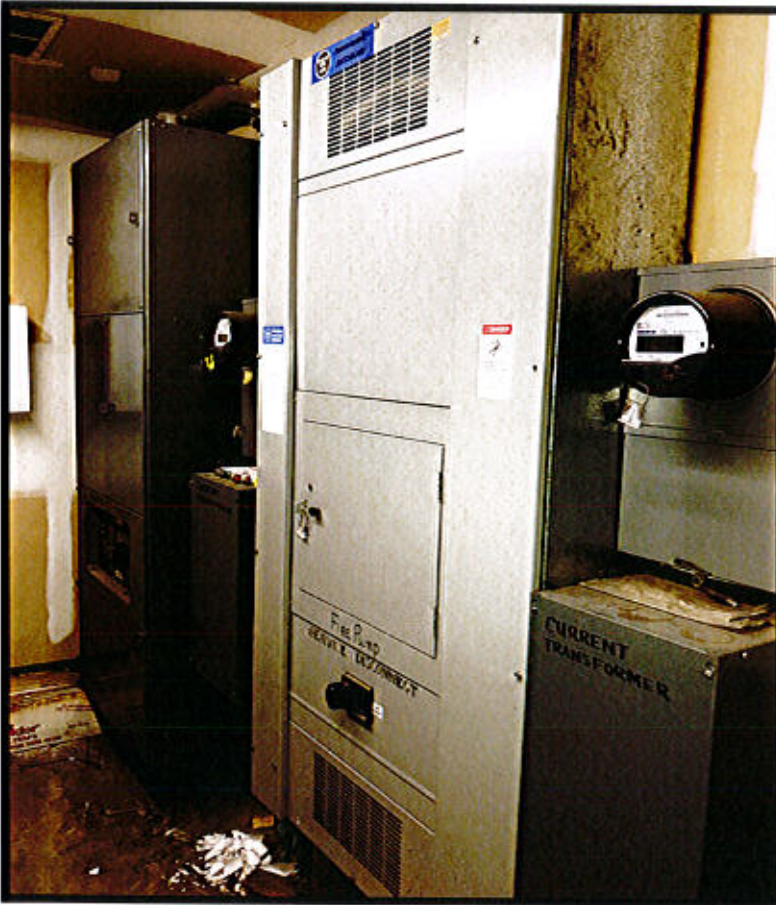
Photo 85.  
Rocky Hill Central Warehouse  
Facility – 600 Broad Street,  
Rocky Hill, CT.  
Electrical Panels.

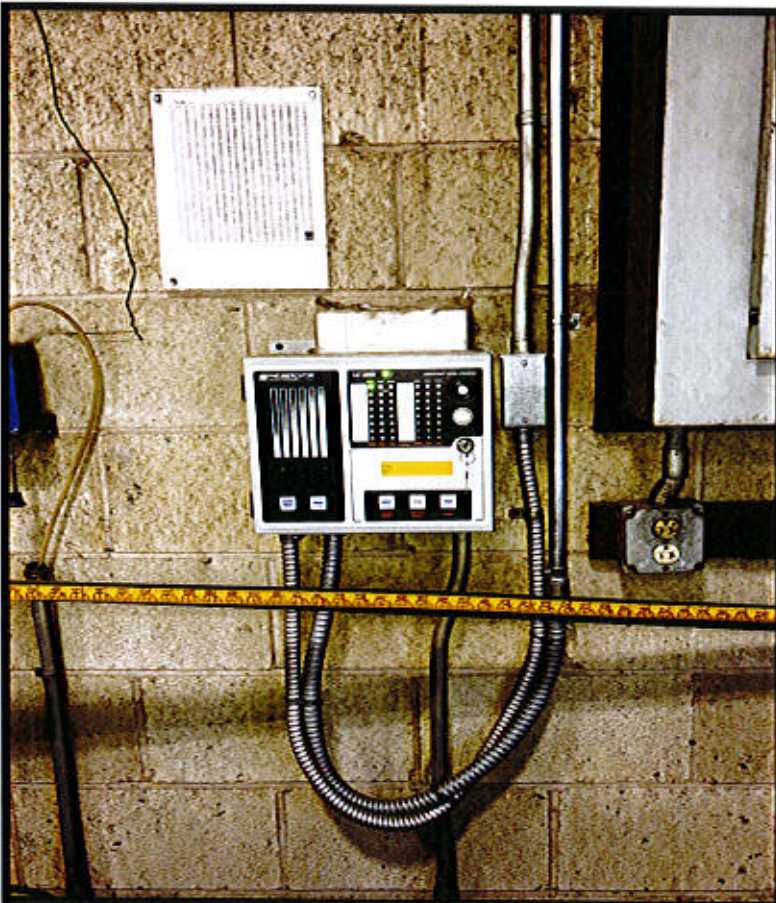
Photo 86.  
Rocky Hill Central Warehouse  
Facility – 600 Broad Street,  
Rocky Hill, CT.  
Tank Monitoring System.

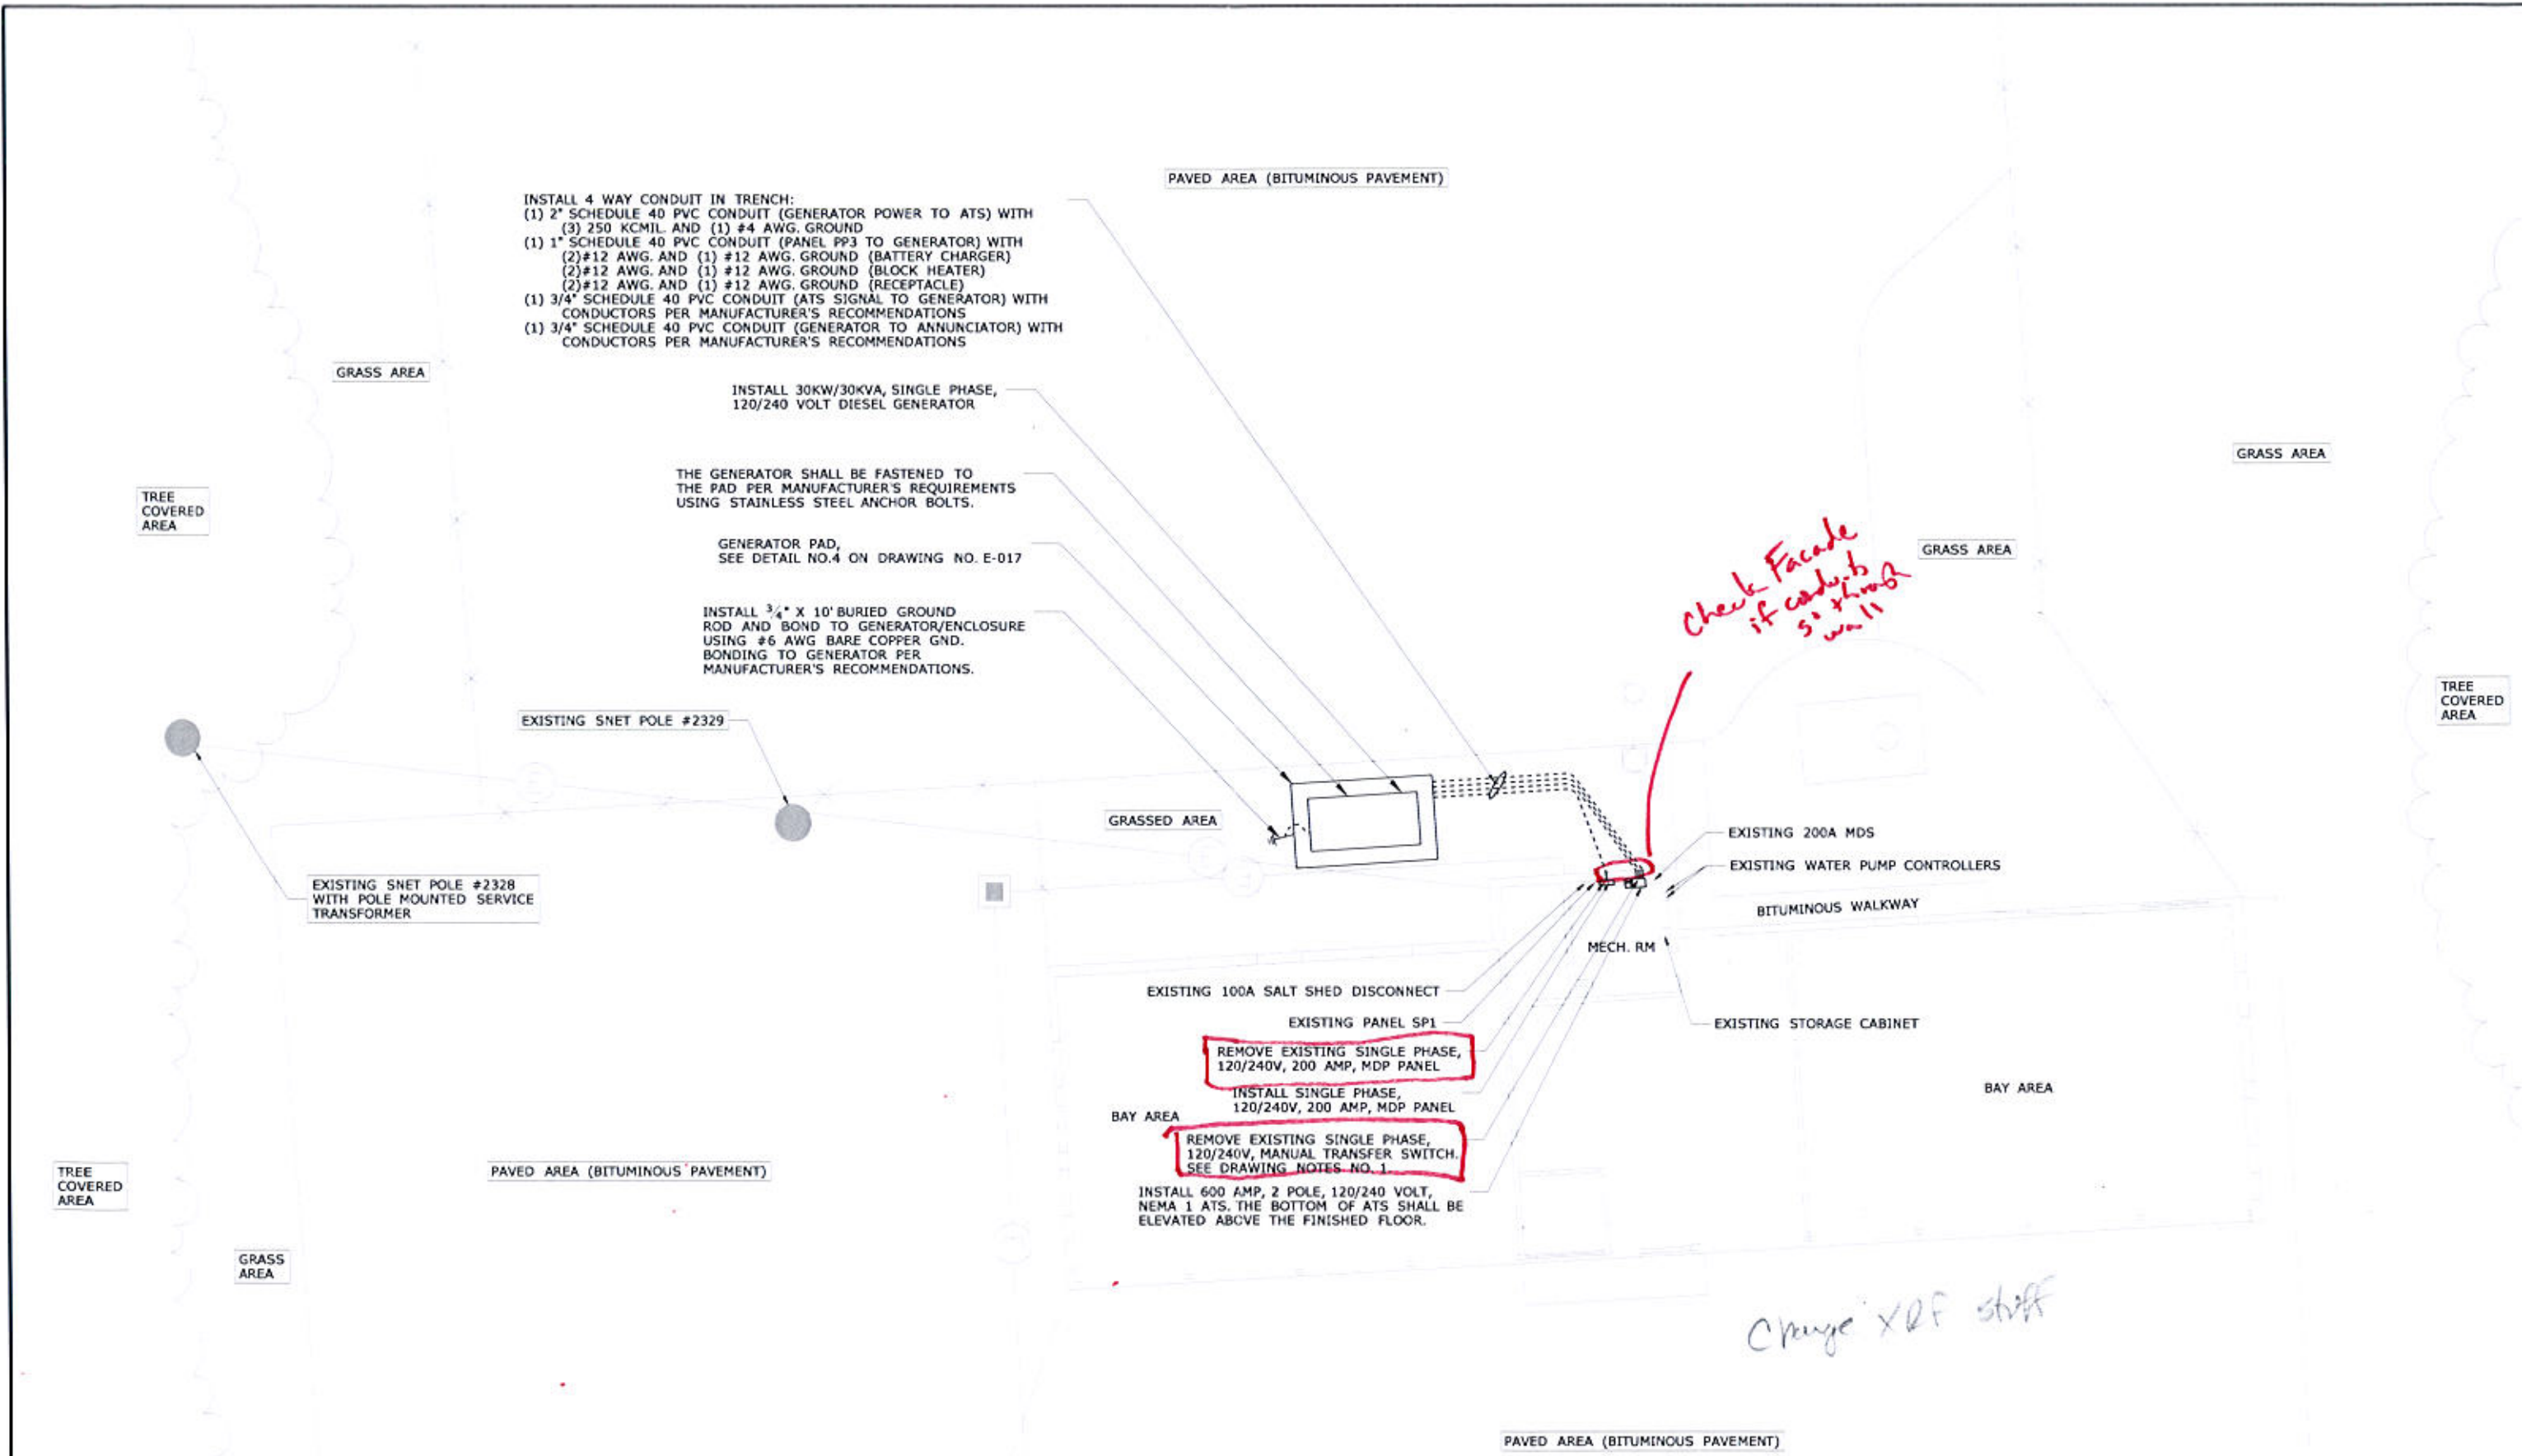
INSTALL 3/4" X 10' BURIED GROUND ROD AND BOND TO GENERATOR/ENCLOSURE USING #6 AWG BARE COPPER GND. BONDING TO GENERATOR PER MANUFACTURER'S RECOMMENDATIONS.

THE GENERATOR SHALL BE FASTENED TO THE PAD PER MANUFACTURER'S REQUIREMENTS USING STAINLESS STEEL ANCHOR BOLTS.

- (1) 2" SCHEDULE 40 PVC CONDUIT (GENERATOR POWER TO ATS) WITH [(4) 1/0 AWG. AND (1) #6 AWG. GROUND]
- (1) 1" SCHEDULE 40 PVC CONDUIT (PB-M TO GENERATOR) WITH
  - (2) #10 AWG. AND (1) #10 AWG. GROUND (BATTERY CHARGER)
  - (2) #10 AWG. AND (1) #10 AWG. GROUND (BLOCK HEATER)
  - (2) #10 AWG. AND (1) #10 AWG. GROUND (SERVICE RECEPTACLE)
- (1) 3/4" SCHEDULE 40 PVC CONDUIT (ATS SIGNAL TO GENERATOR) WITH CONDUCTORS PER MANUFACTURER'S RECOMMENDATIONS
- (1) 3/4" SCHEDULE 40 PVC CONDUIT (GENERATOR TO ANNUNCIATOR) WITH CONDUCTORS PER MANUFACTURER'S RECOMMENDATIONS
- (1) 3/4" SCHEDULE 40 PVC CONDUIT (TMS TO GENERATOR TANK) WITH CONDUCTORS PER MANUFACTURER'S RECOMMENDATIONS

REPLACE EXISTING MDS WITH 600A, 3 PHASE, 120/208V MDS PANEL

REPLACE EXISTING MDP WITH 600A, 3 PHASE, 120/208V MDP PANEL WITH 42 CIRCUITS

REPLACE EXISTING ATS WITH 600A, 3 POLE, 120/208V, NEMA 1 ATS. THE BOTTOM OF THE ATS SHALL STANDOFF FROM THE FINISHED FLOOR.

1. SALVAGE EXISTING DIESEL TANK AND ASSOCIATED COMPONENTS. REMOVE EXISTING PROBE CONDUCTORS TO THE TANK. FUEL SHALL BE SALVAGED AND DELIVERED TO DOT'S TRUMBULL. EXISTING PENETRATIONS FOR THE FUEL TANK VENT PIPING SHALL BE REPAIRED AND SEALED TO MATCH THE EXISTING WALL/CEILING. THE CONTRACTOR SHALL MATCH EXISTING WALL/CEILING USING COMPATIBLE MATERIALS AND ACCEPTABLE MEANS AND METHODS APPROVED BY THE ENGINEER.

2. REMOVE THE EXISTING GENERATOR, ATS, BATTERY CHARGER, AND ALL ASSOCIATED COMPONENTS. REMOVE ALL EXISTING CONDUCTORS AND CUT CONDUIT TO FINISHED FLOOR. ALL EXISTING PENETRATIONS FOR THE GENERATOR EXHAUST, INTAKE, MOTORIZED LOUVERS SHALL BE REPAIRED AND SEALED TO MATCH THE EXISTING WALL/CEILING. THE CONTRACTOR SHALL MATCH EXISTING WALL/CEILING USING COMPATIBLE MATERIALS AND ACCEPTABLE MEANS AND METHODS APPROVED BY THE ENGINEER.

(GENERATOR/ATS TO REMOTE ANNUNCIATOR)  
(1) 3/4" SURFACE MOUNTED CONDUIT WITH CONDUCTORS PER MANUFACTURER'S RECOMMENDATIONS

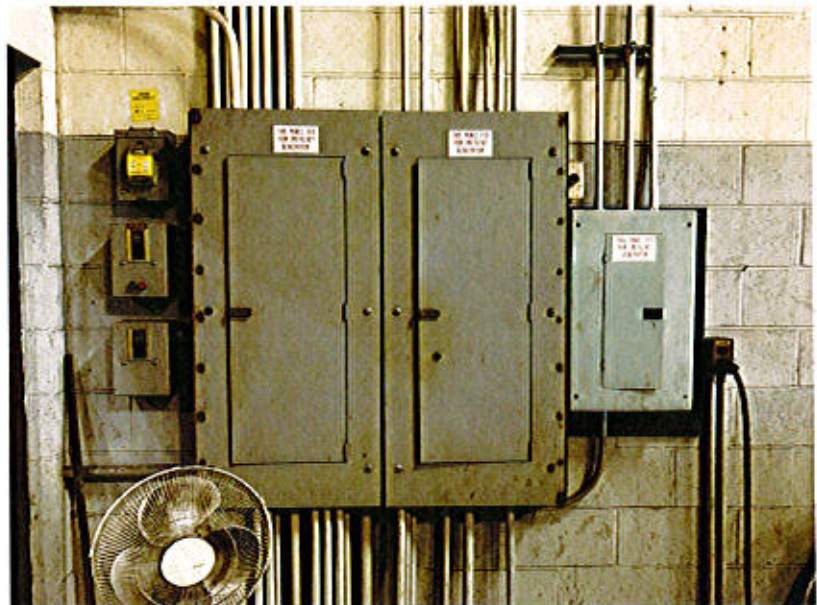
Generator electrical panel

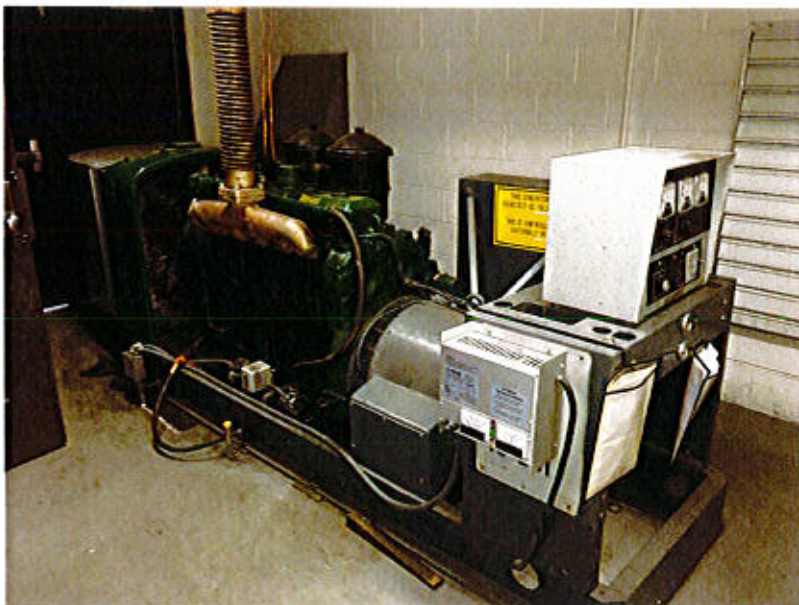
Generator

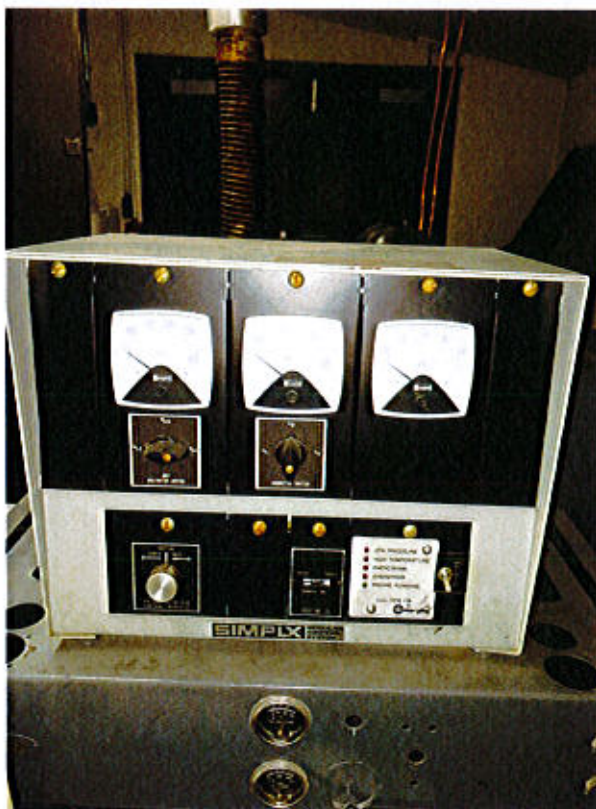
Generator Control

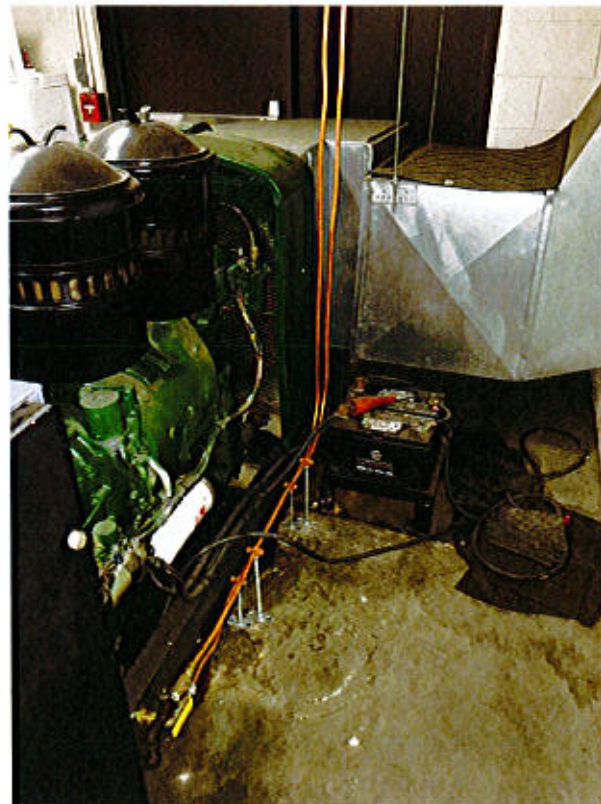
Generator

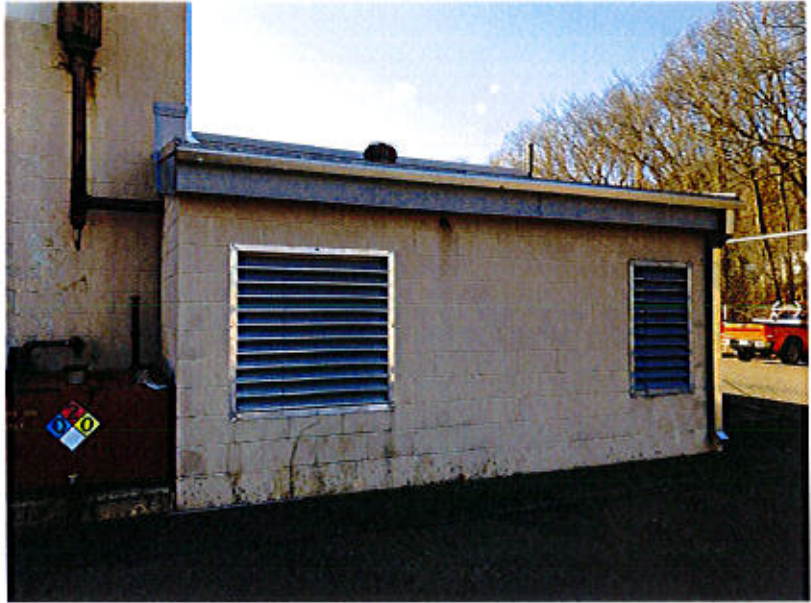
Generator vents

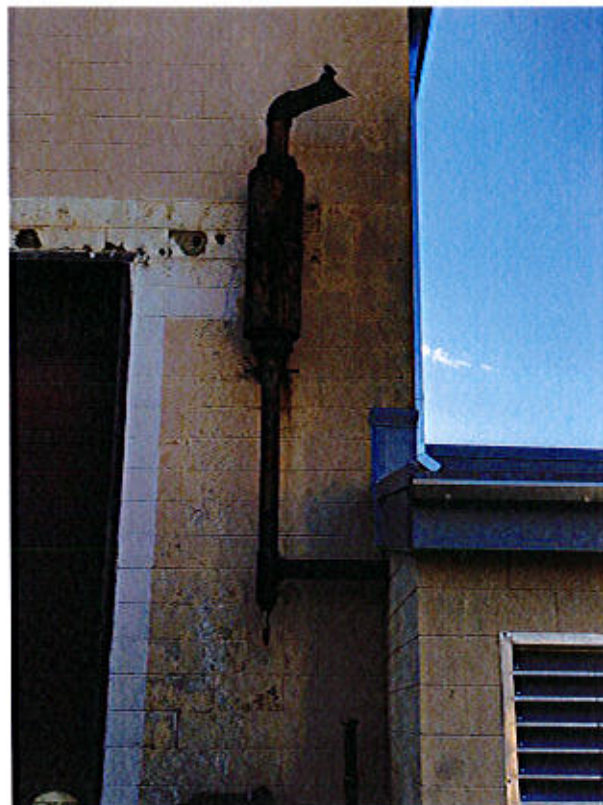
Generator exhaust

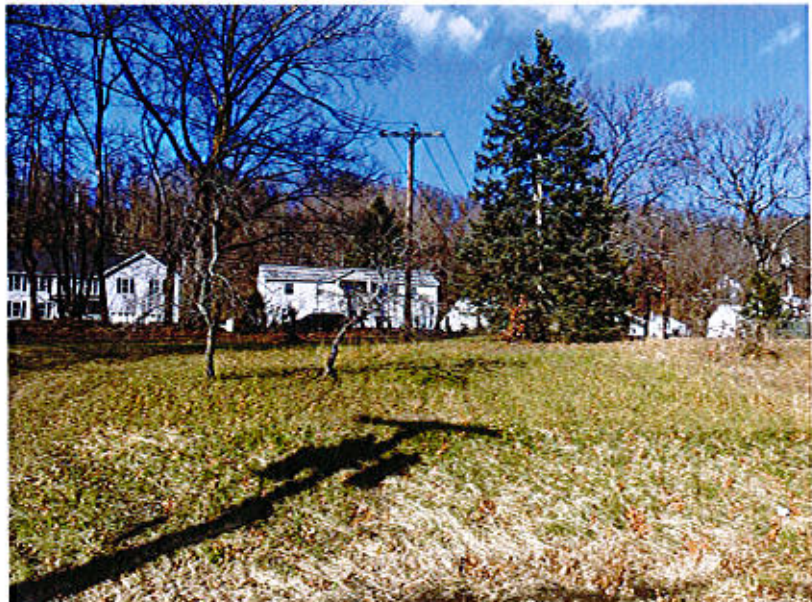
Proposed generator location

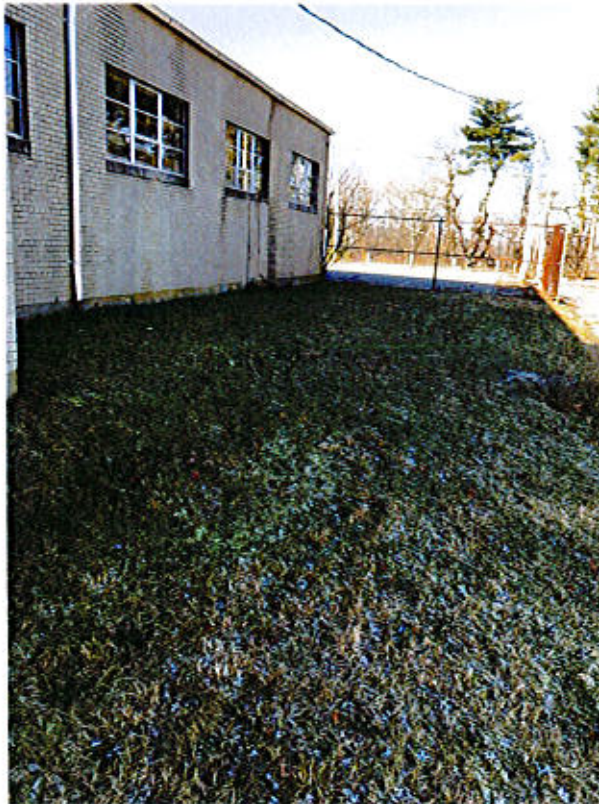
Proposed generator location

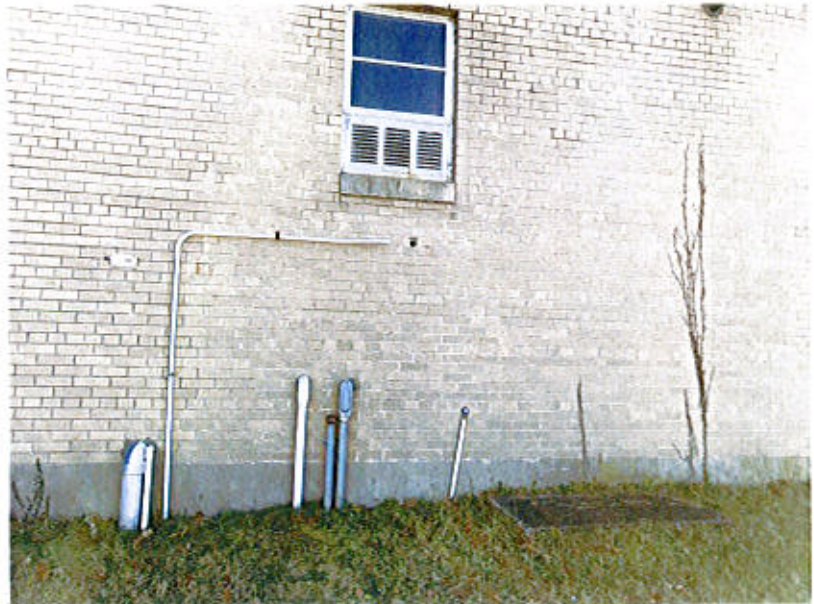
Wall penetration location

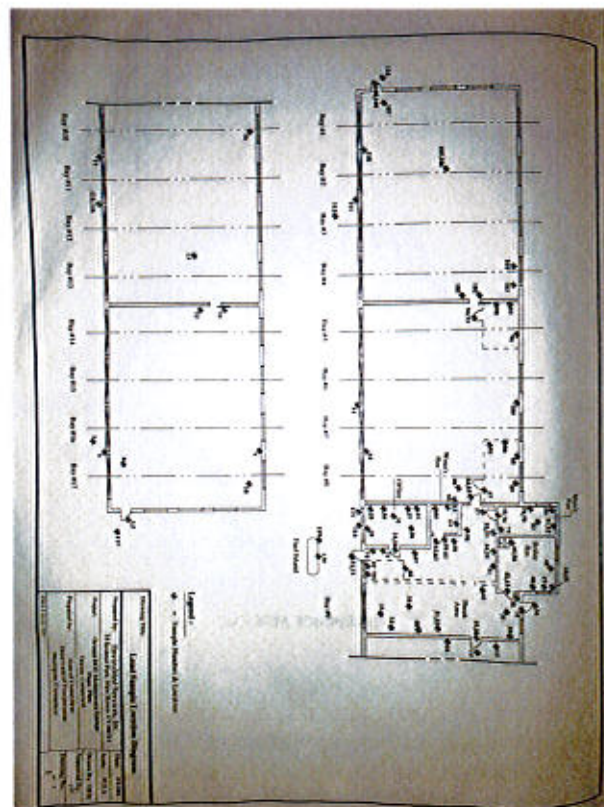
Site sketch

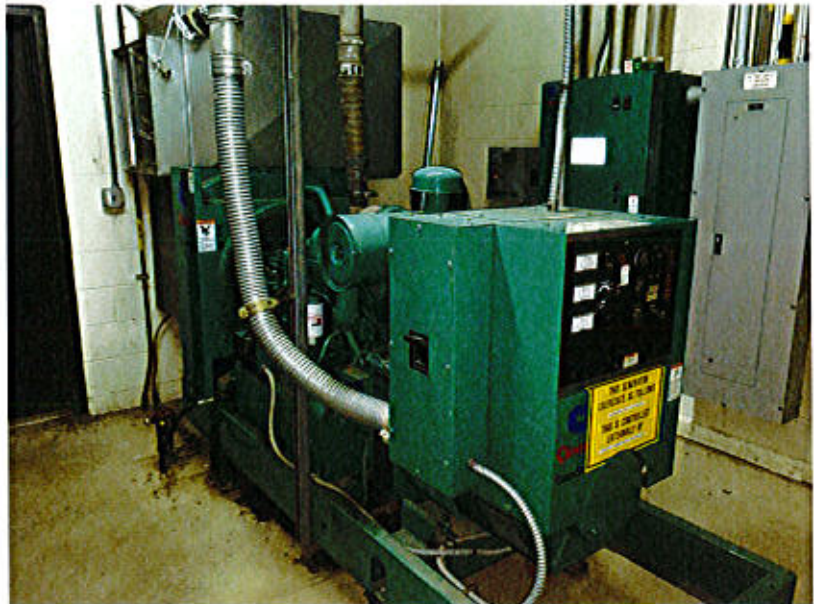
Generator

General Notes Generator Room white paint on cmu walls. Concrete floor, metal deck ceiling. Exterior walls not painted. No suspect ACM. Oils and lube associated with generator. Silicone on outside louvre. One layer CMU walls.

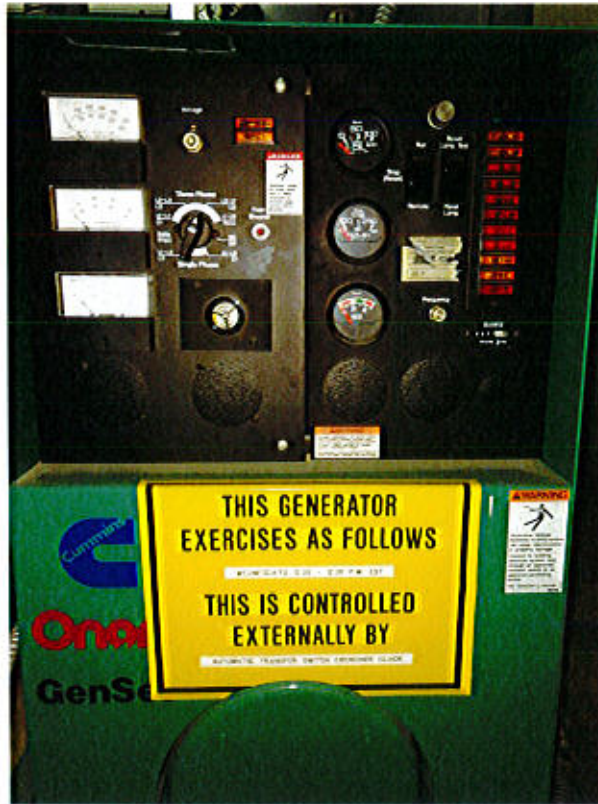
Generator Control

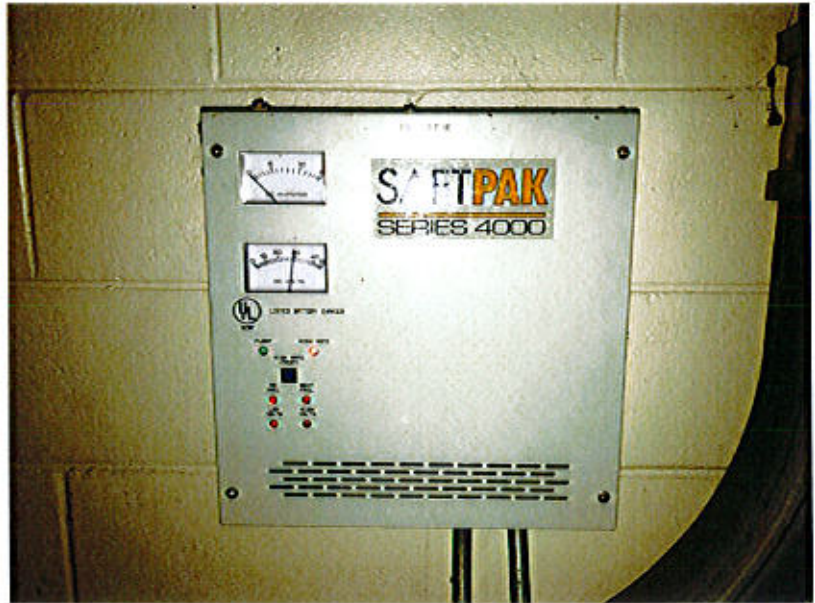
Control panel
