**PRE-RENOVATION  
INVESTIGATIVE SURVEY FOR  
HAZARDOUS BUILDING MATERIALS  
DOT GENERATOR INSTALLATION/  
REPLACEMENT PROJECTS  
EAST HAVEN, EAST LYME, EAST WINDSOR,  
HADDAM, HARTFORD, MANSFIELD & ROCKY  
HILL, CONNECTICUT  
Project No. 170-3476**

**PRE-RENOVATION  
INVESTIGATIVE SURVEY FOR  
HAZARDOUS BUILDING MATERIALS**

**GENERATOR INSTALLATION/  
REPLACEMENTS**  
**EAST HAVEN, EAST LYME, EAST WINDSOR,  
HADDAM, HARTFORD, MANSFIELD &  
ROCKY HILL, CONNECTICUT**  
Project No. 170-3476

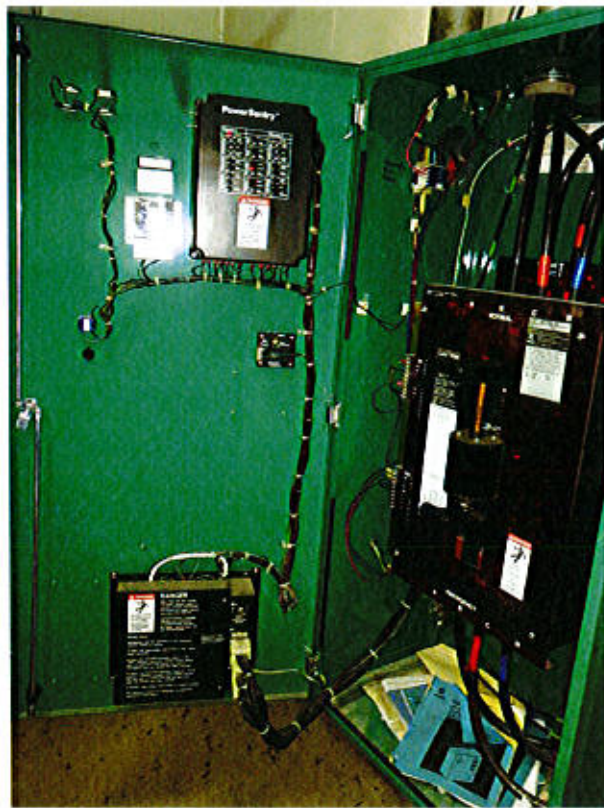
Inside generator control

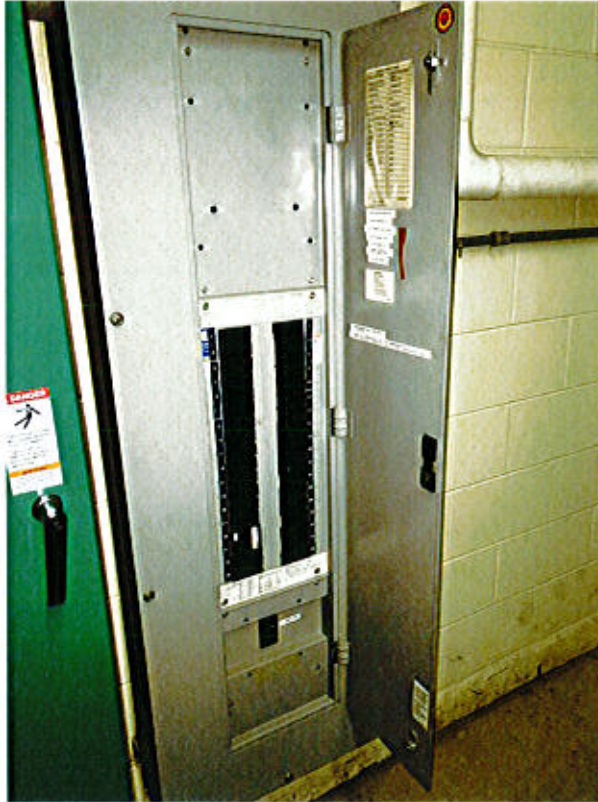
Electrical panel

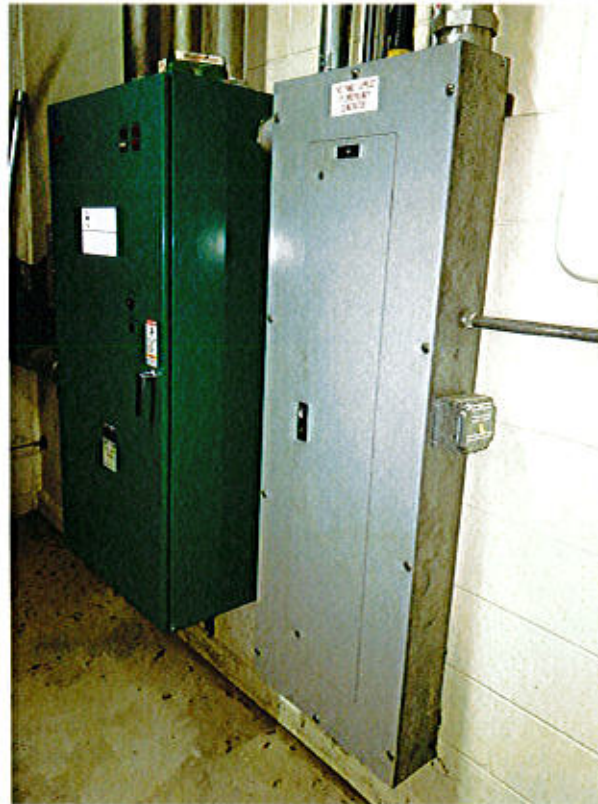
Generator & electrical box

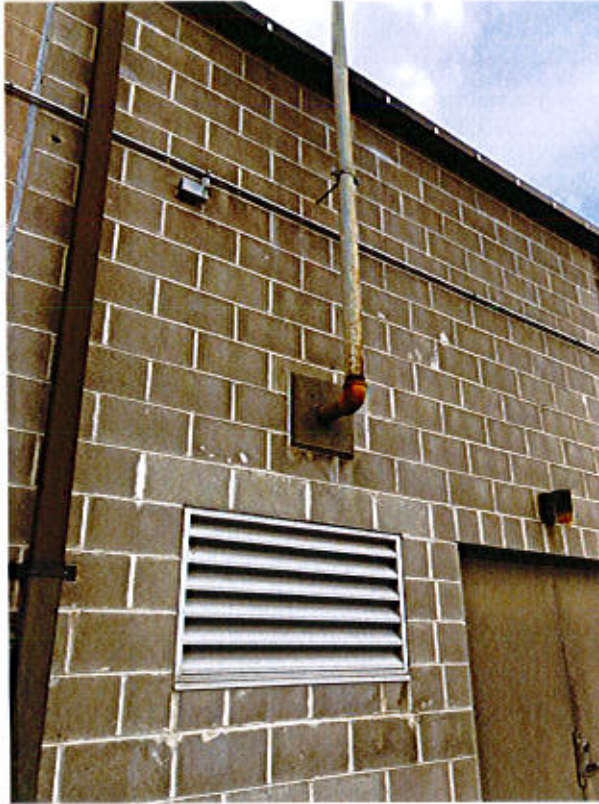
Generator room vent and generator exhaust

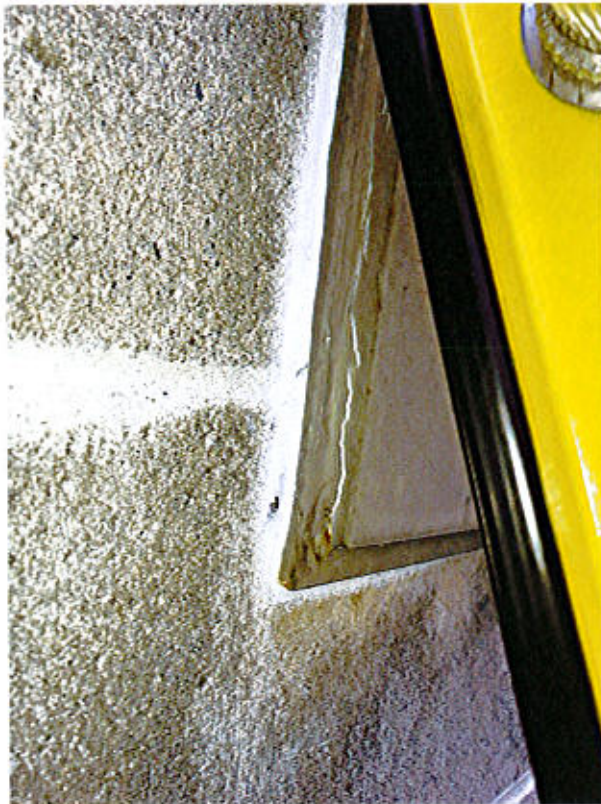
Generator exhaust caulk

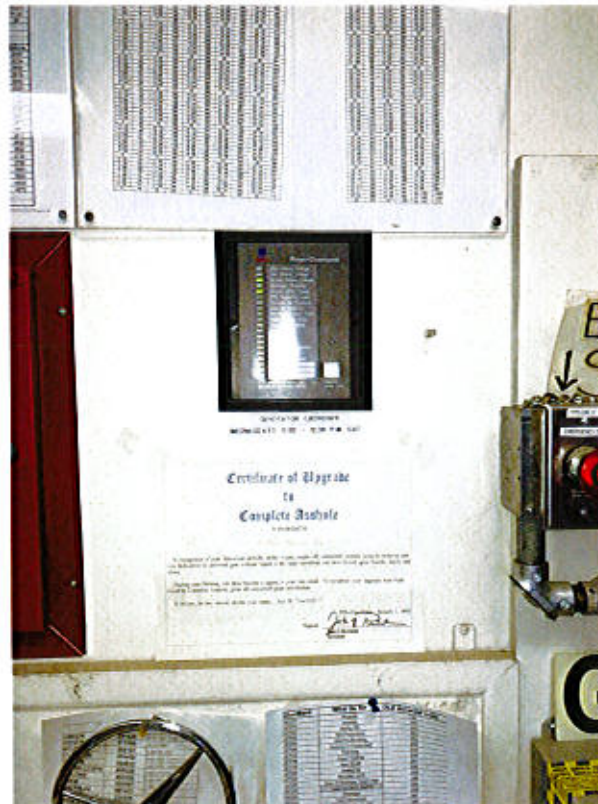
Tank monitoring system

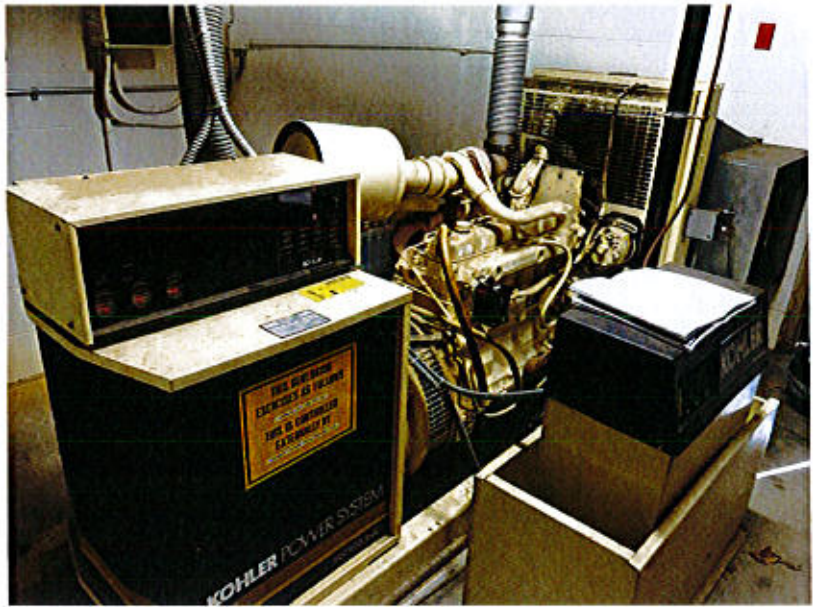
Generator

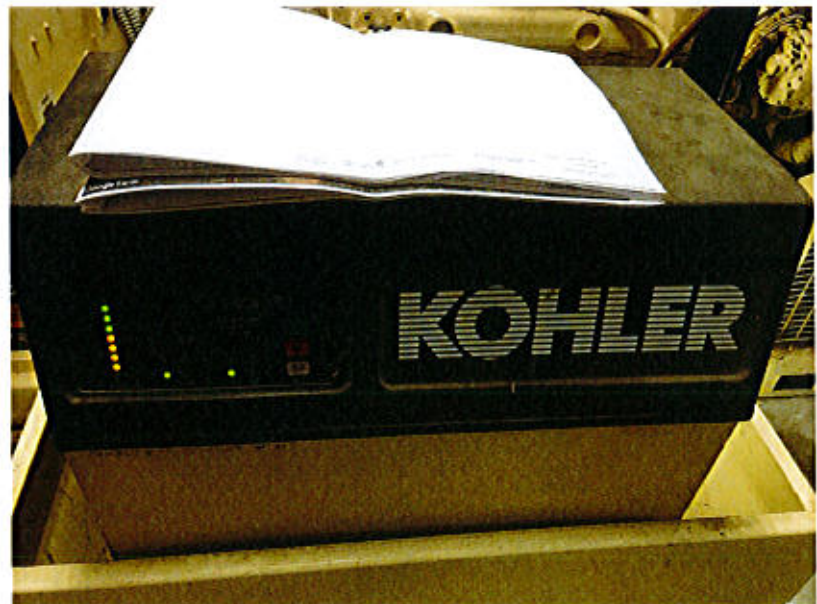
Generator control

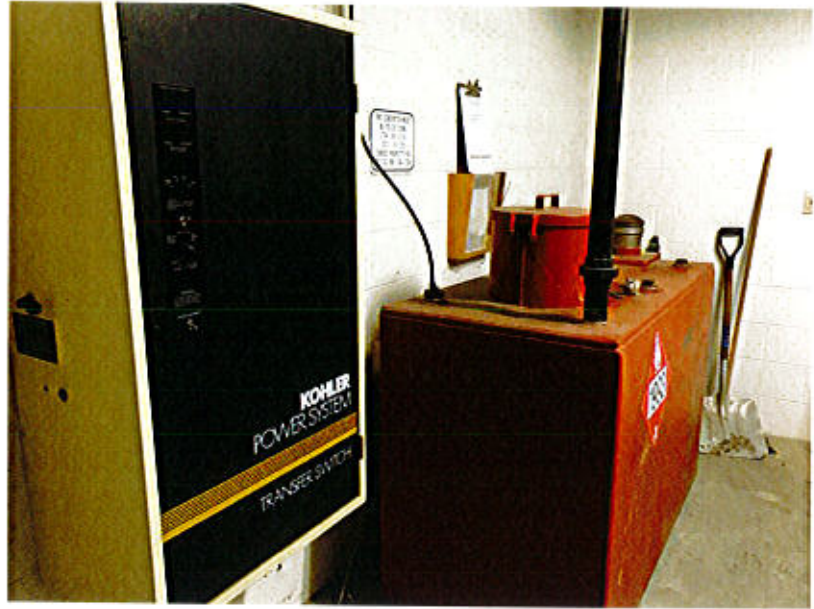
Generator transfer and fuel tank

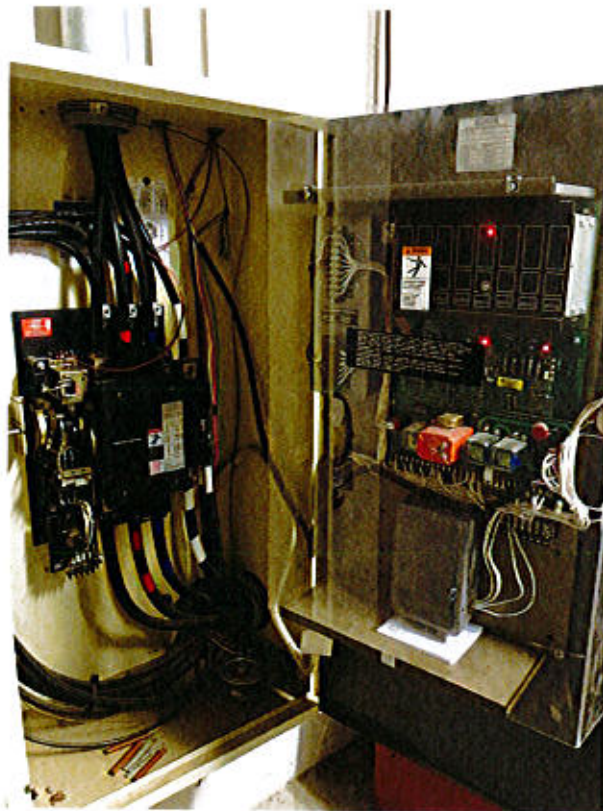
Inside generator transfer

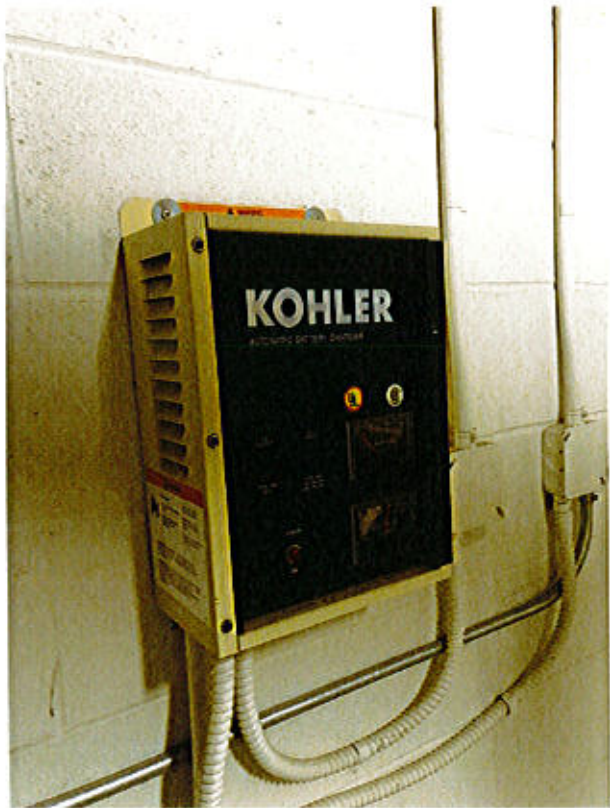
Generator battery charger

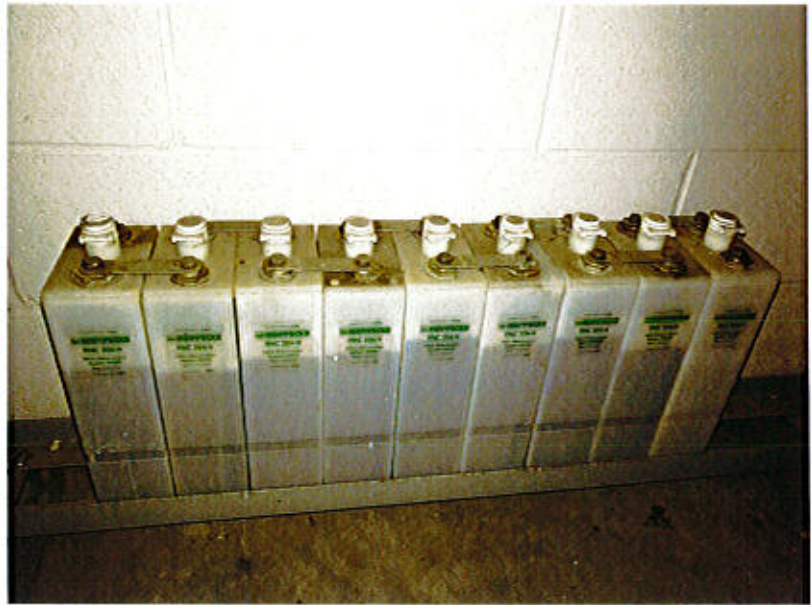
Batteries

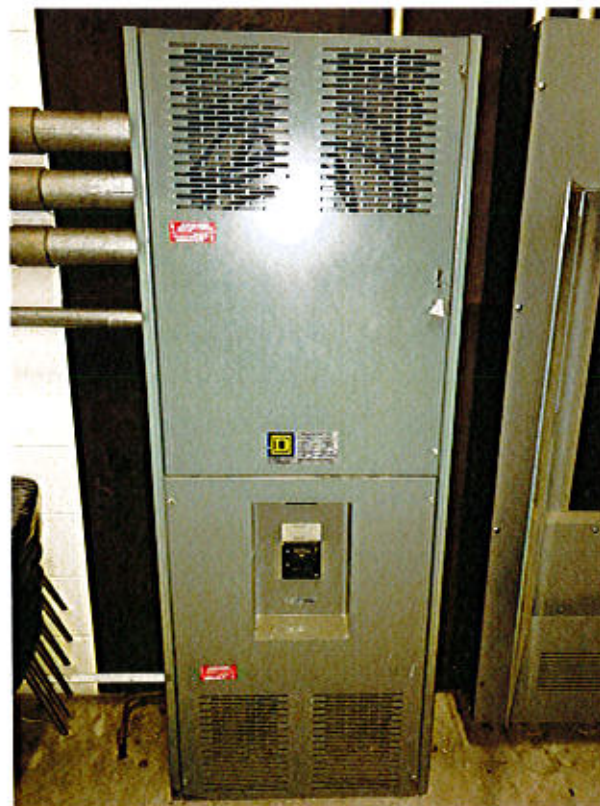
Generator room panel

General Notes Generator Control Rm. Concrete floor. Suspect ACM on metal wall seams exterior. One layer block walls inside. Metal deck and truss ceiling. Suspect fire penetration sealant. Generator no suspect ACM. Has oils and lives and circuit board.

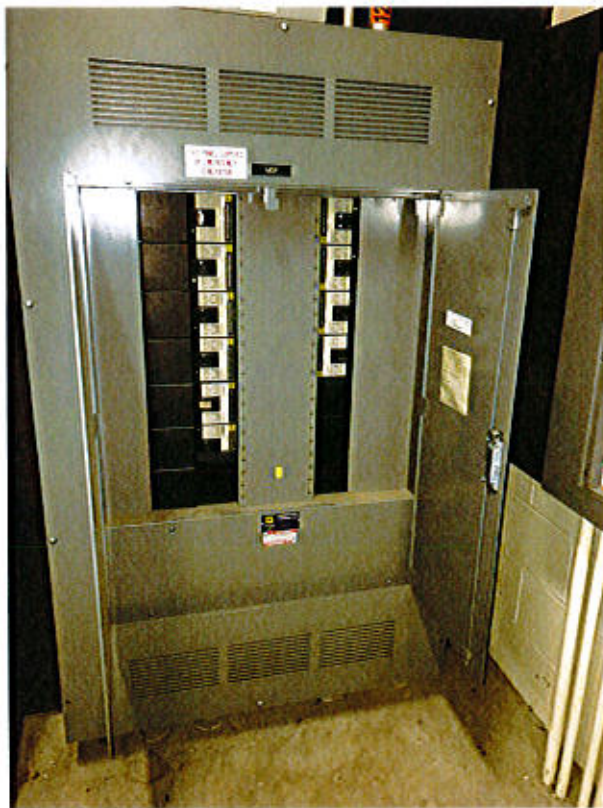
Generator panel

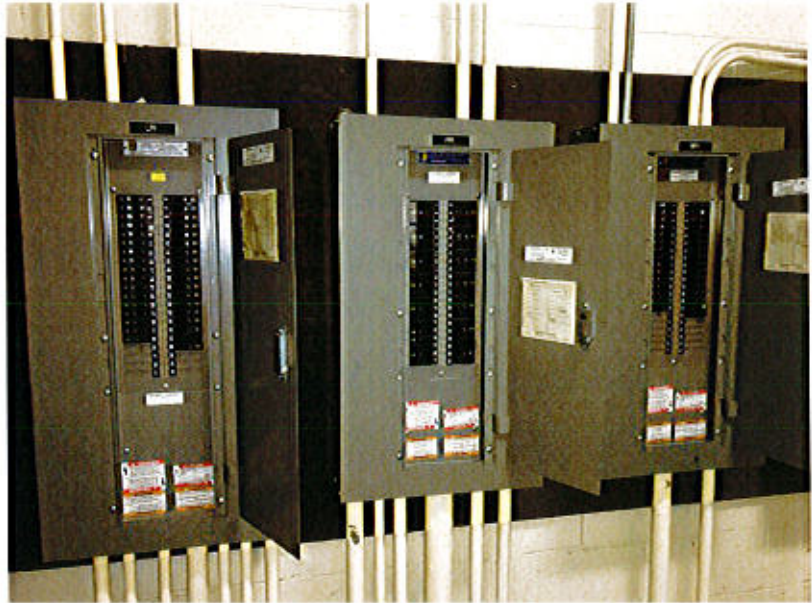
Generator room panel

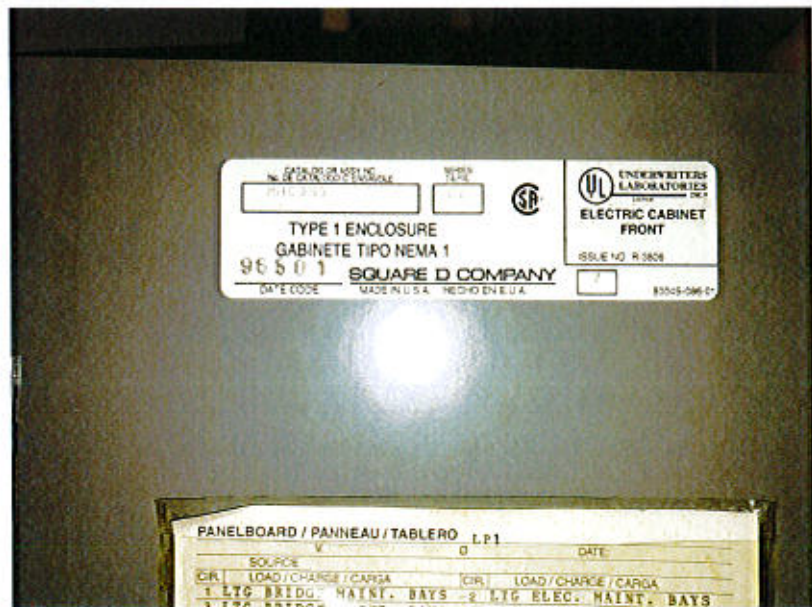
Generator room electrical panel

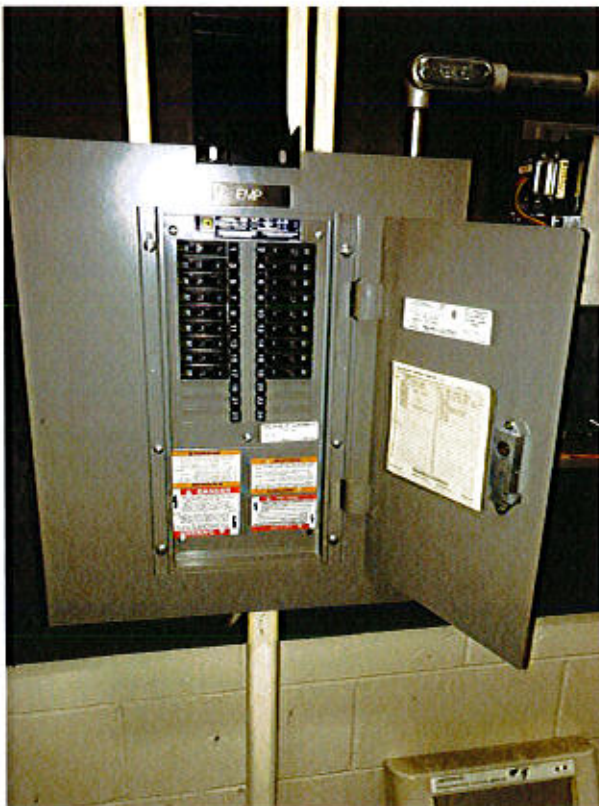
Electrical panel label

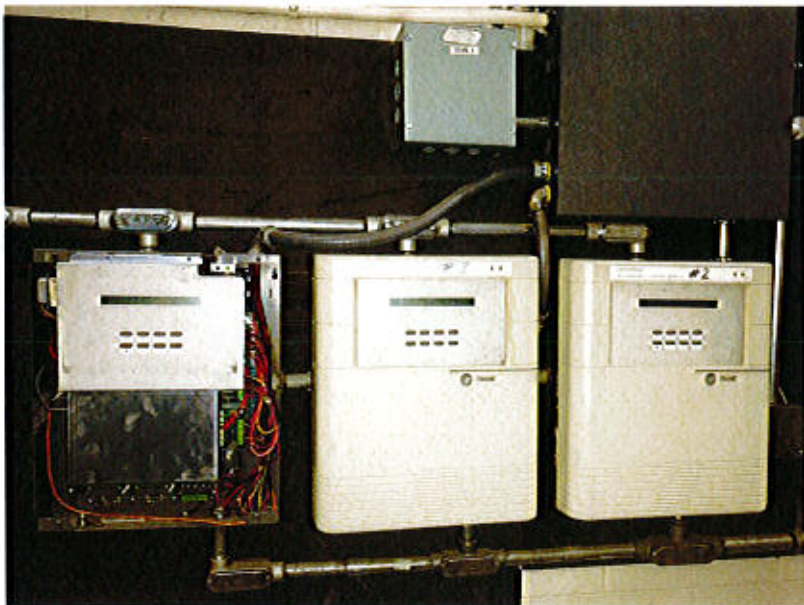
Generator room electrical panel

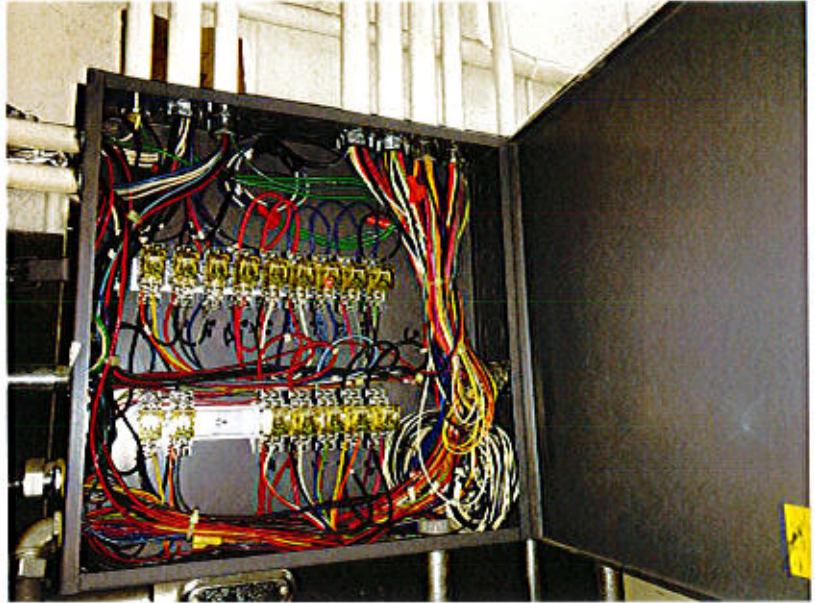
Trane Control boxes

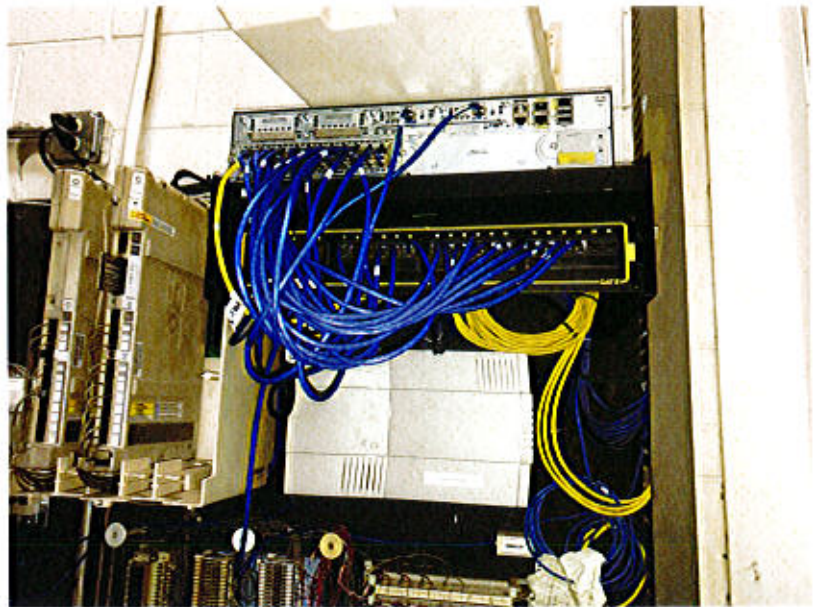
Control box

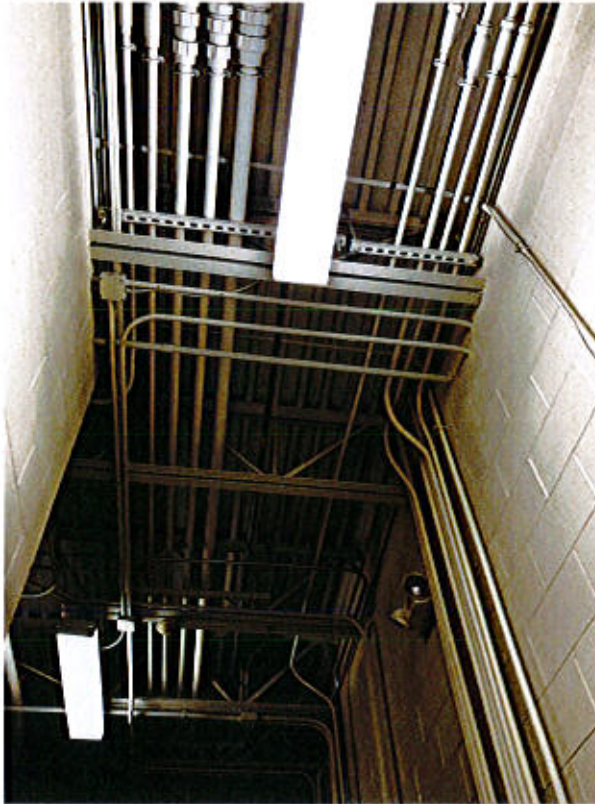
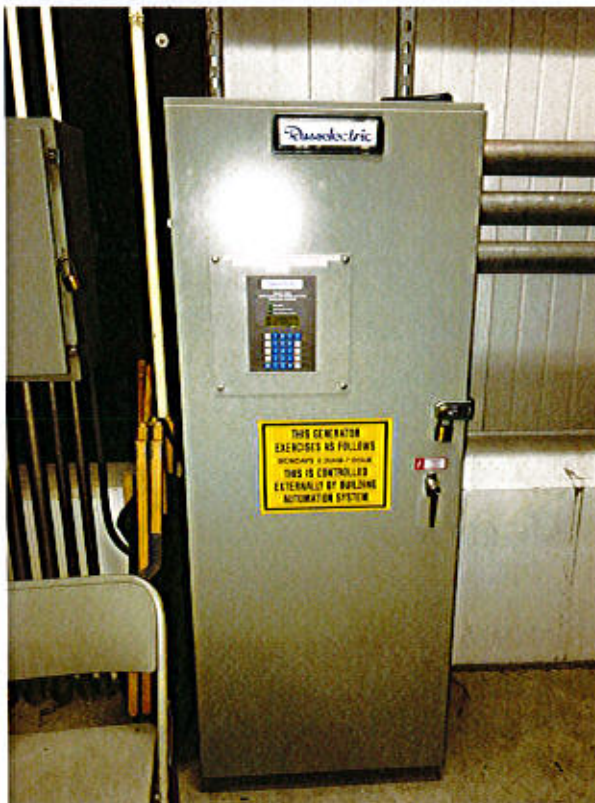
Varios controls

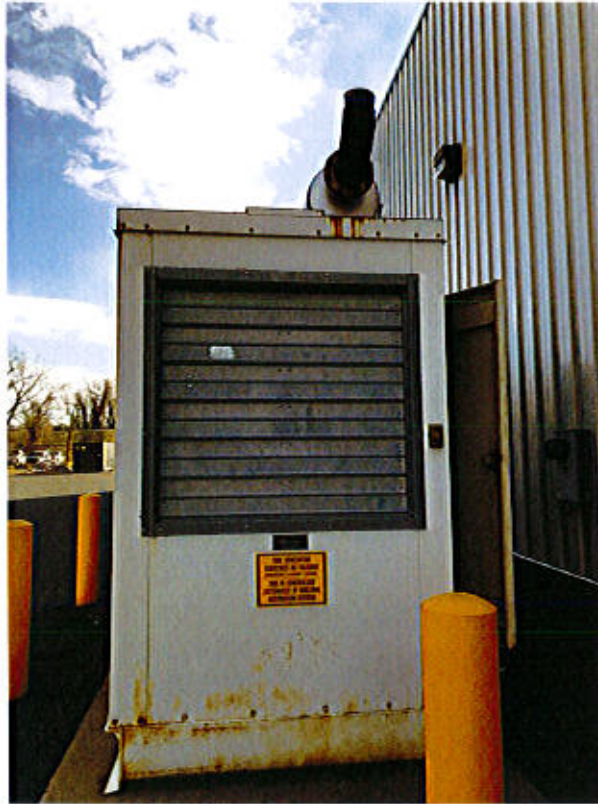
Generator Control box

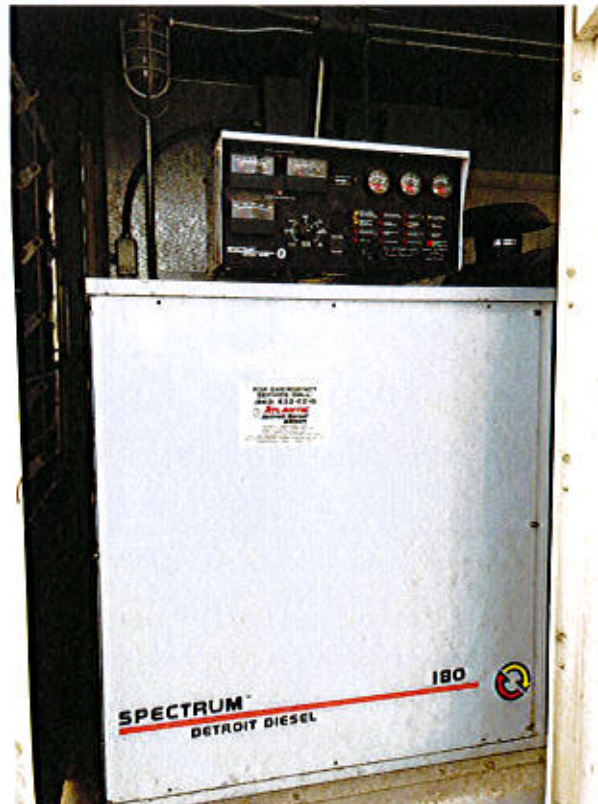
Generator

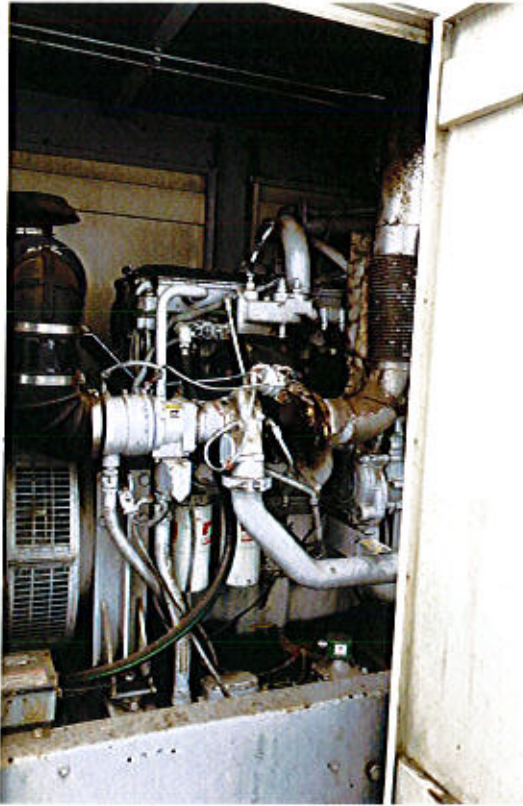
Inside generator

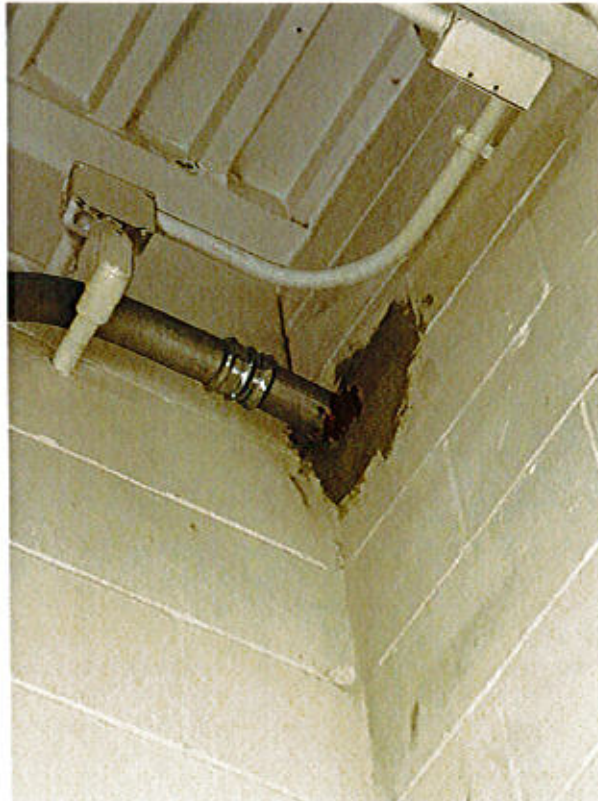
( 2 ), PS1, Red Rubbery Penetration sealant

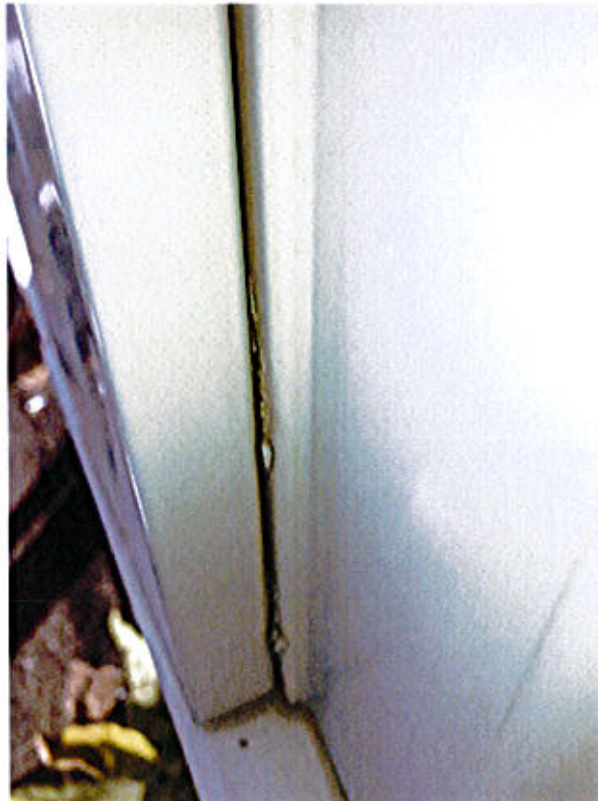
**( 2 ), SS1, Tan brittle metal wall siding seam sealant.**

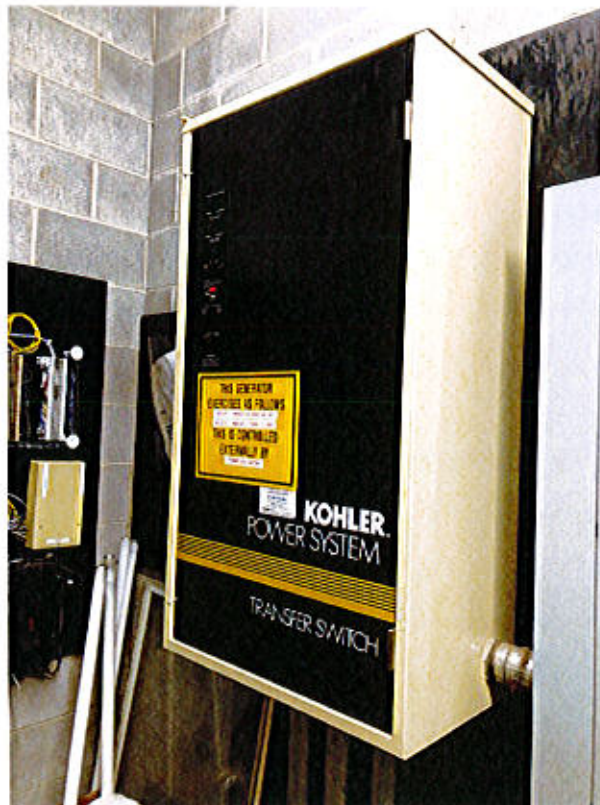
Generator transfer switch

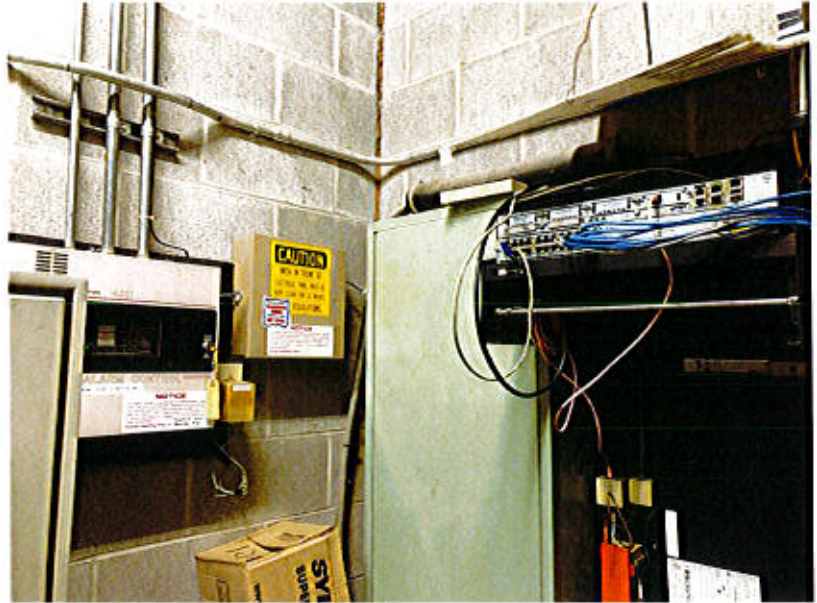
Alarm Control

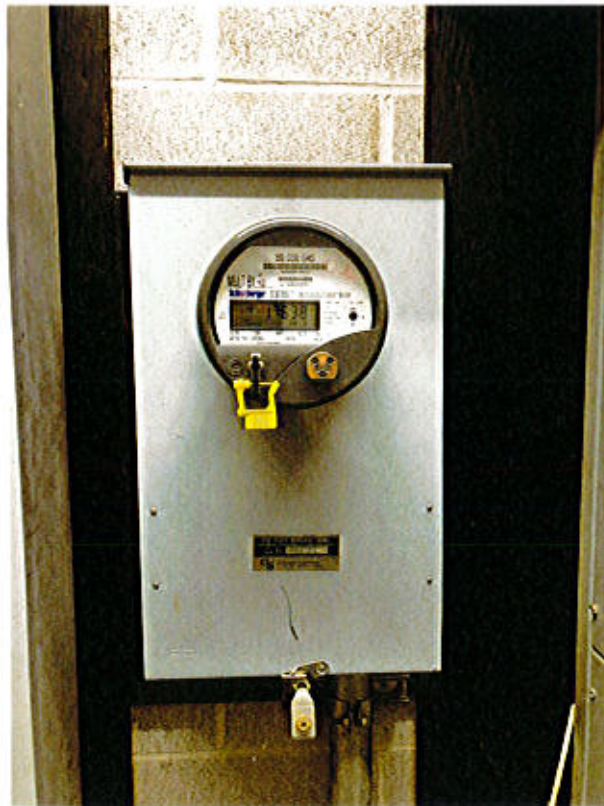
Electrical meter

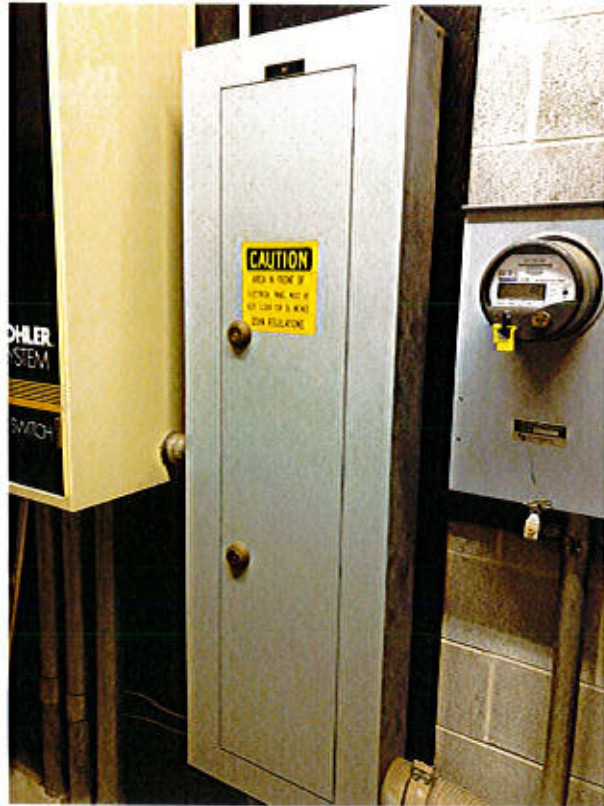
Electrical panel

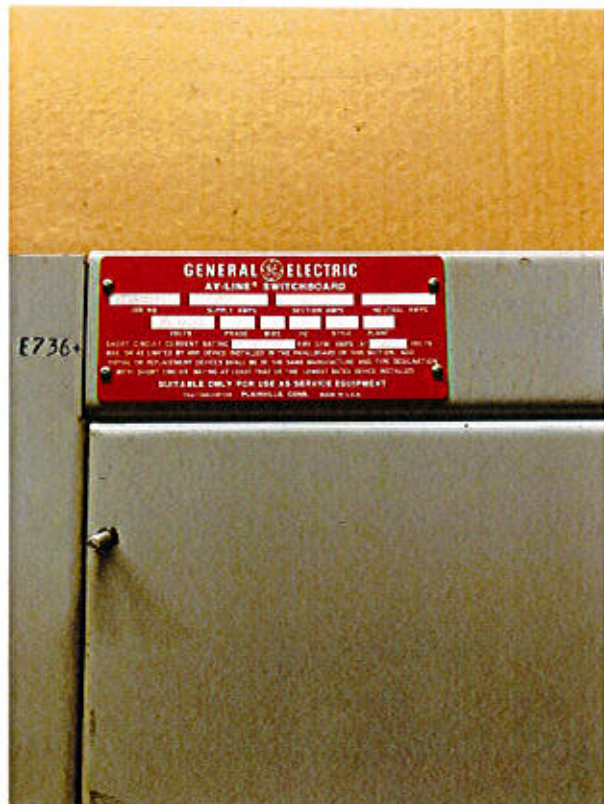
Electrical panel label

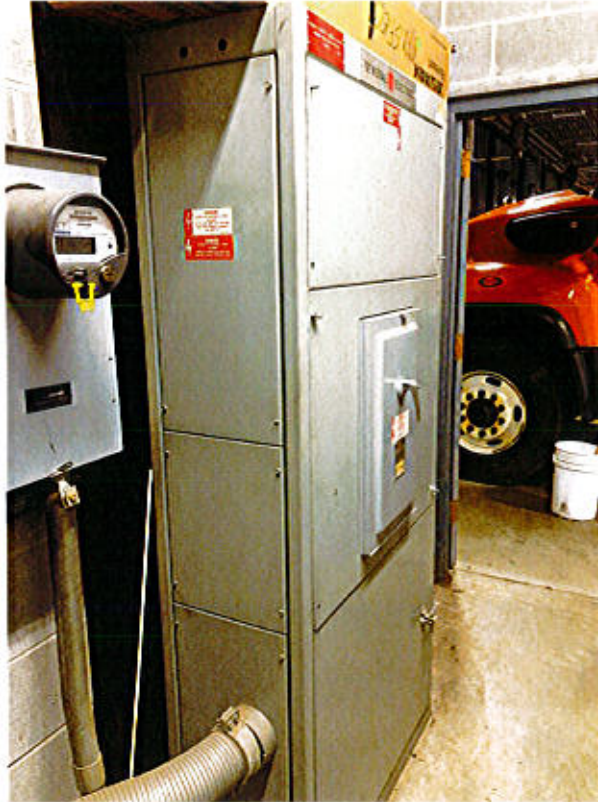
Transfer switch q

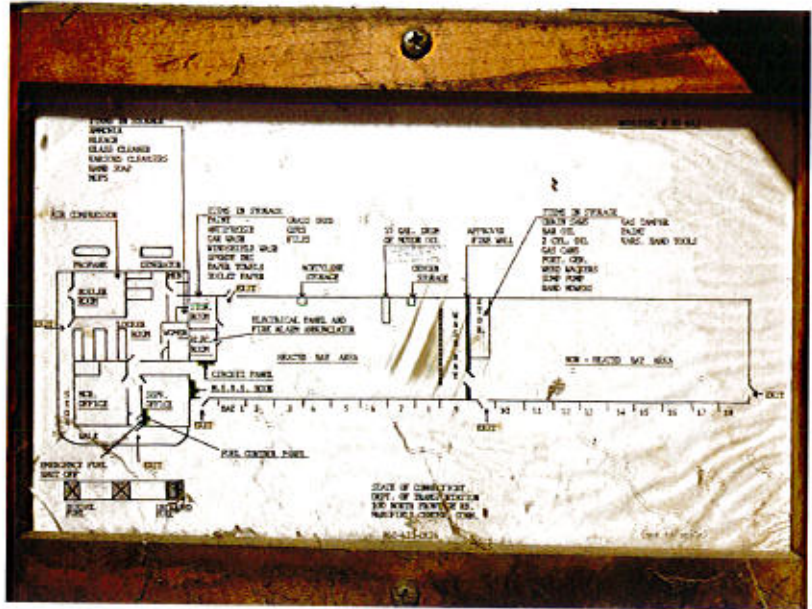
Building sketch

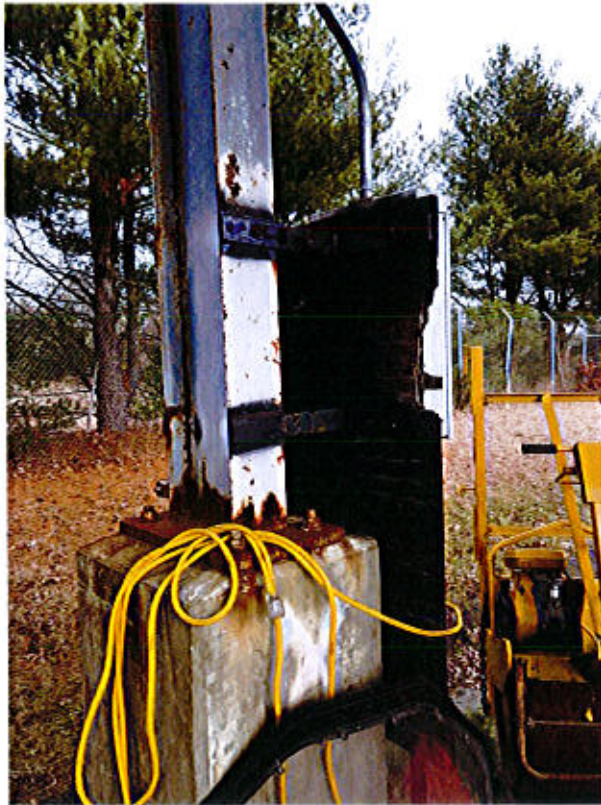
Generator electrical panel

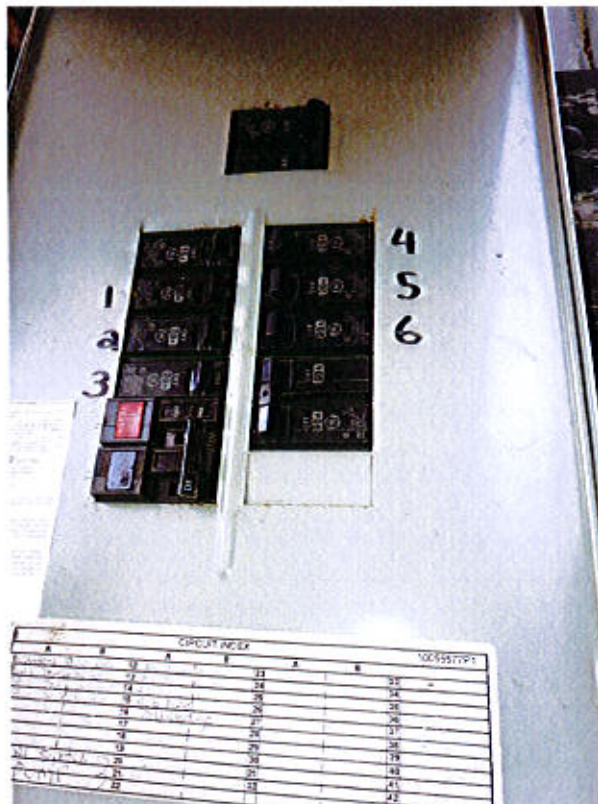
Generator electrical panel

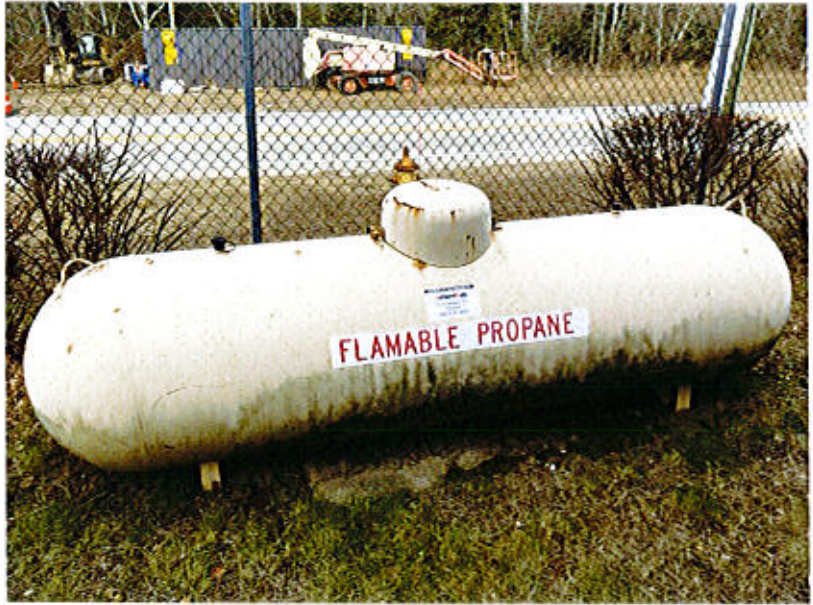
Propane tank

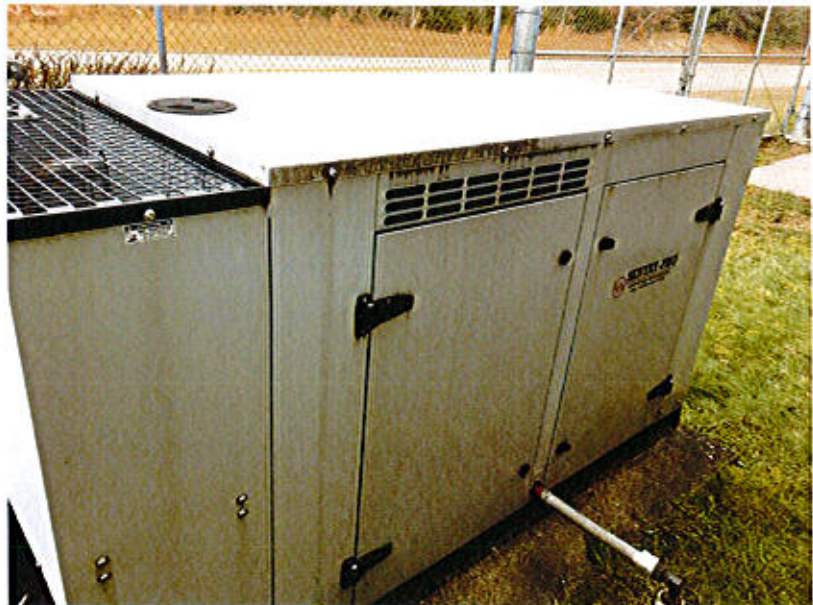
Generator

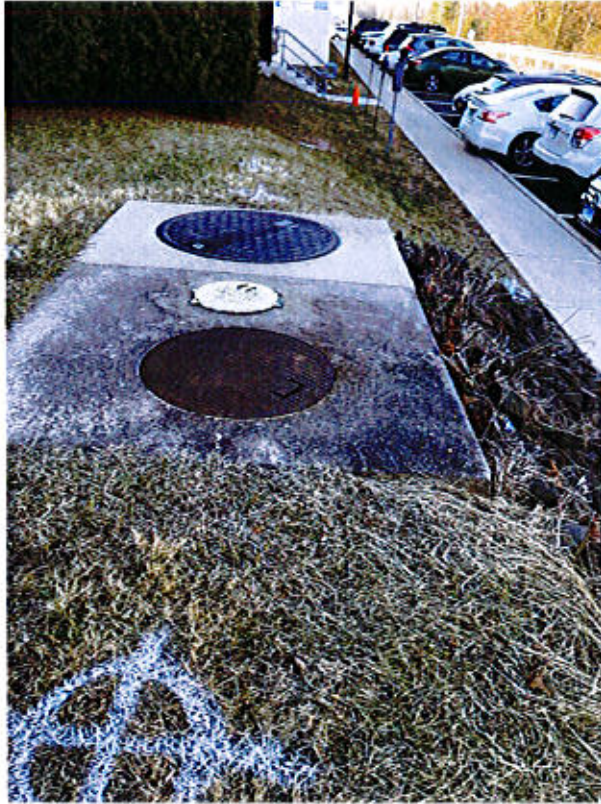
UST covers

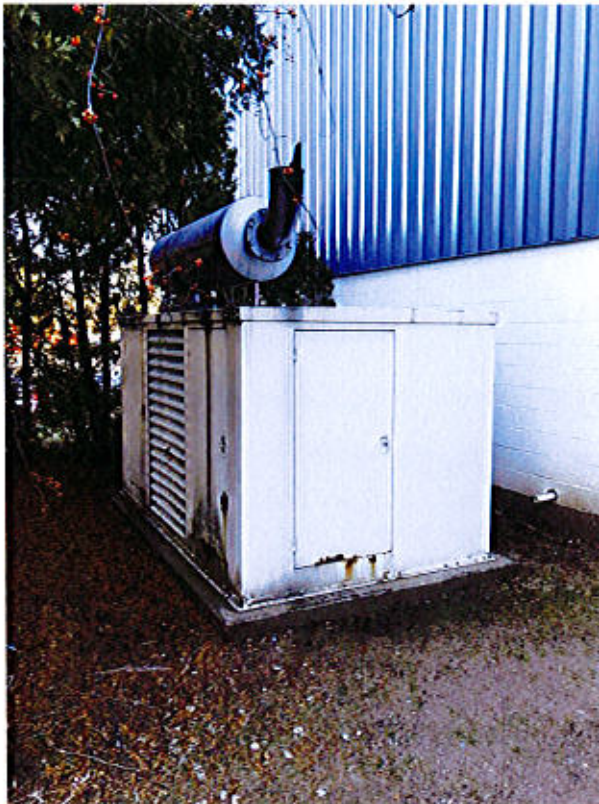
Generator

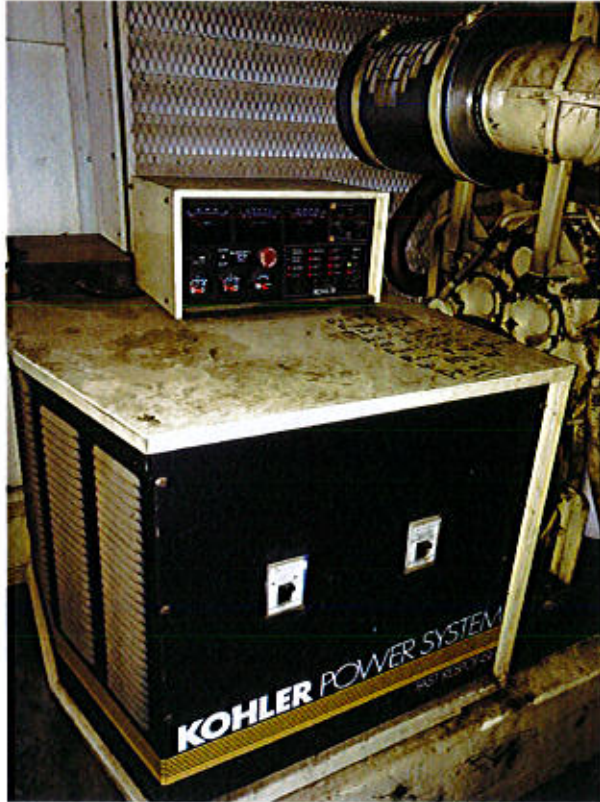
Inside generator

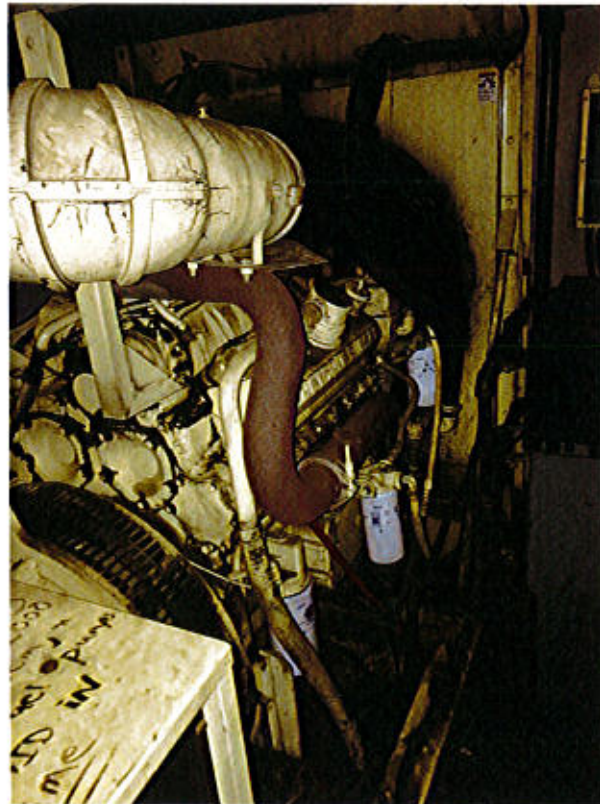
Inside generator

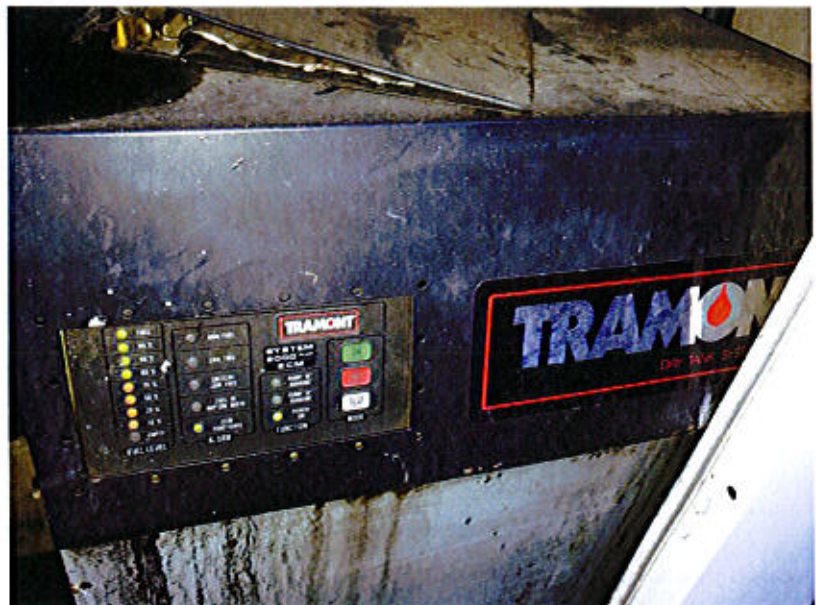
Inside generator control

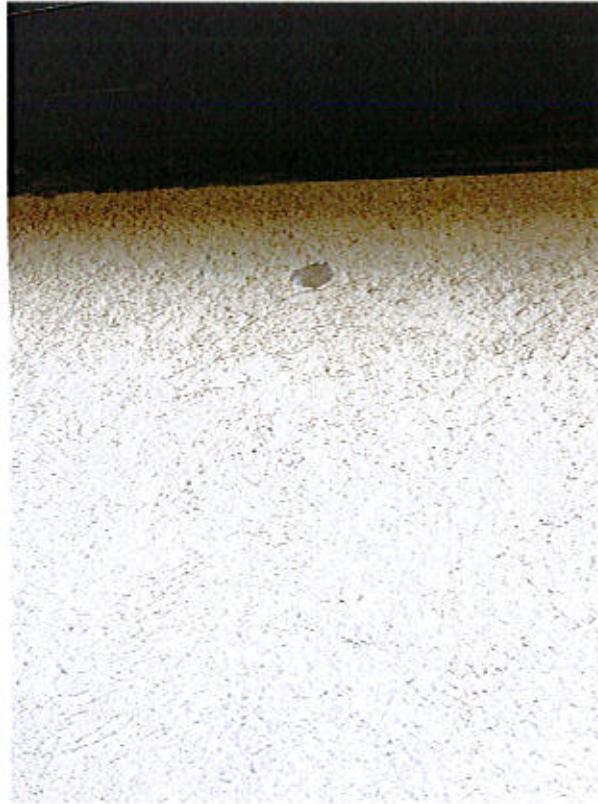
( 2 ), SW1, Grey stucco wall
