# Norwalk Feasibility Study

Naramake Elementary School		
16 King Street, Norwalk, CT 06851

# NARMAKE ELEMENTARY SCHOOL

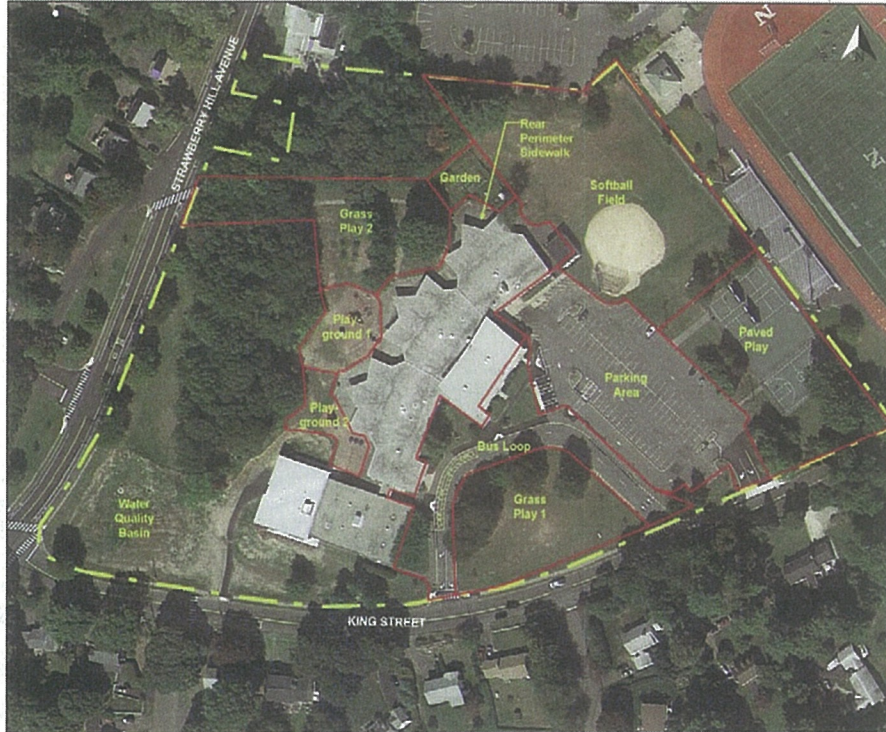
### Site Plan

Property Information		Capital Needs Prioritization		
Acreage	20.2	Work Area	Total	Priority 1&2
Separate Bus/Parent Drop-off	Mixed	1. Main Entrance/ Bus Loop	\$ 308,000	\$ 122,000
Site Lighting	Poor	2. Parking Area	\$ 234,000	\$ 234,000
Parking	Adequate	3. Grass Play 1	\$ 7,000	\$ 7,000
General Condition		4. Paved Play	\$ 14,000	\$ 8,000
Accessibility	Fair	5. Softball Field	\$ 124,000	\$ 117,000
Driveways	Poor	6. Rear Perimeter Sidewalk	\$ 16,000	\$ 12,000
Walkways	Fair	7. Garden	\$ 3,000	\$ 3,000
Landscaping	Fair	8. Grass Play 2	\$ 25,000	\$ 25,000
Athletic Facilities	Poor	9. Playground 1	\$ -	\$ -
Playgrounds/Play Structures	Fair/Good	10. Playground 2	\$ -	\$ -
Service Areas	Fair	11. Water Quality Basin	\$ -	\$ -
* Includes 25% Contingency		<b>Total:</b>	<b>\$ 731,000</b>	<b>\$ 528,000</b>
