BRIDGE NO.01213

52980 - NEWTOWN
INTERSTATE 84 EASTBOUND
over
HRRC & BOULEVARD ROAD

Routine Inspection

3/27/2017

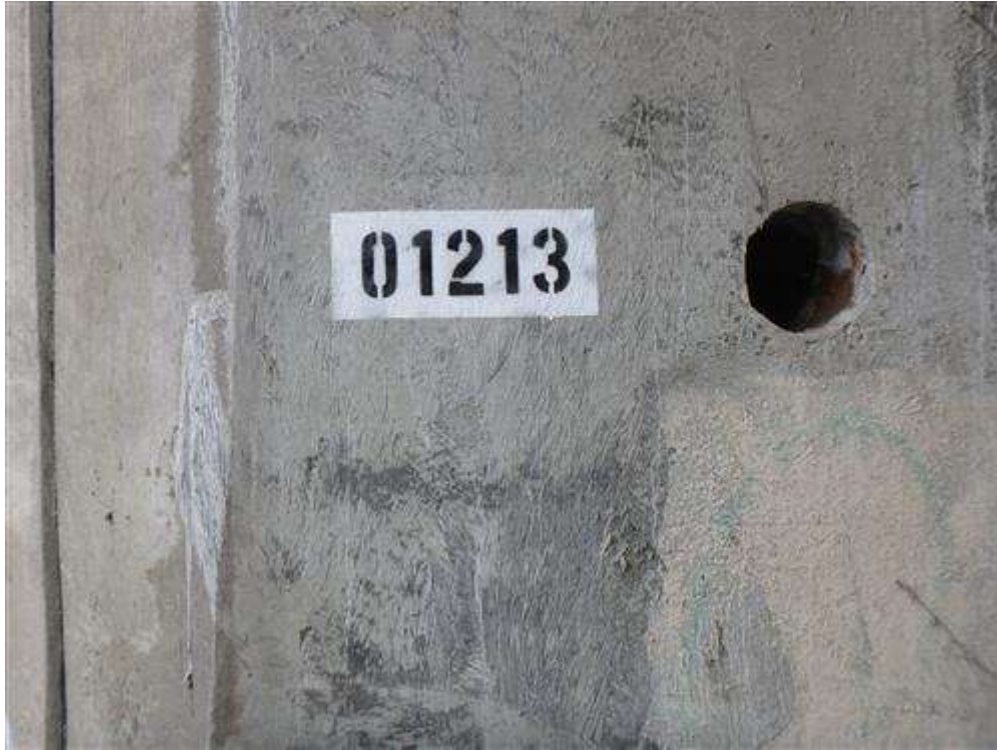
Photo Number: 1

Bridge Identification Number. Stenciled at the time of inspection.

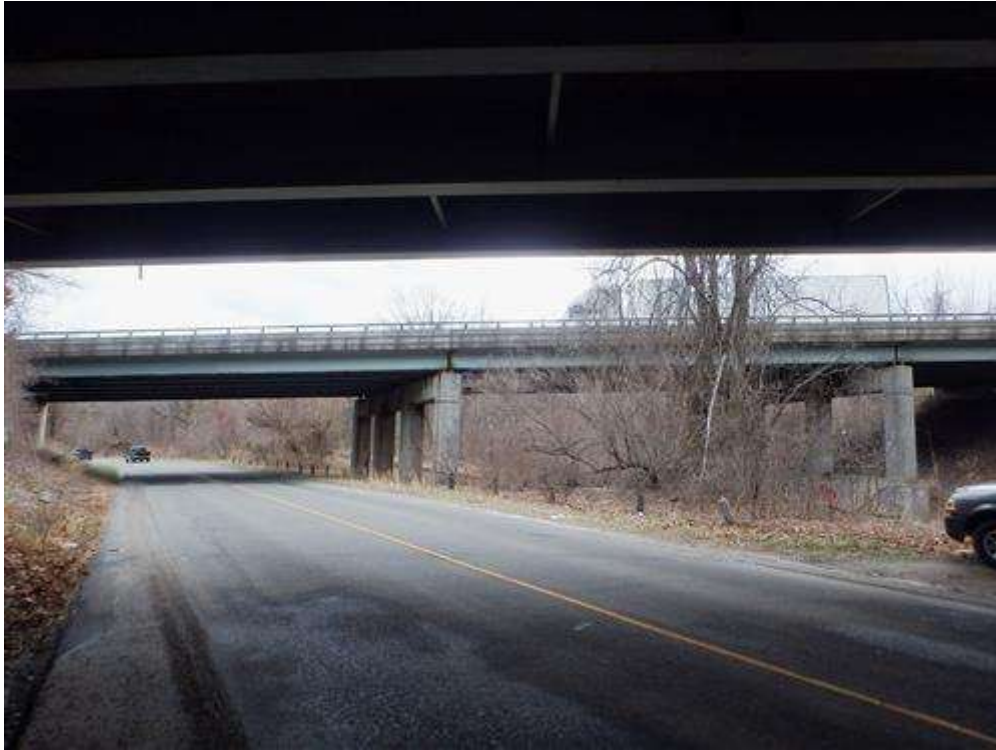
Photo Number: 3

North elevation of bridge.

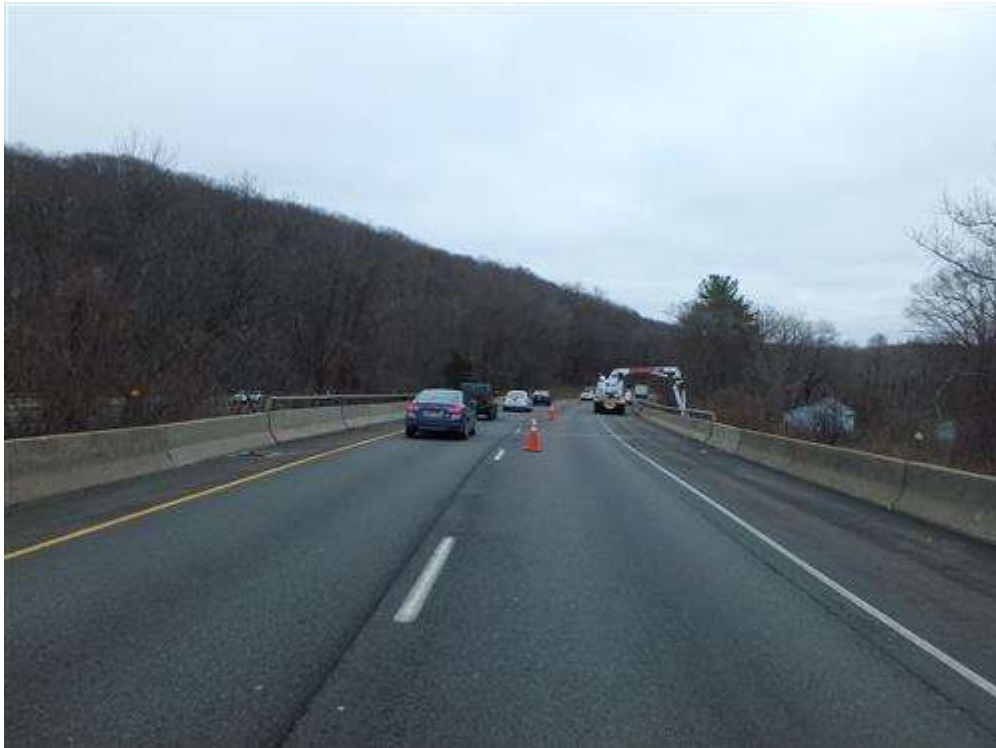
Photo Number: 4

Bridge from west approach.

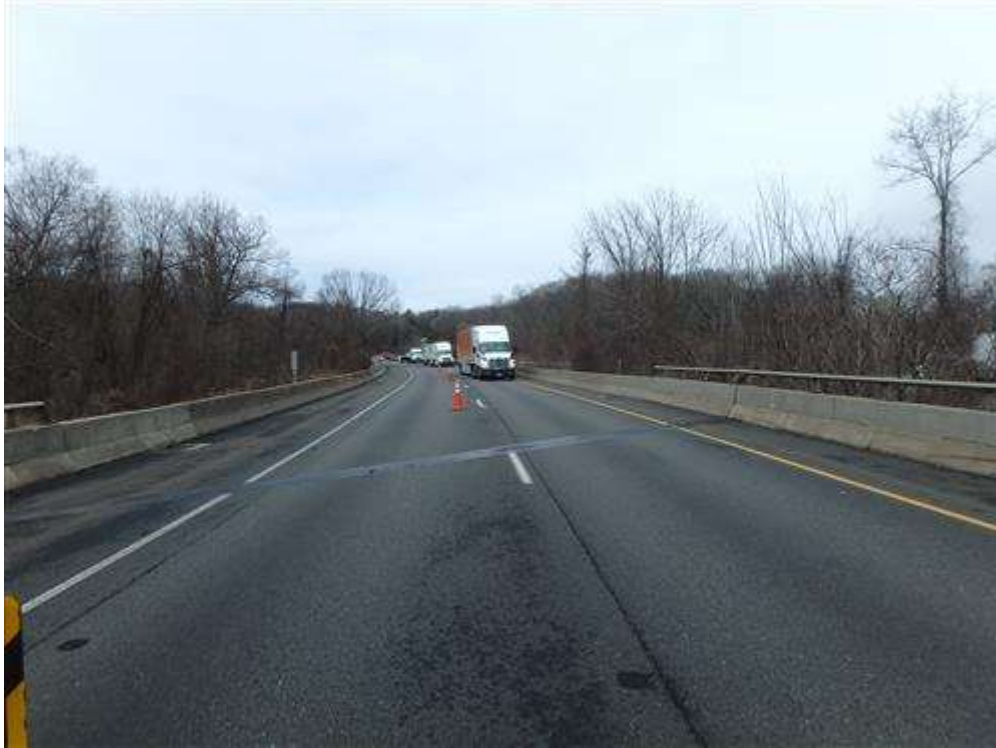
Photo Number: 5

West approach from bridge.

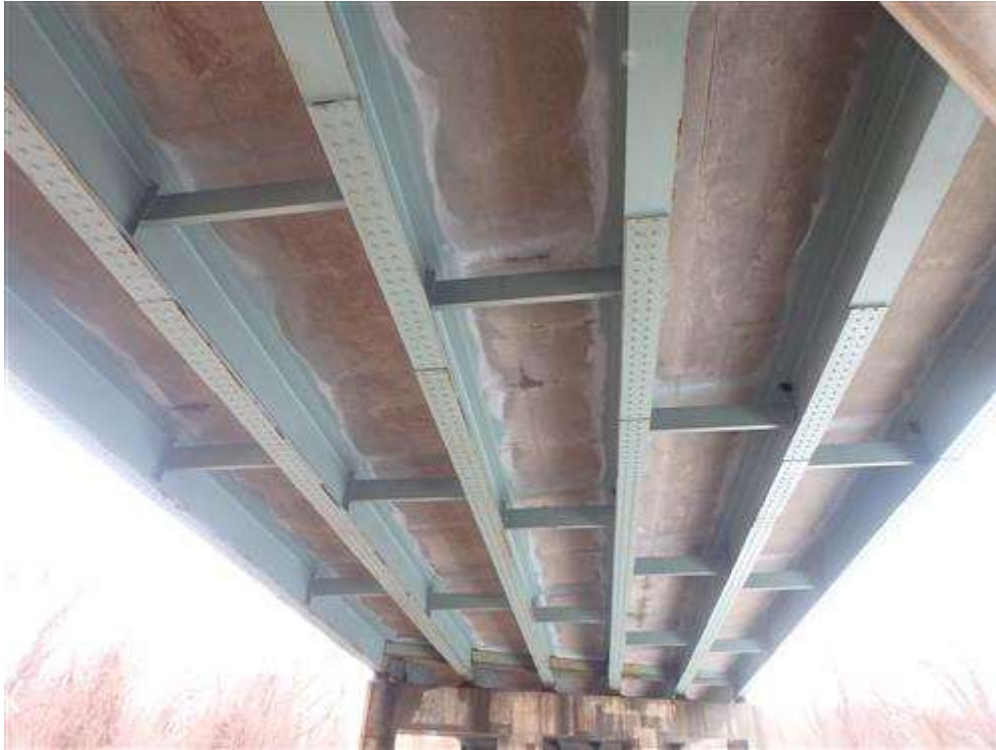
Photo Number: 9

Typical underside of deck & superstructure configuration and condition. Span 2 shown.

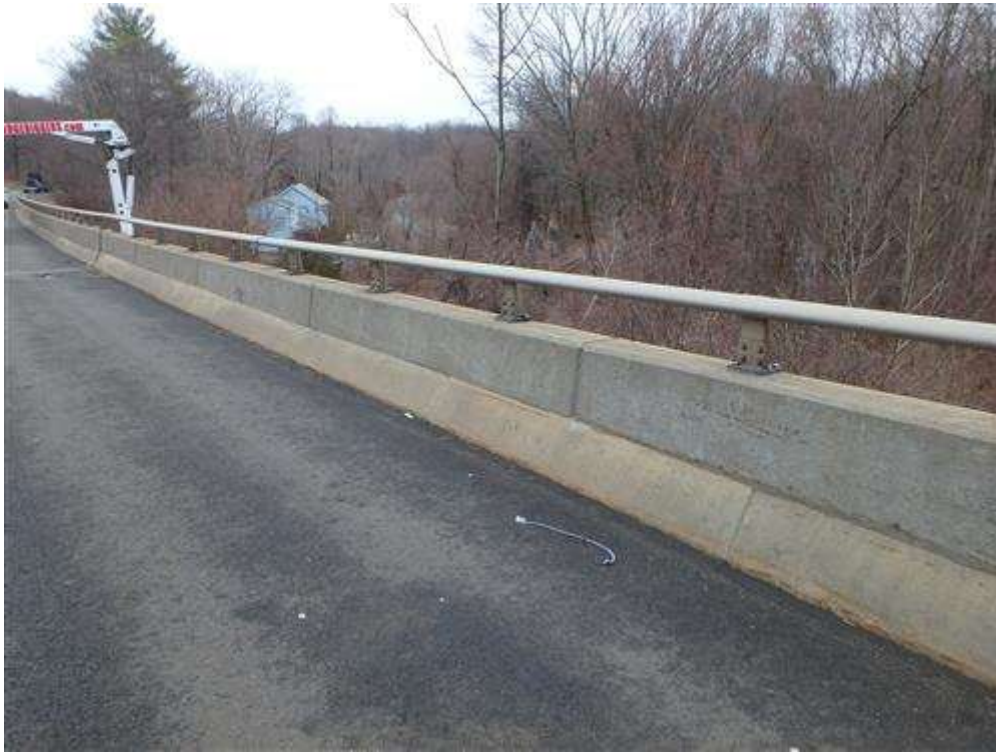
Photo Number: 11

Typical curb, parapet and bridge railing condition. South side shown.

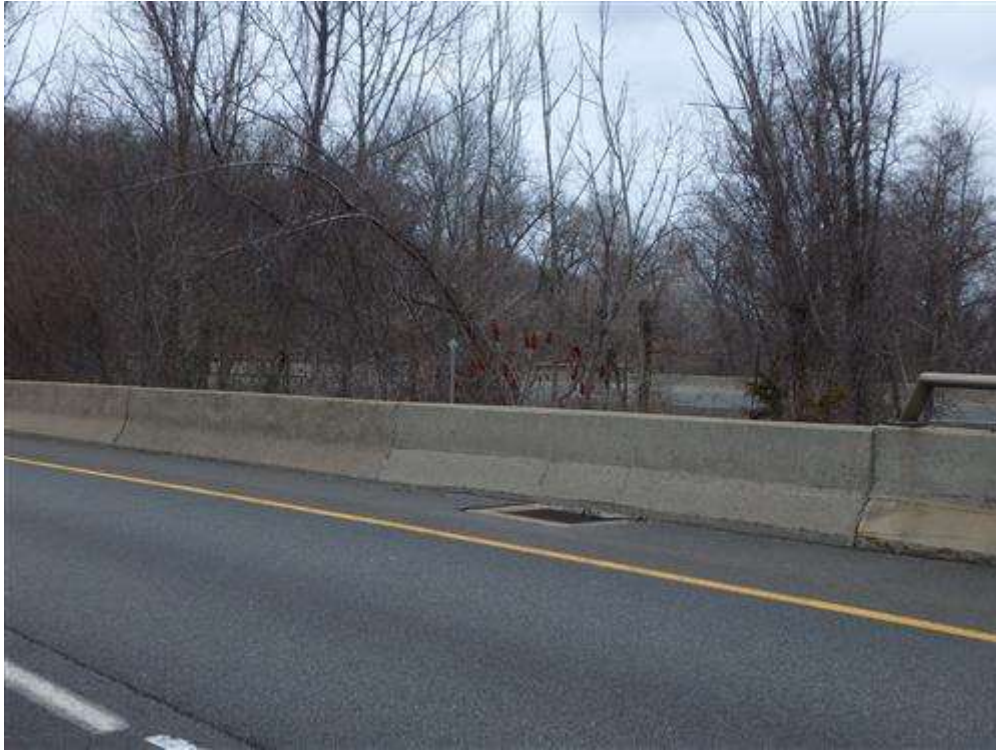
Photo Number: 19

Northwest approach jersey barrier (leading end). Typical condition.

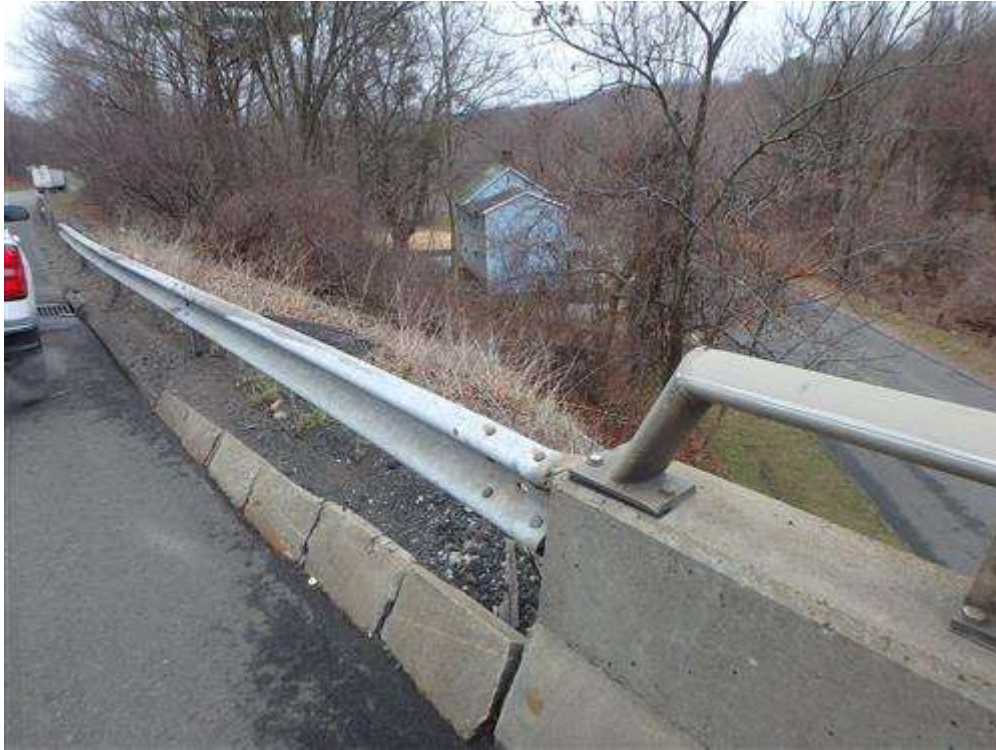
Photo Number: 21

Southeast metal beam guide rail (trailing end). Typical condition.

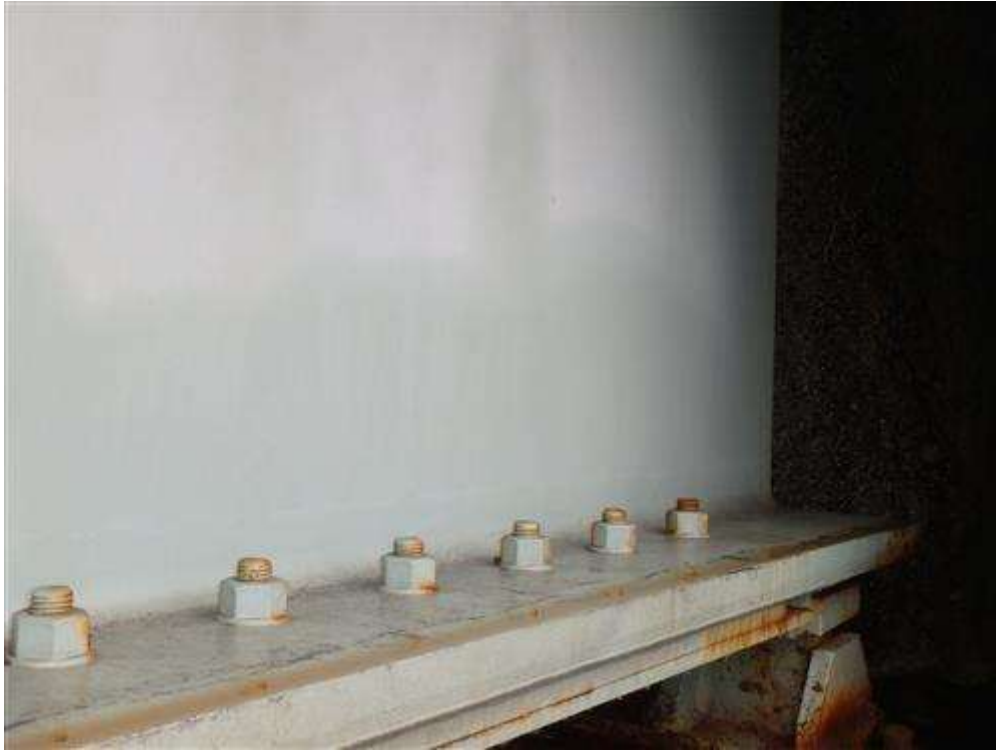
Photo Number: 35

Same location as Photo #34. South side of girder end has no loss.

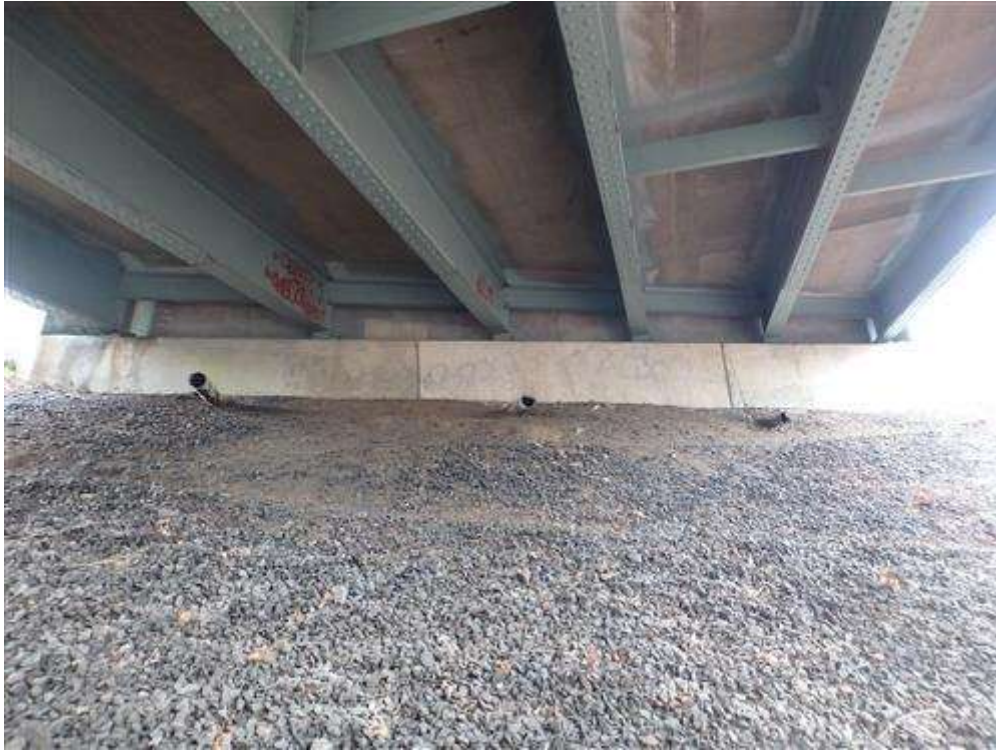
Photo Number: 37

Abutment 1 elevation.

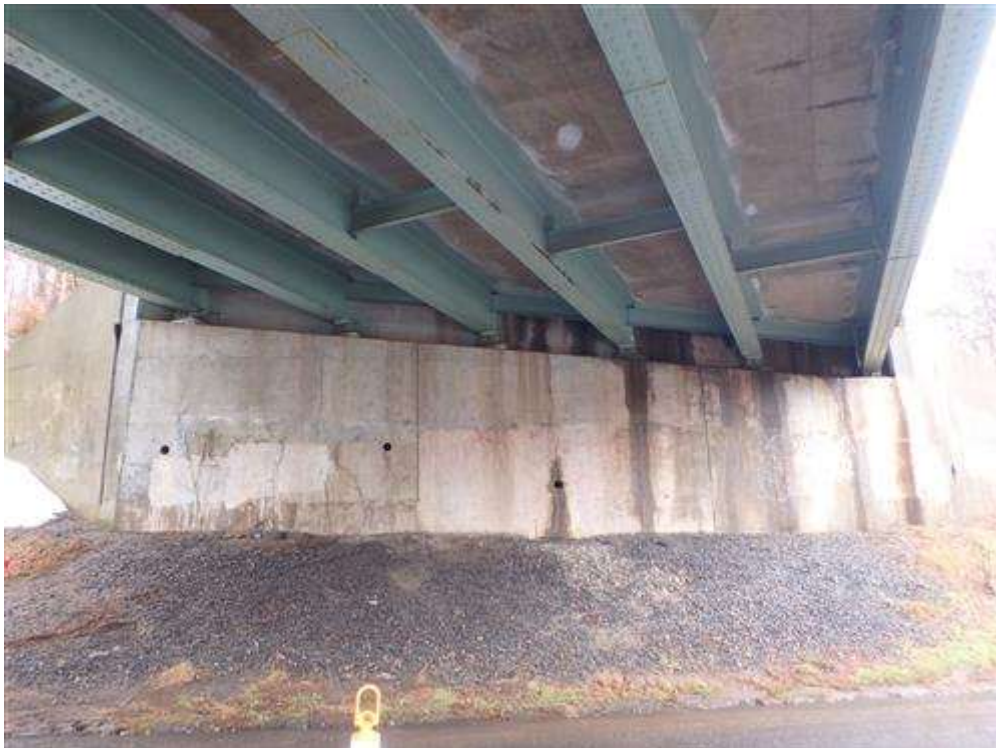
Photo Number: 38

Abutment 2 elevation.

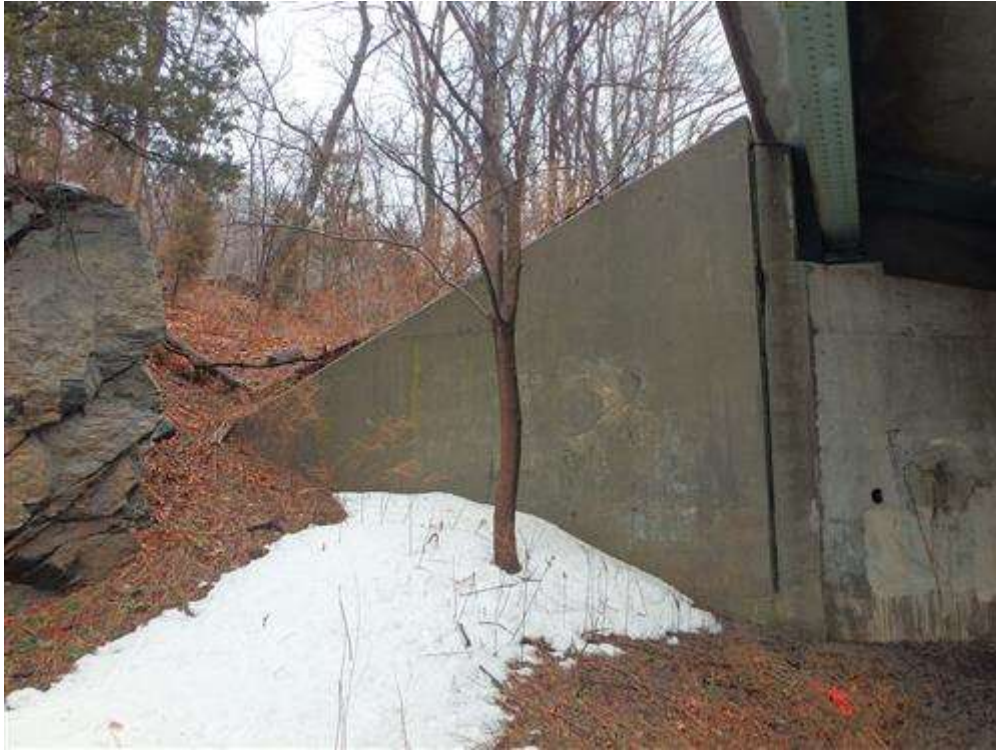
Photo Number: 39

Wingwall 2A. Typical condition.

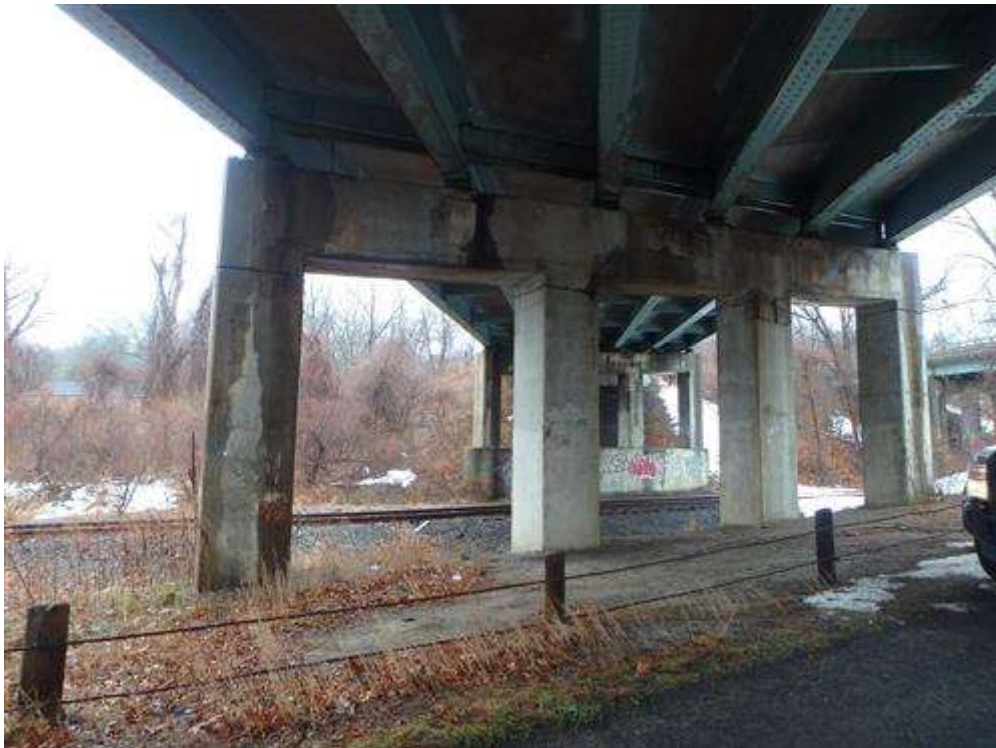
Photo Number: 40

Pier 2, east elevation.

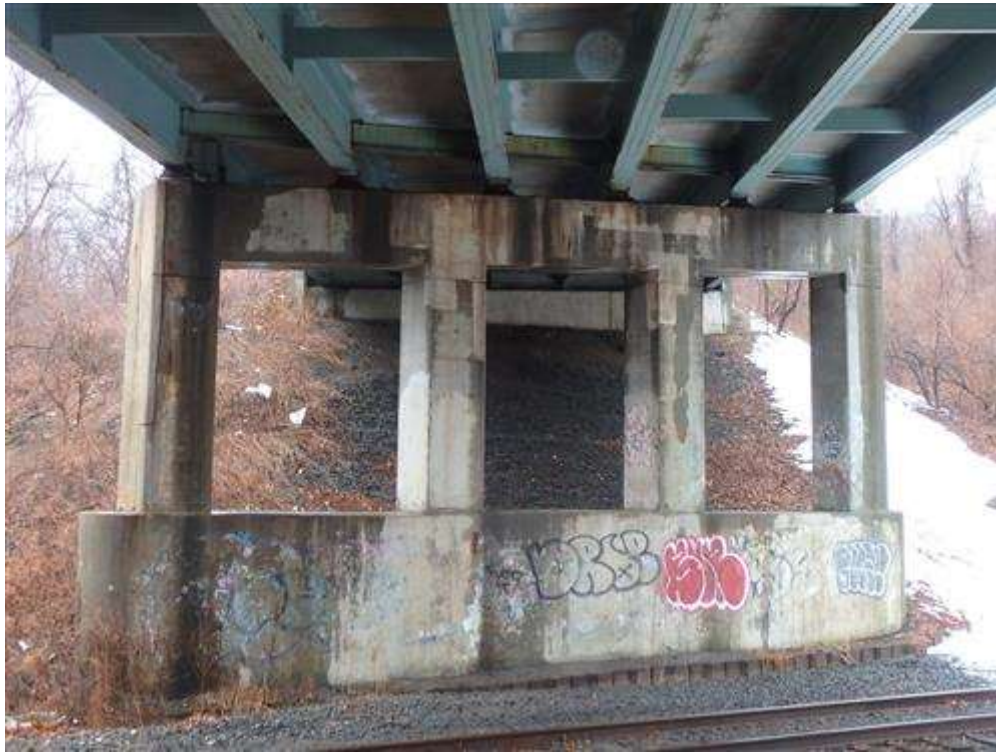
Photo Number: 41

Pier 1, east elevation. Crash wall has areas of light to moderate graffiti.

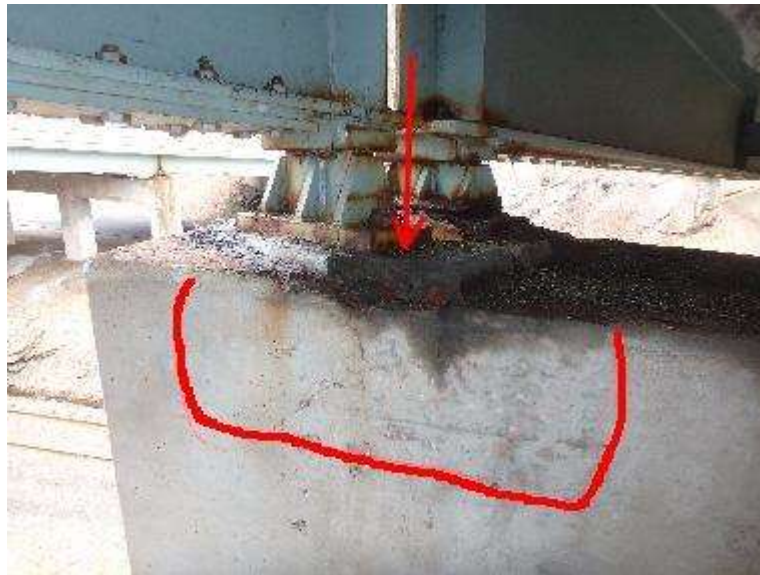
Photo Number: 42

Pier 1 cap below girder G1 in Span 1 has a hollow area. Girder pedestal has a corner spall with no undermining.

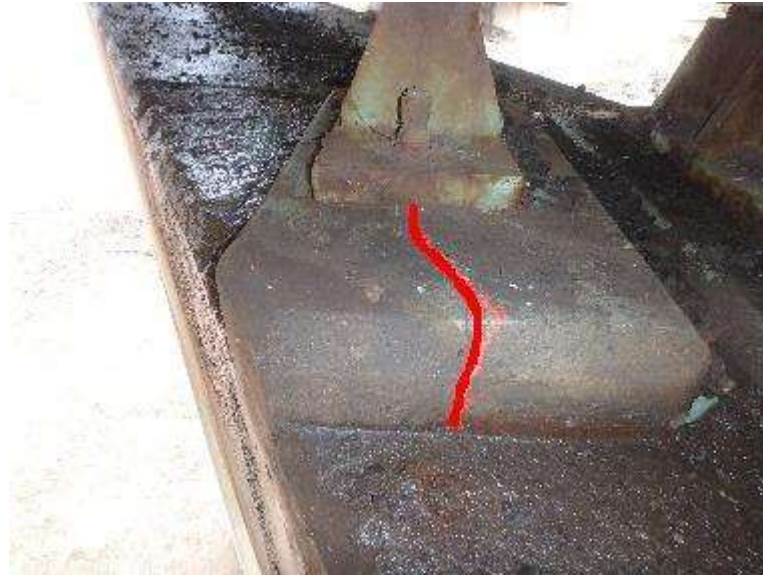
Photo Number: 45

Pier 2, girder G2 pedestal in Span 2 has a hairline crack on the South side that extends to the anchor bolt.
