BRIDGE NO.01218

52980 - NEWTOWN
INTERSTATE 84 EASTBOUND
over
HOUSATONIC RIVER

Fracture Critical and Routine Inspection

9/10/2018

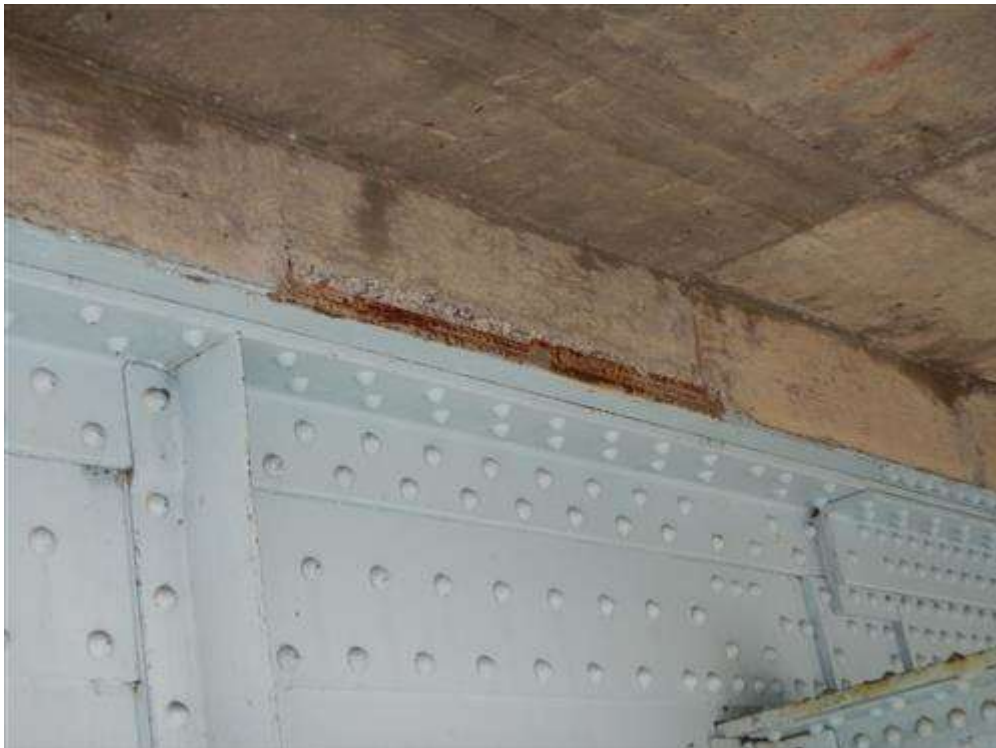
Photo Number: 10

Note: Haunch spall.

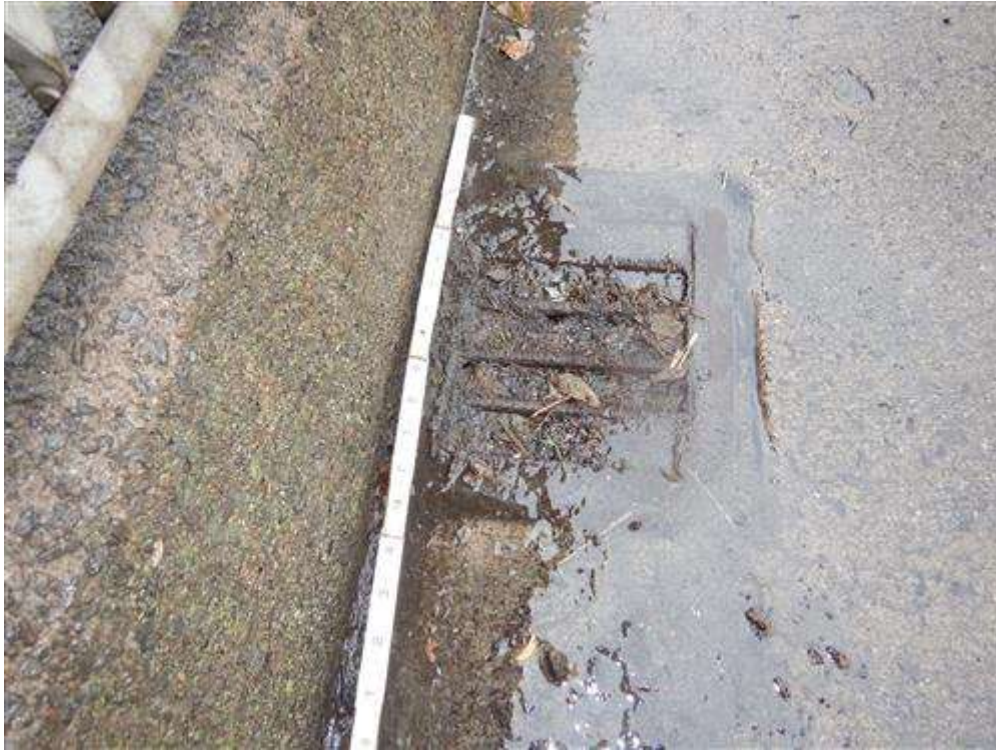
Photo Number: 13

Sidewalk Scupper Grate in Span 4

Note: Clogged.

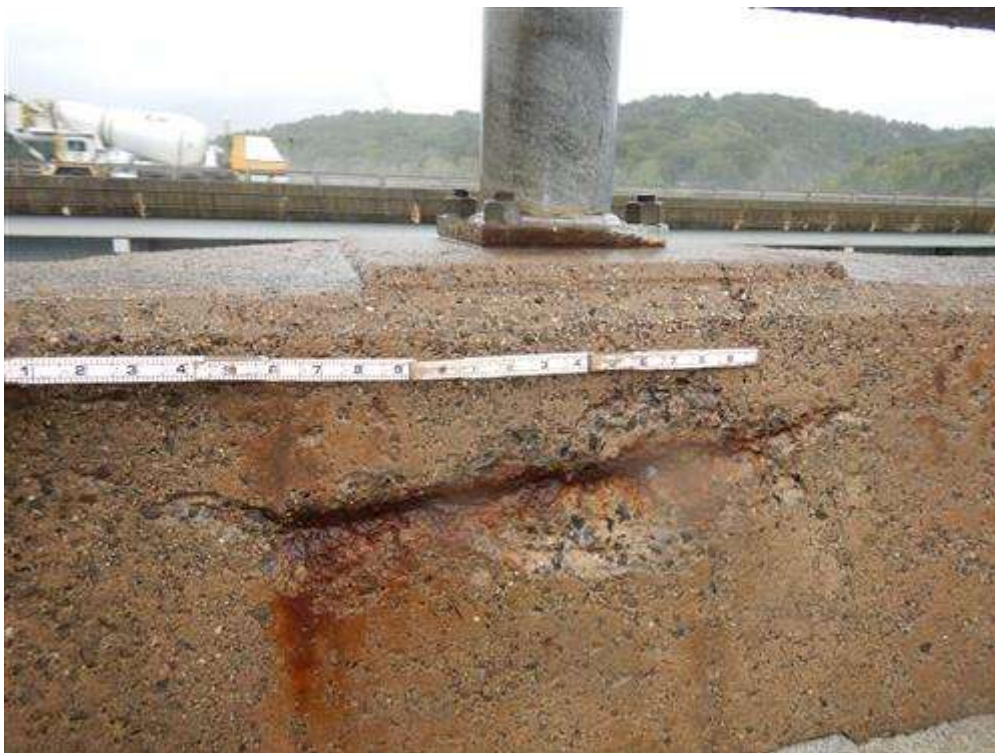
Photo Number: 16

Note: Spall 18" long x 3" high x 1" deep and hollow area 10" diameter at sign connection.

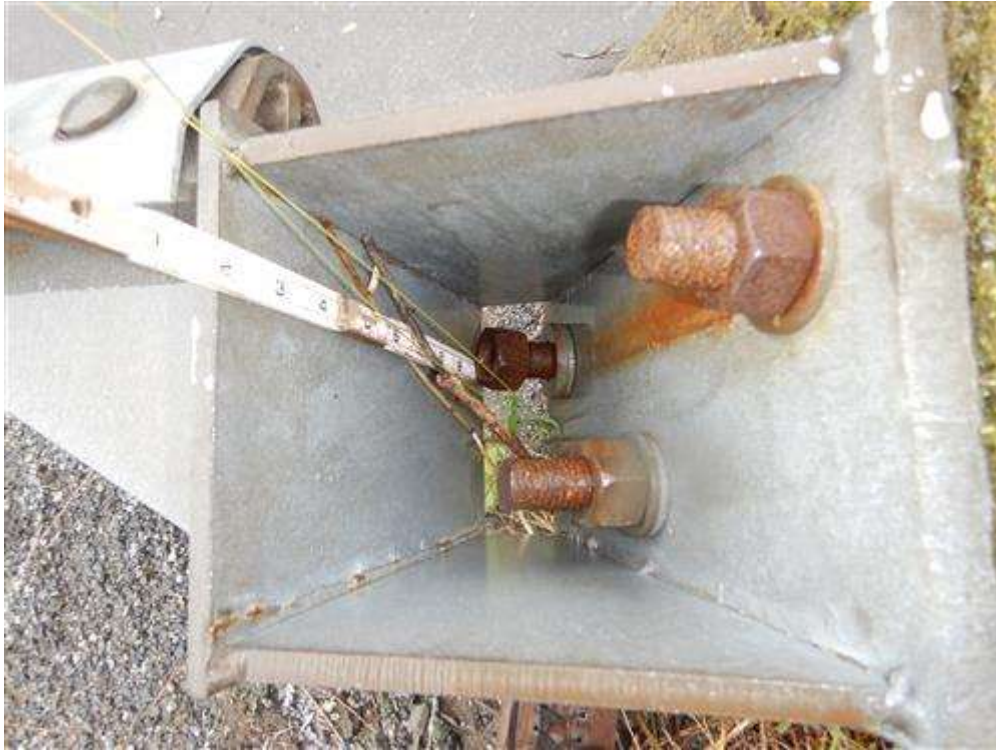
Photo Number: 29

Northwest Guide Rail

Note: 1 anchor bolt nut backed off 3/4" at parapet connection.

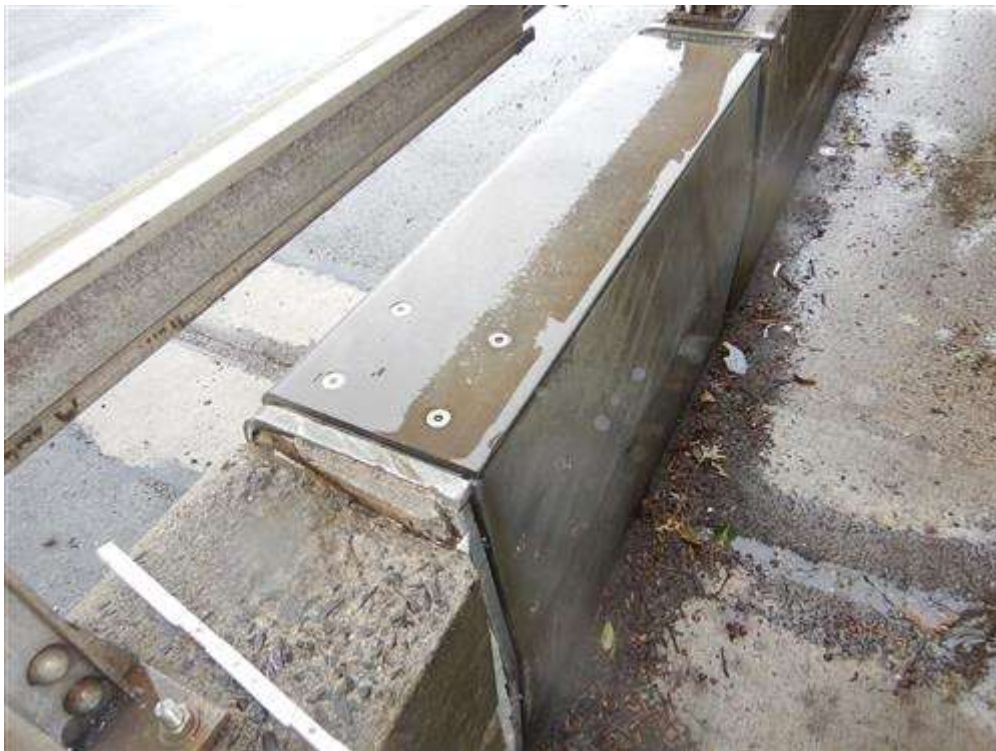
Photo Number: 30

Note: Spall 10" long x 10" wide x 1-1/2" deep on top face.

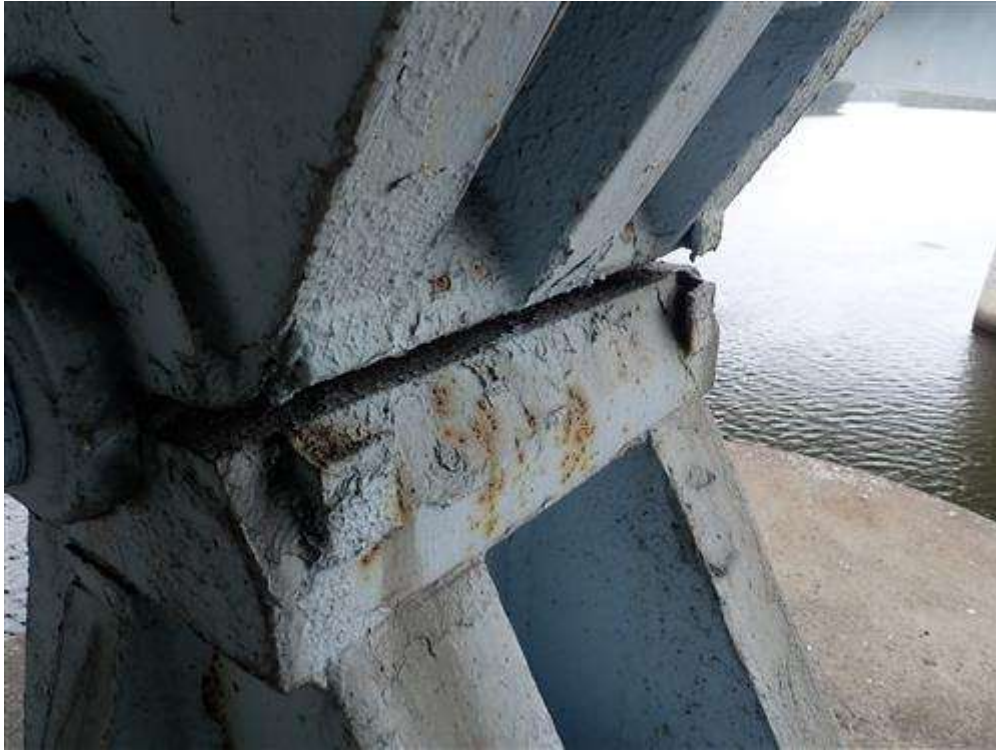
Photo Number: 35

Brackets Torch Cut Off Bearings

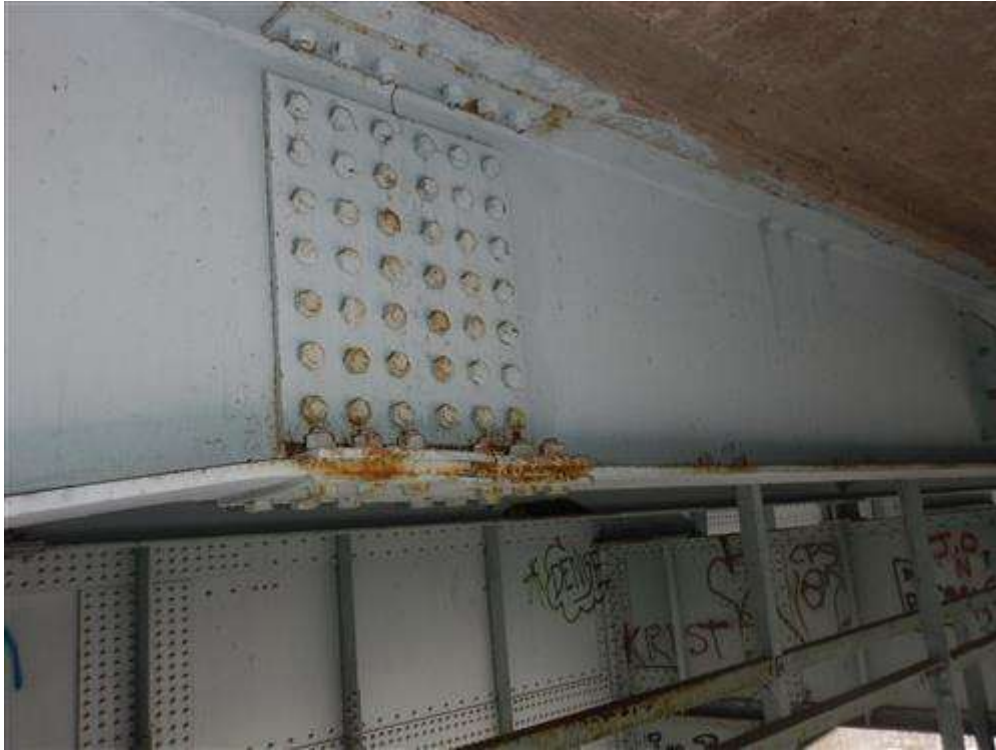
Photo Number: 39

Stringer 5 Field Splice Between Floor Beam 7 and Floor Beam 8

Note: Bent up to 1/4".

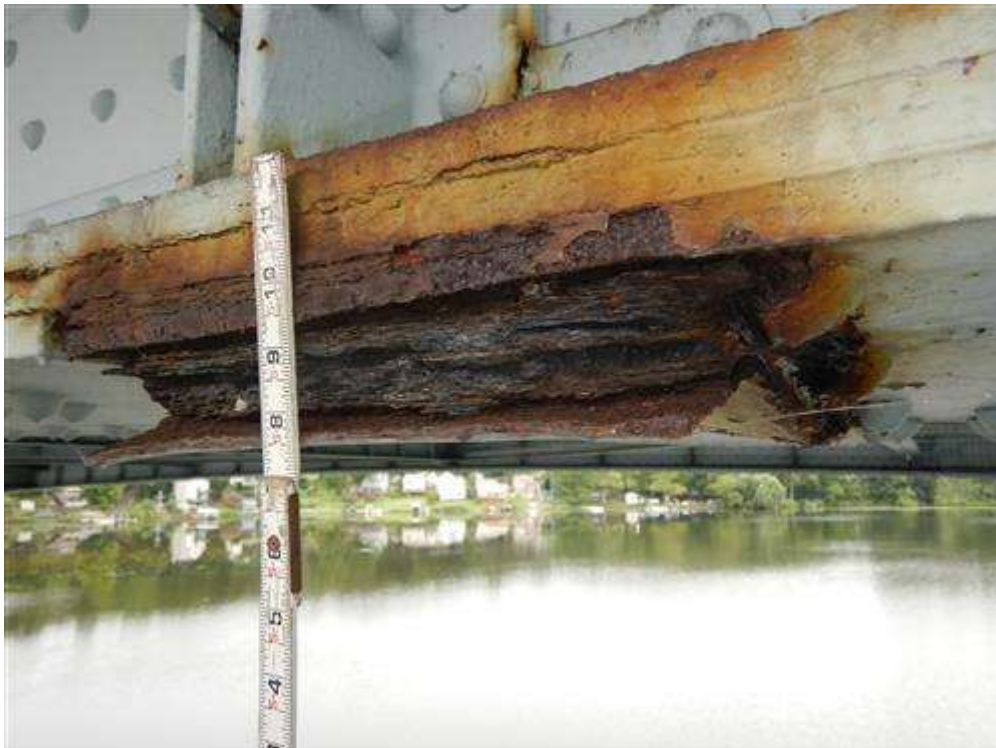
Photo Number: 44

Note: Pack rust between cover plates 2" thick.

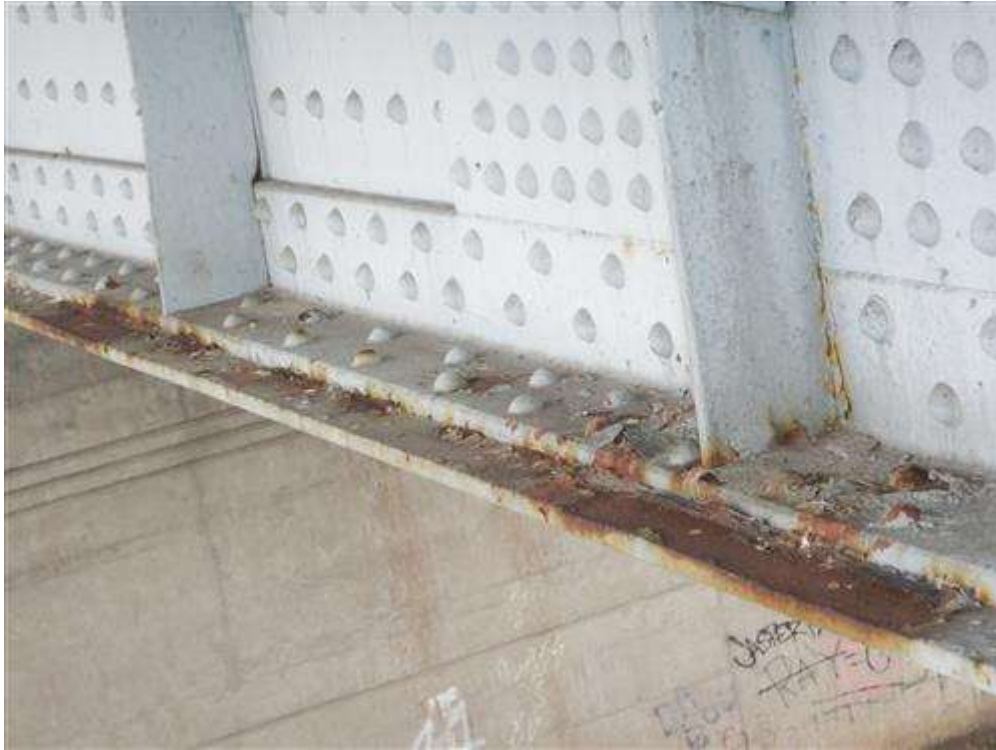
Photo Number: 45

Girder 1 West Face at Floor Beam 13

Note: Bottom flange cover plate section loss.

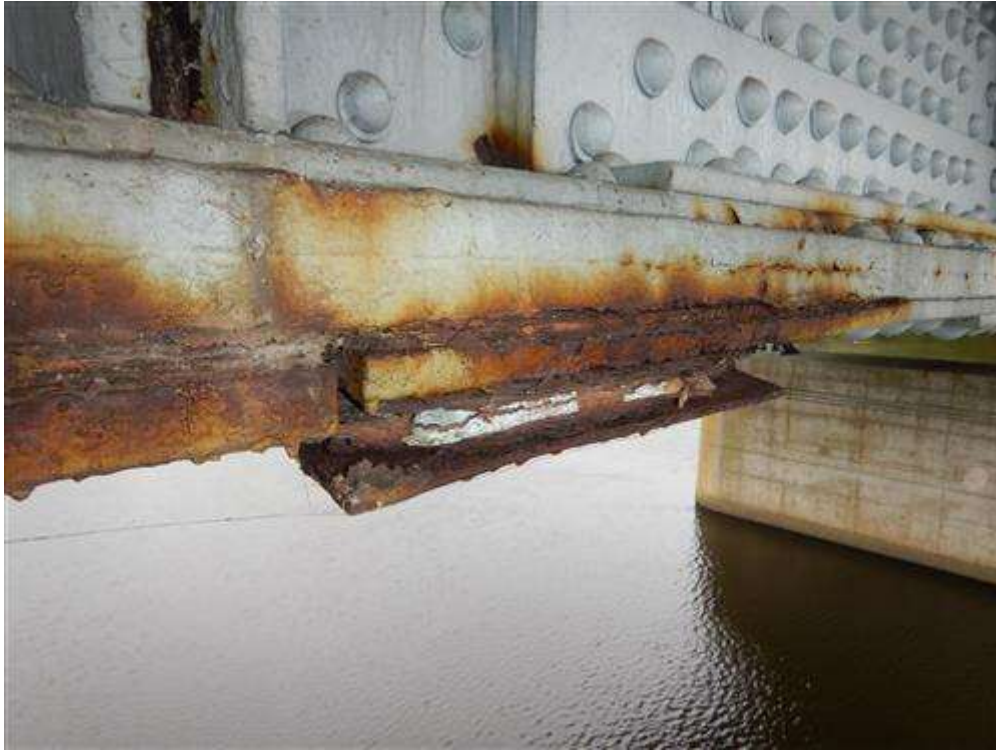
Photo Number: 47

Girder 1 Splice Plate Near Floor Beam 18

Note: 1-1/8" pack rust between cover plates at edges with up to 3/16" deep pitting loss at bottom of cover plate.

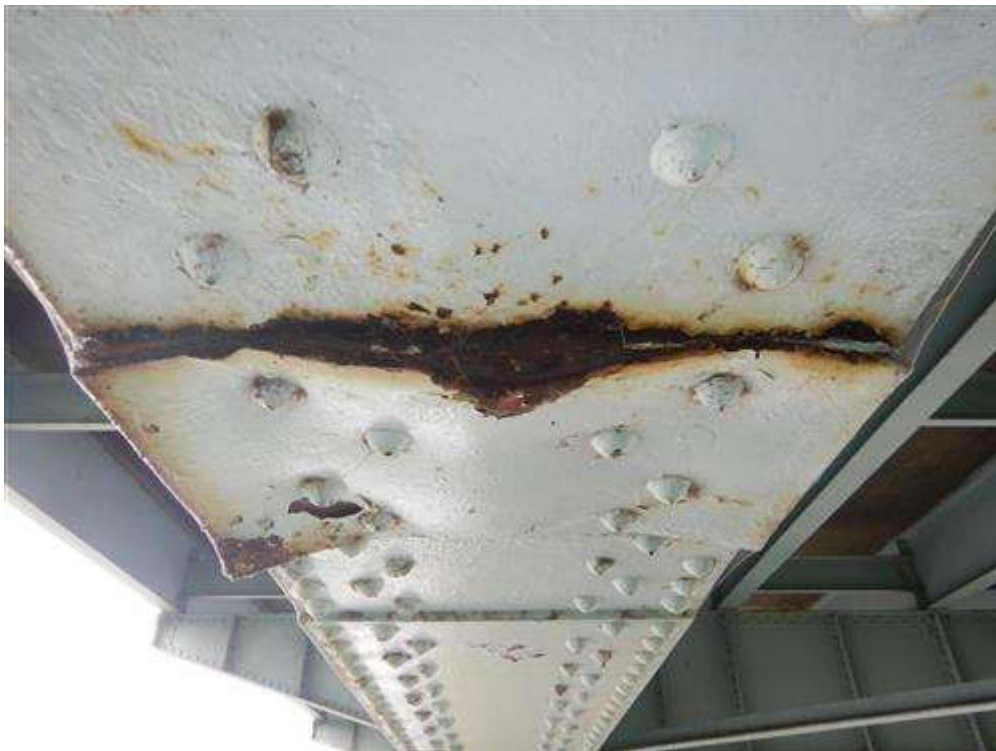
Photo Number: 48

Note: Underside has a 3" long x 2" wide rusted through hole due to pack rust.

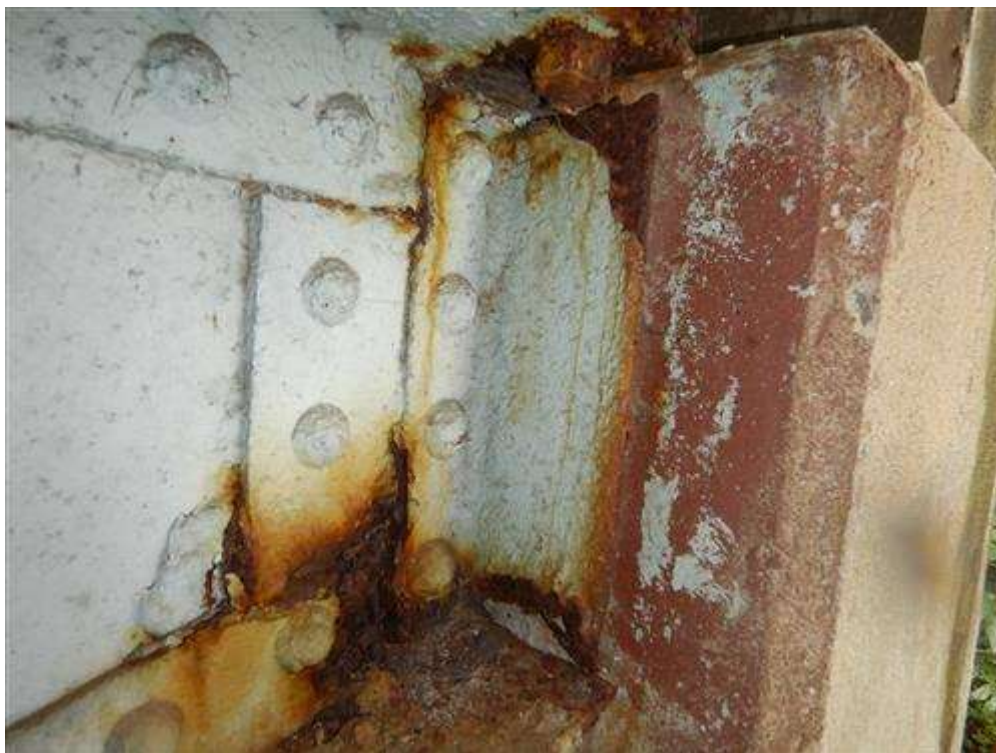
Photo Number: 54

Note: Stiff with rust holes full width x 1" high at top and bottom.

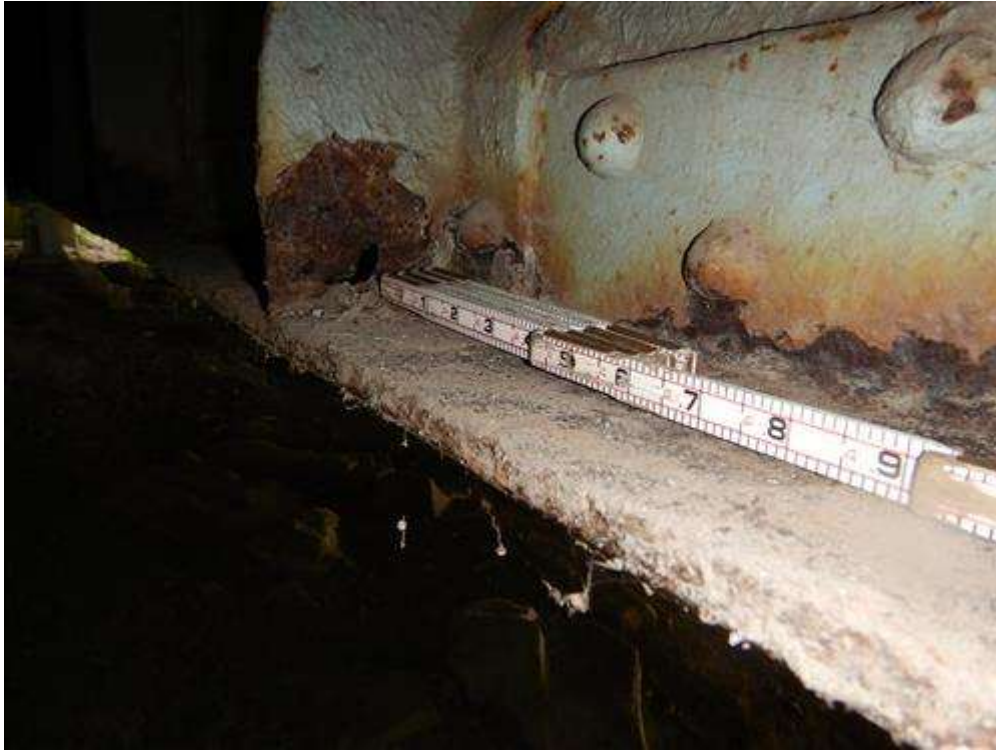
Photo Number: 55

Floor Beam 1, South Face, Between Girder 2 and Stringer 6.

Note: Top flange and stiffener bent.

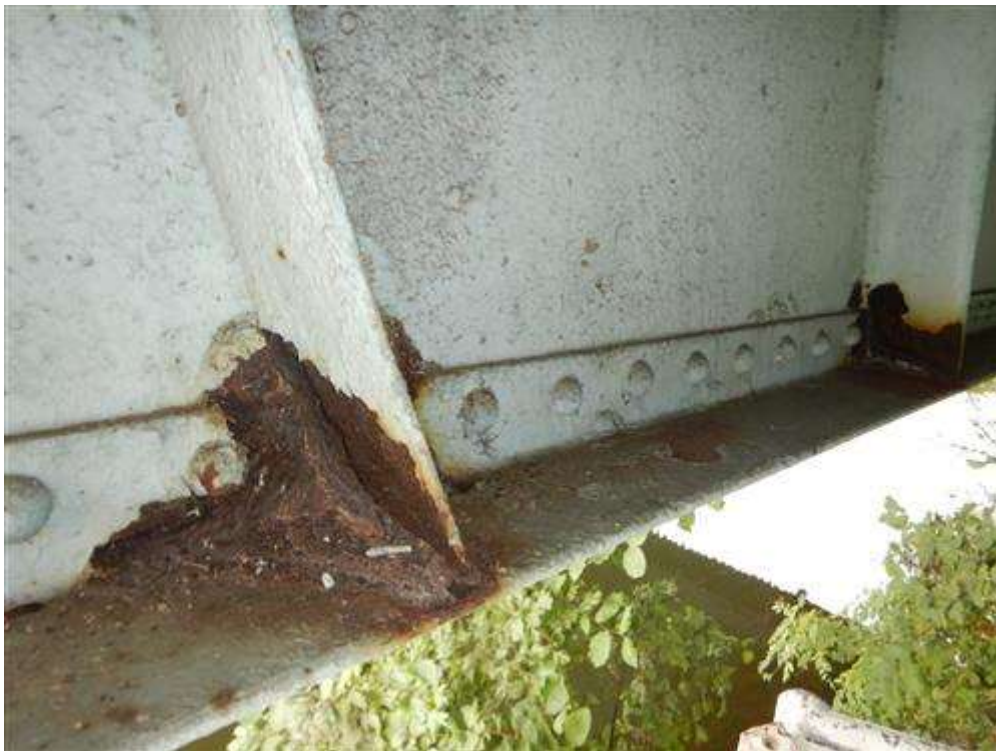
Photo Number: 56

Note: Heavy laminar rust with pitting adjacent to stiffeners.

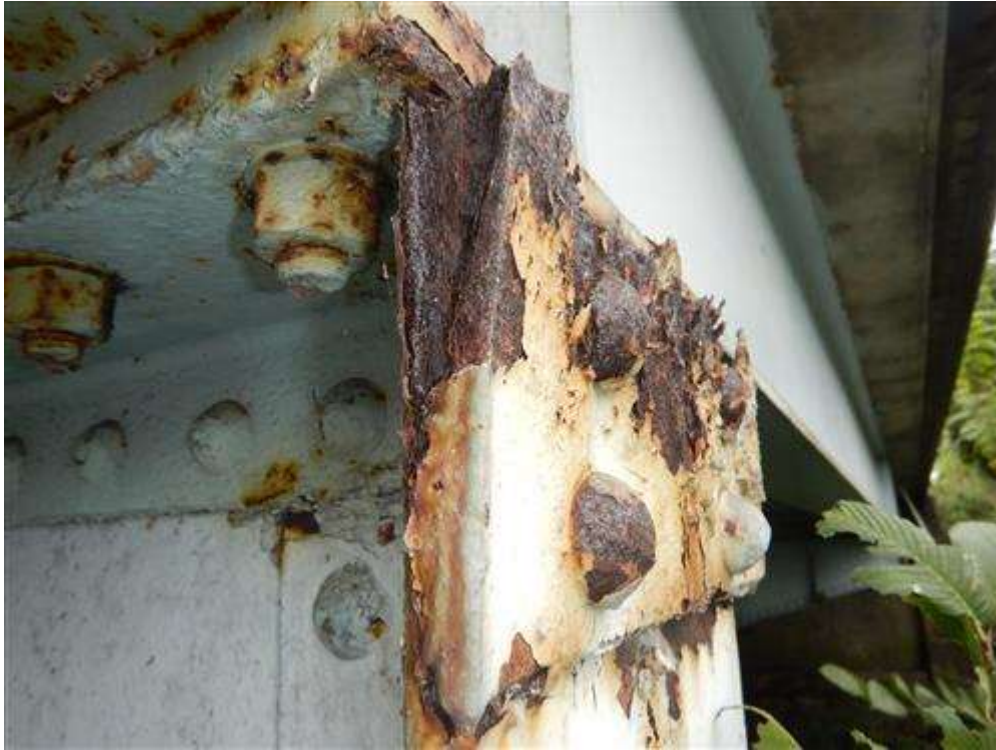
Photo Number: 57

Floor Beam 3, South Riveted End Plate

Note: Pack rust.

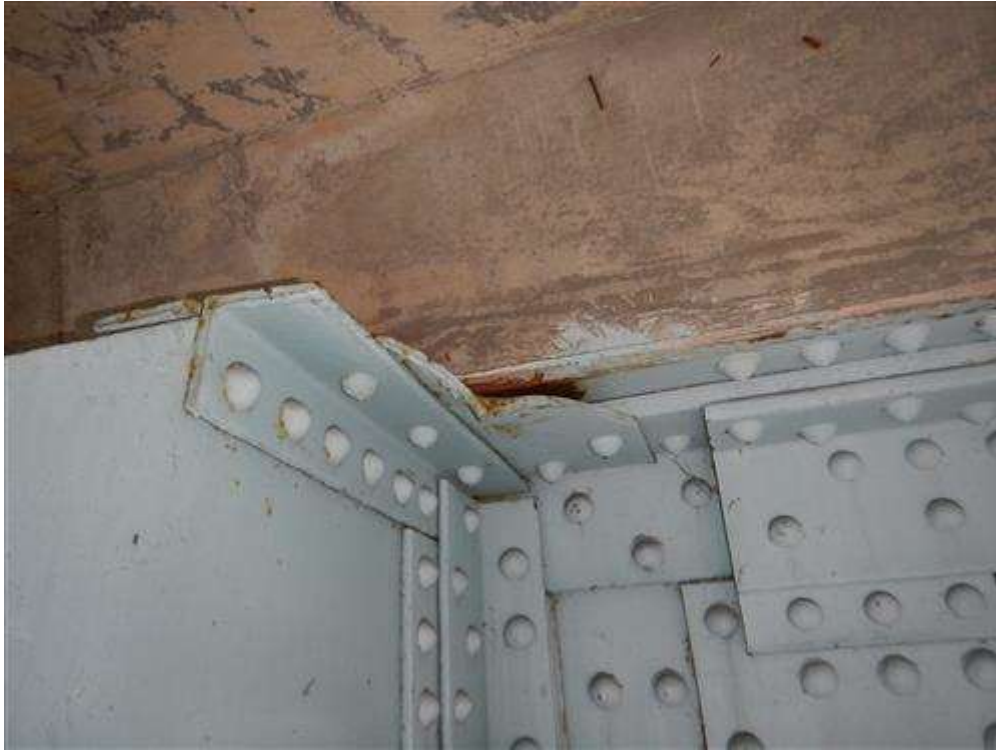
Photo Number: 59

Floor Beam 6 Connection to Girder 2

Note: Knee brace bent and has a 1" long tear.

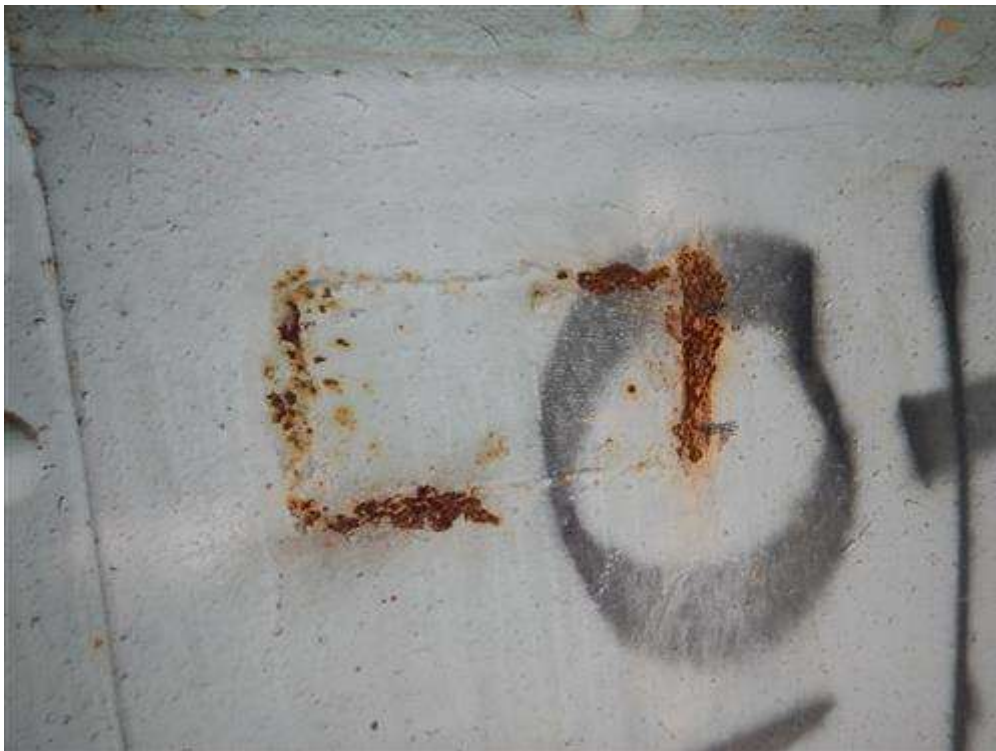
Photo Number: 60

Note: No crack found in web coupon.

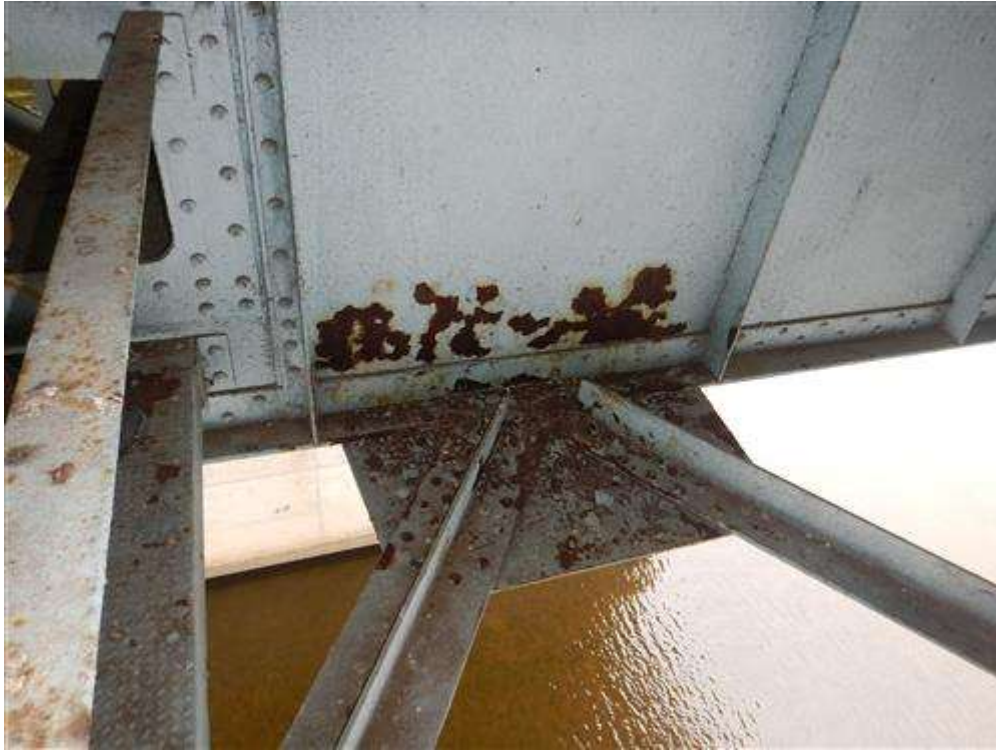
Photo Number: 61

Floor Beam 22 South Face Between Stringer 4 and Stringer 5

Note: Up to 1/8" deep section loss.

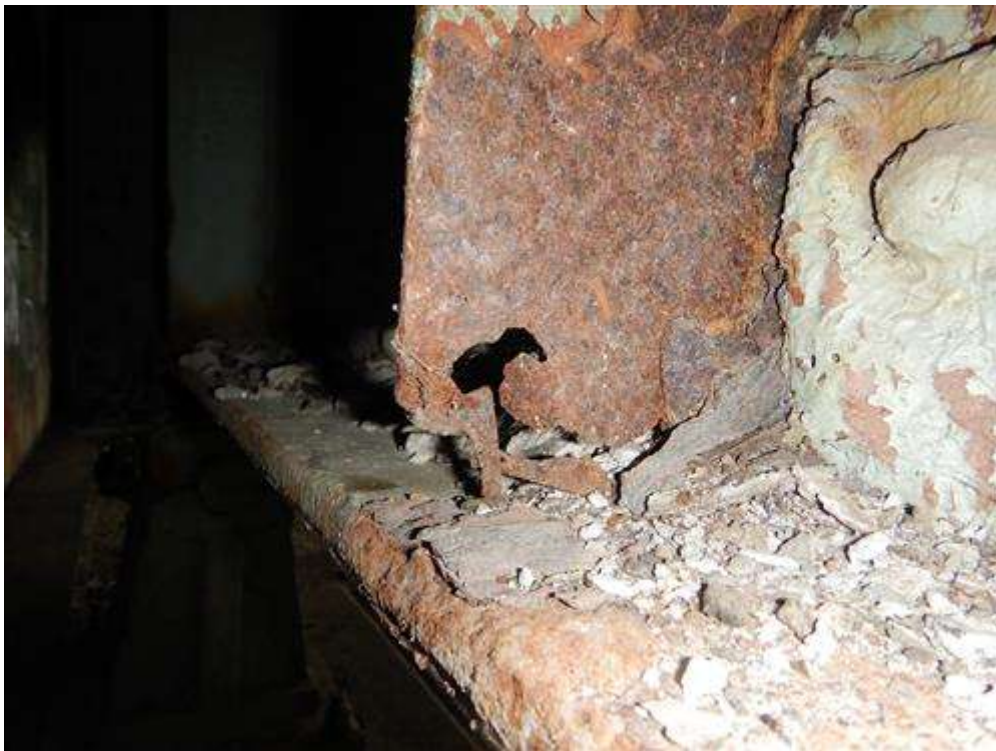
Photo Number: 62

Note: Stiffener rust hole.

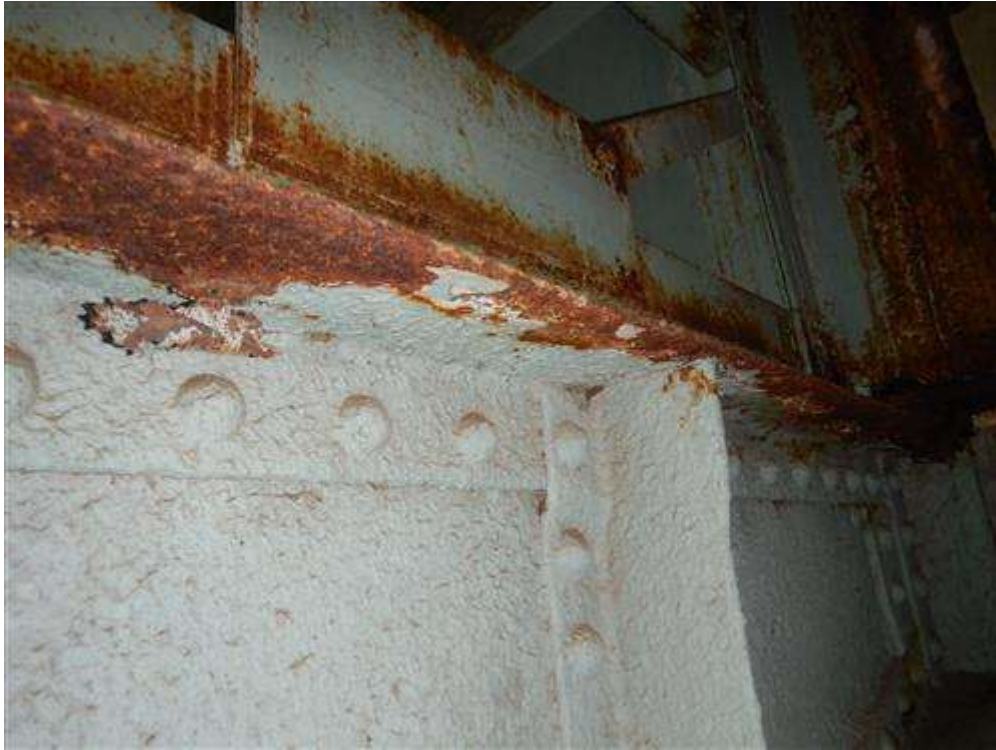
Photo Number: 63

Floor Beam 29, North Face Between Stringer 1 and Stringer 2

Note: Top flange section loss.

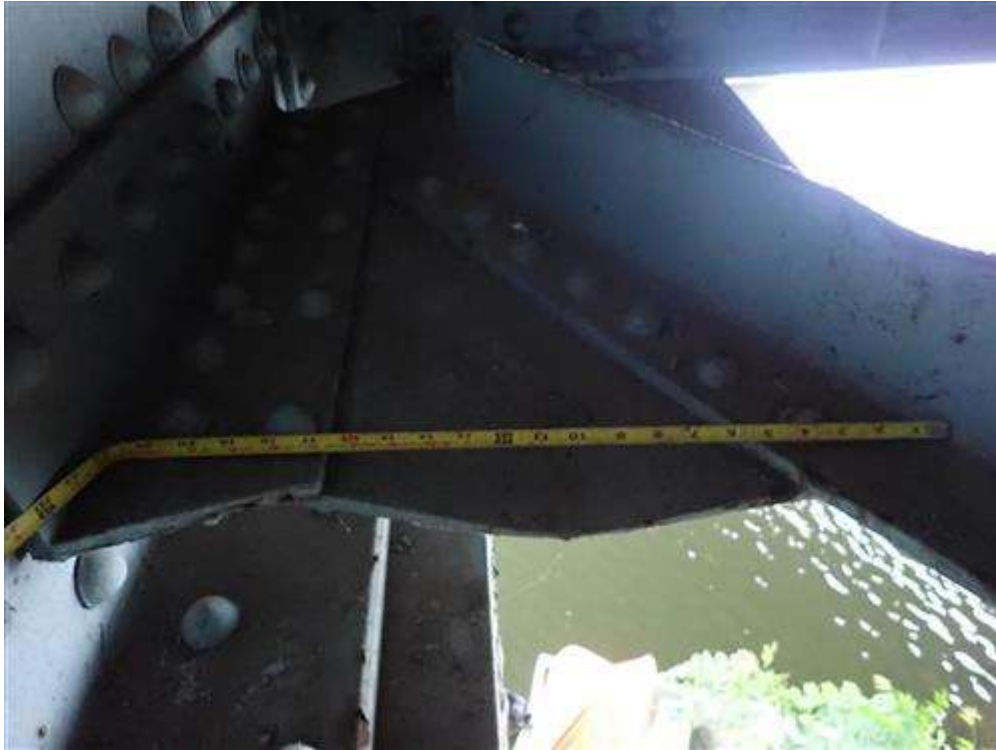
Photo Number: 65

Lateral Bracing at Floor Beam 3 at Girder 1

Note: Bowed 1' long x 2-1/2" high.

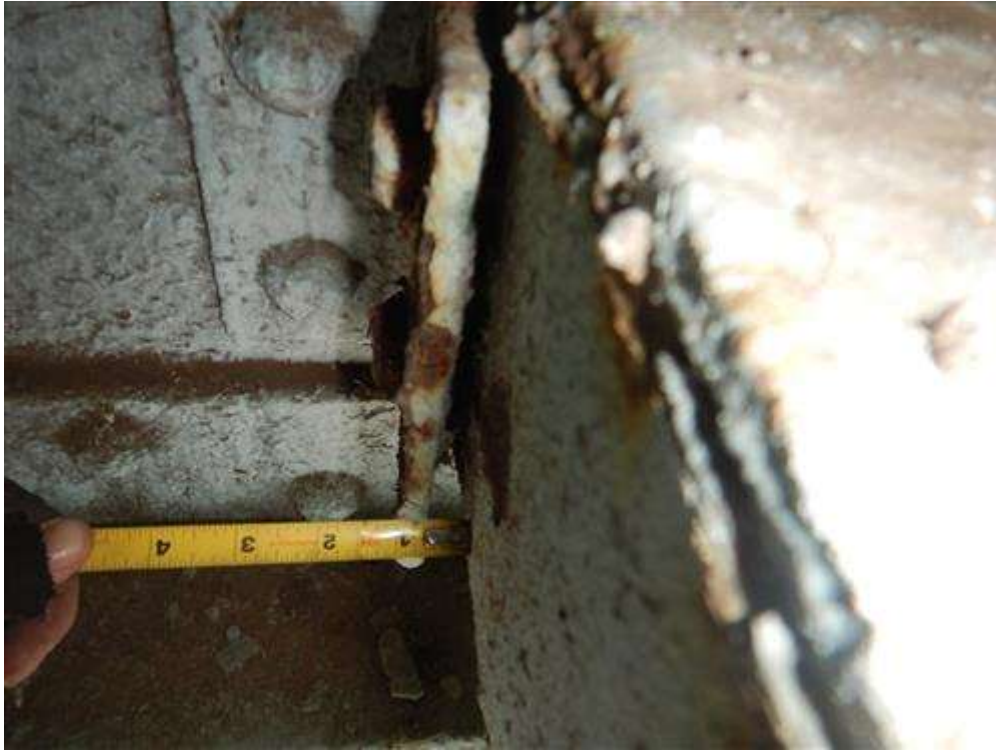
Photo Number: 67

Catwalk Connection to Floor Beam 16 North Side

Note: 5/8" gap.

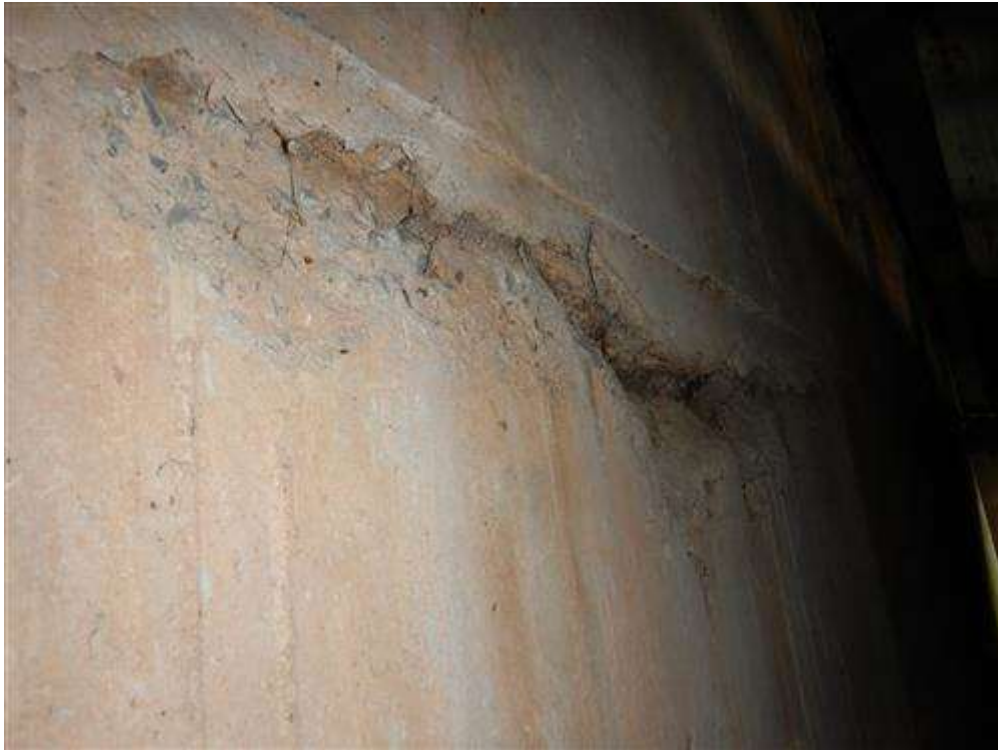
Photo Number: 70

Note: Spalls along cold joint up to 2" deep.

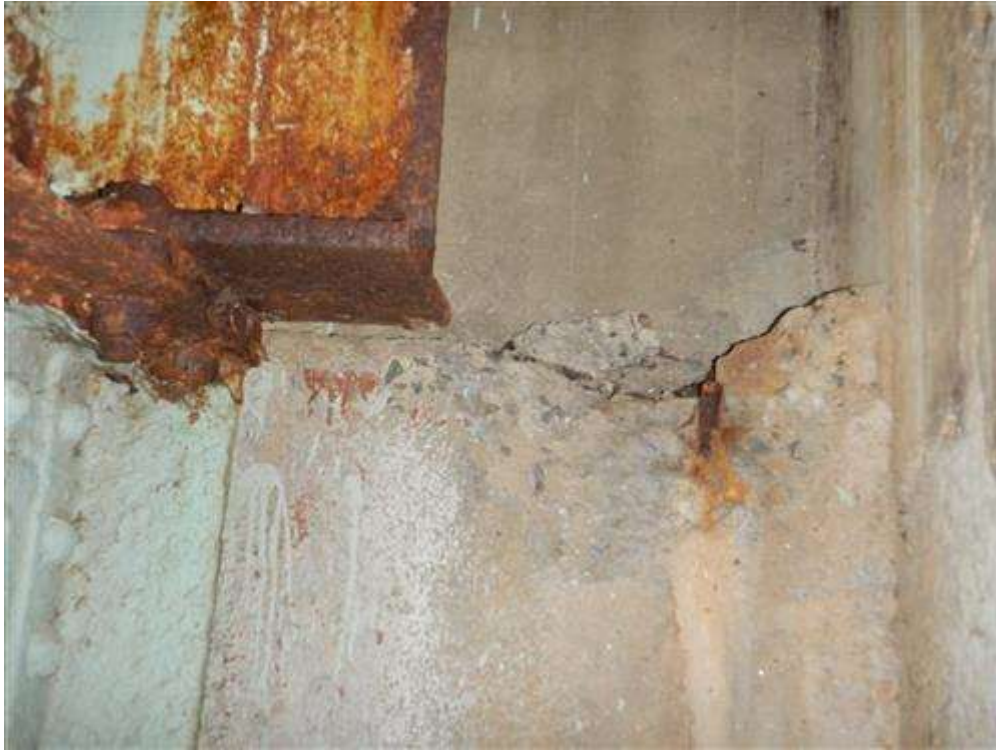
Photo Number: 71

Abutment 2, West Cheekwall

Note: Spall.

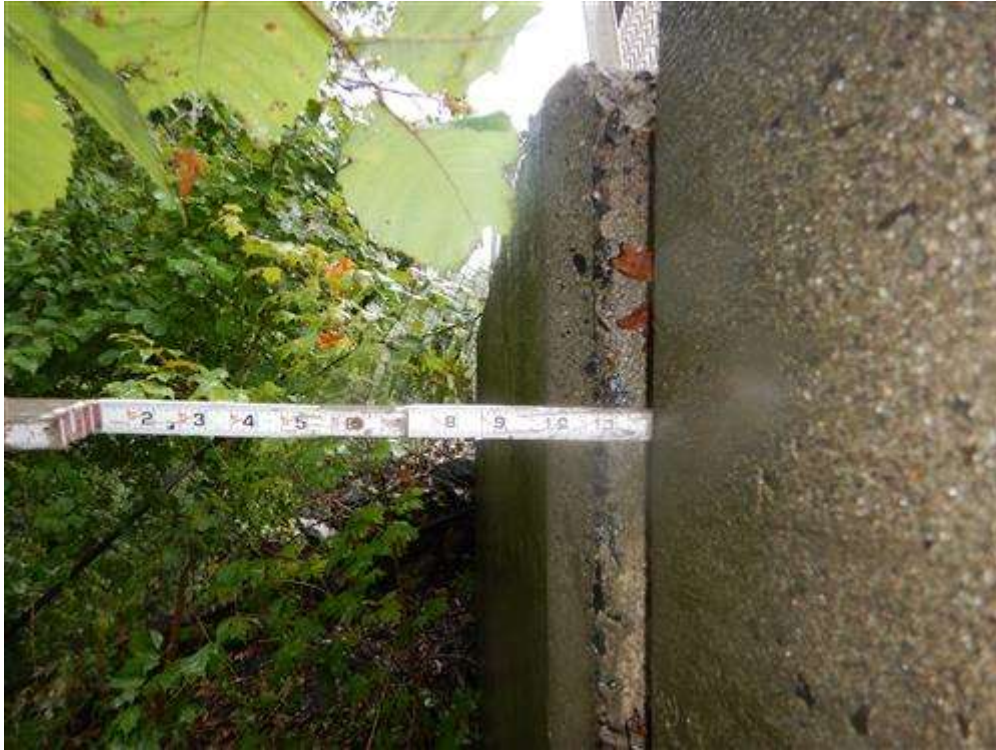
Photo Number: 73

Wingwall 2A

Note: Lateral misalignment.

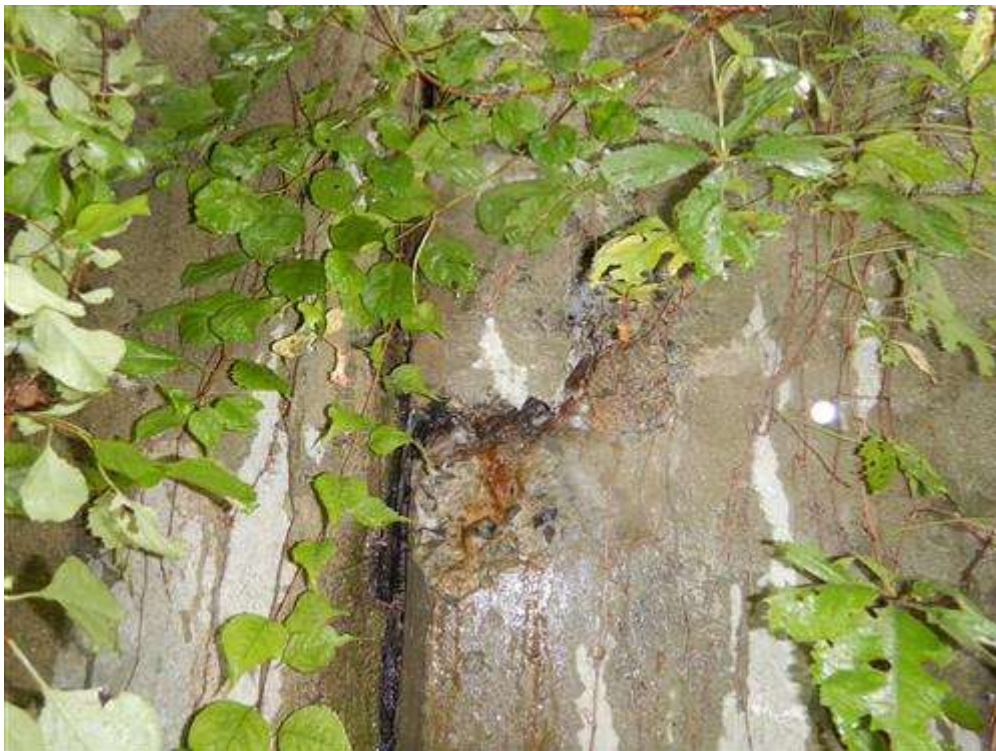
Photo Number: 74

Note: Spall/hollow area.
