## BRIDGE NO.04180

52980 - NEWTOWN  
INTERSTATE 84 WESTBOUND  
over  
HOUSATONIC RIVER

Fracture Critical and Routine Inspection

9/12/2018

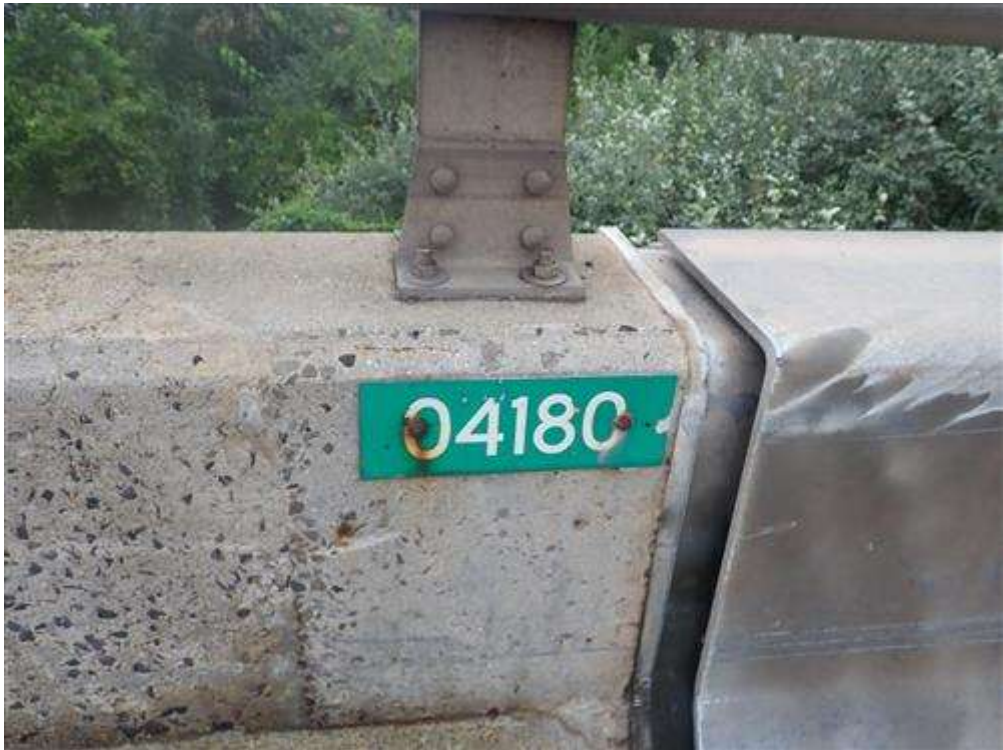
Photo Number: 1

Bridge Identification Number

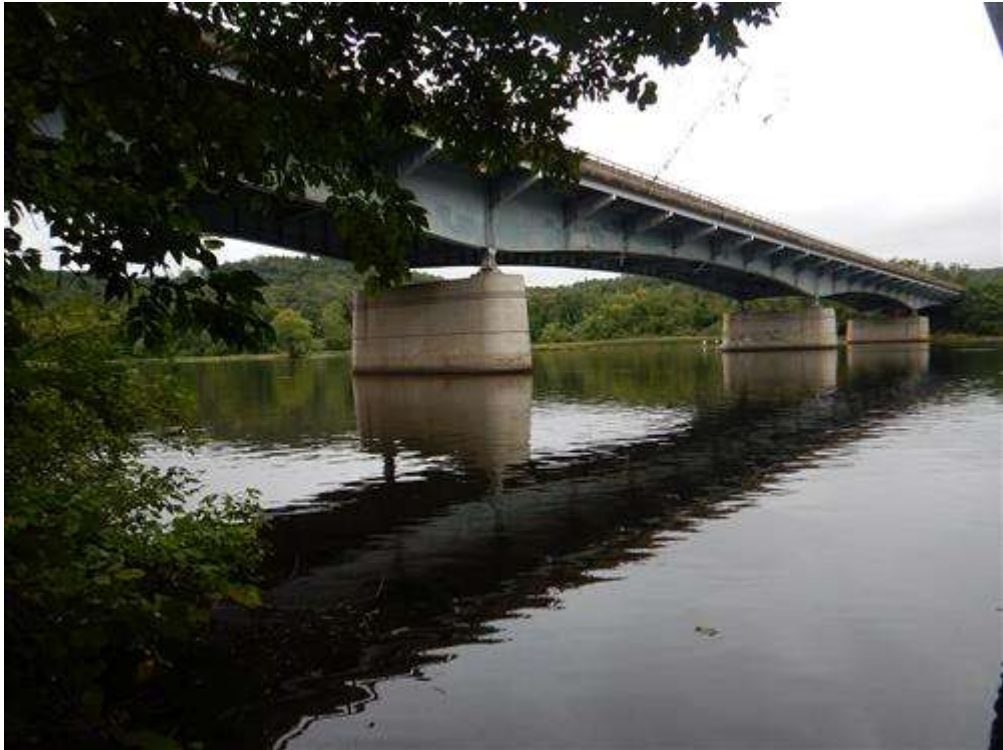
Photo Number: 2

Right Elevation

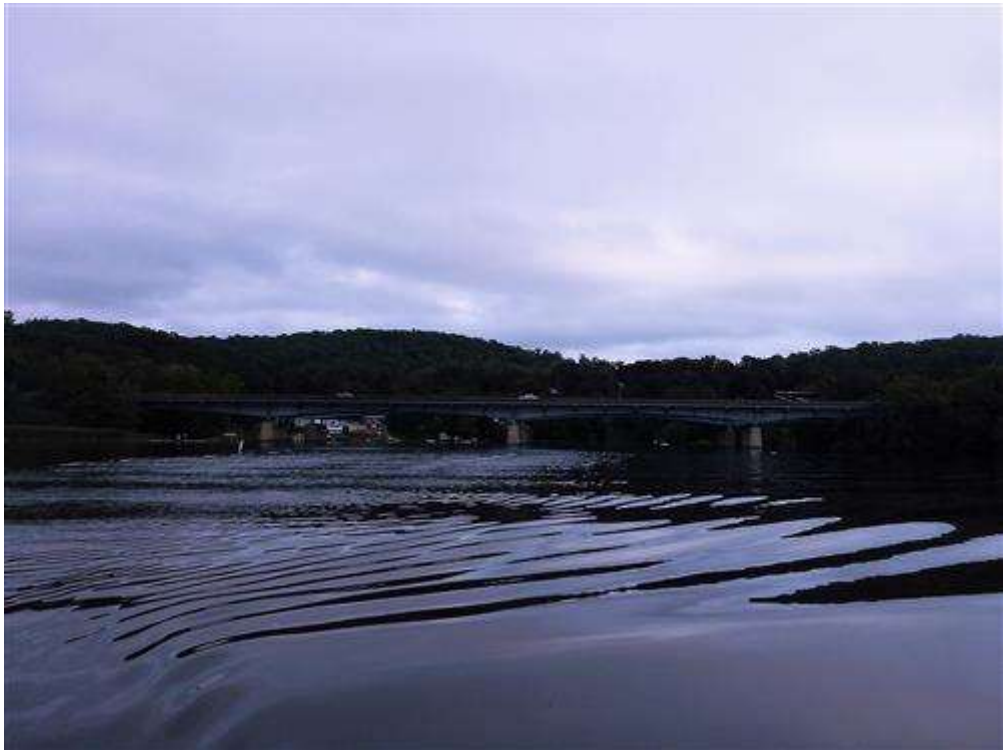
Photo Number: 3

Left Elevation

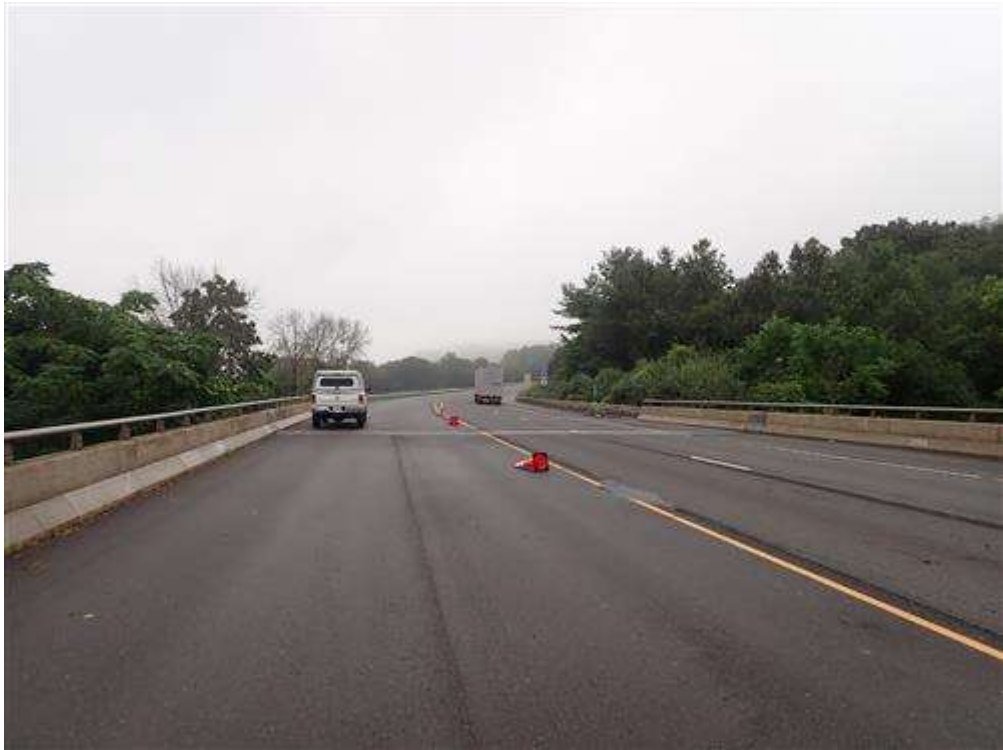
Photo Number: 4

South Approach From Bridge

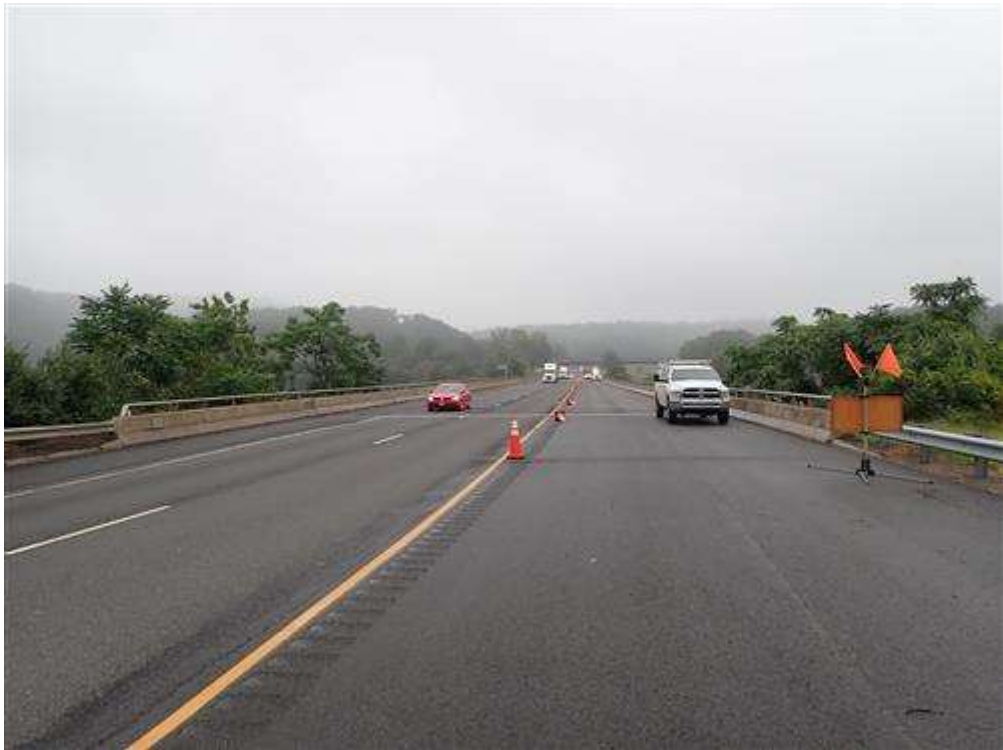
Photo Number: 5

Bridge From South Approach

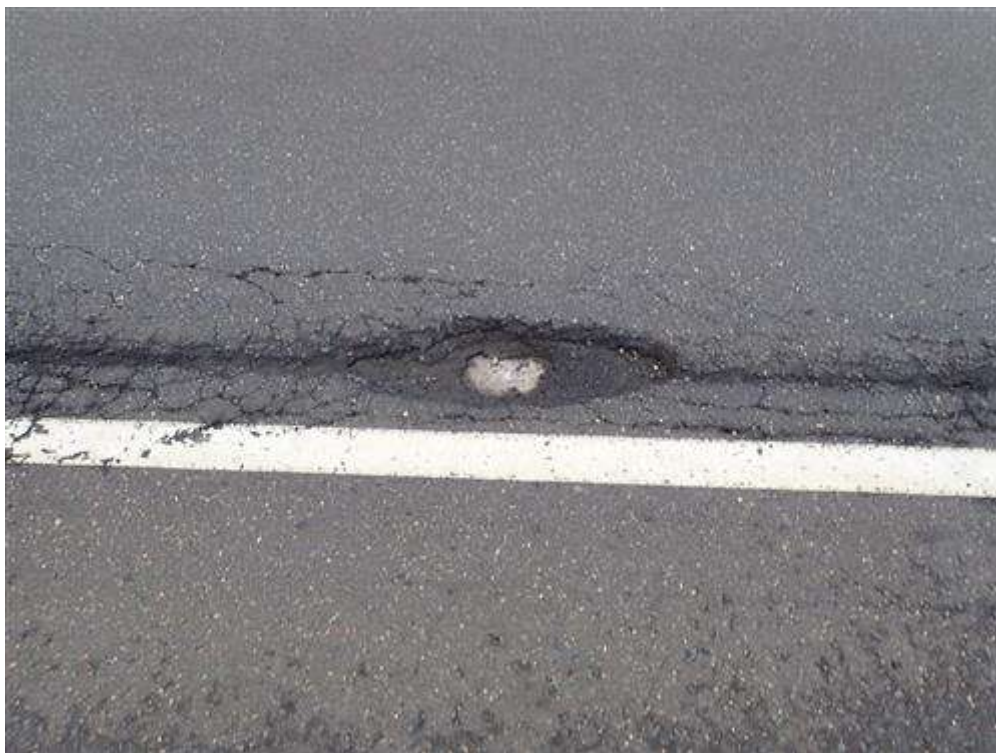
Photo Number: 8

Bituminous Concrete Overlay in Span 2

Note: Failing patch with 2" deep pothole.

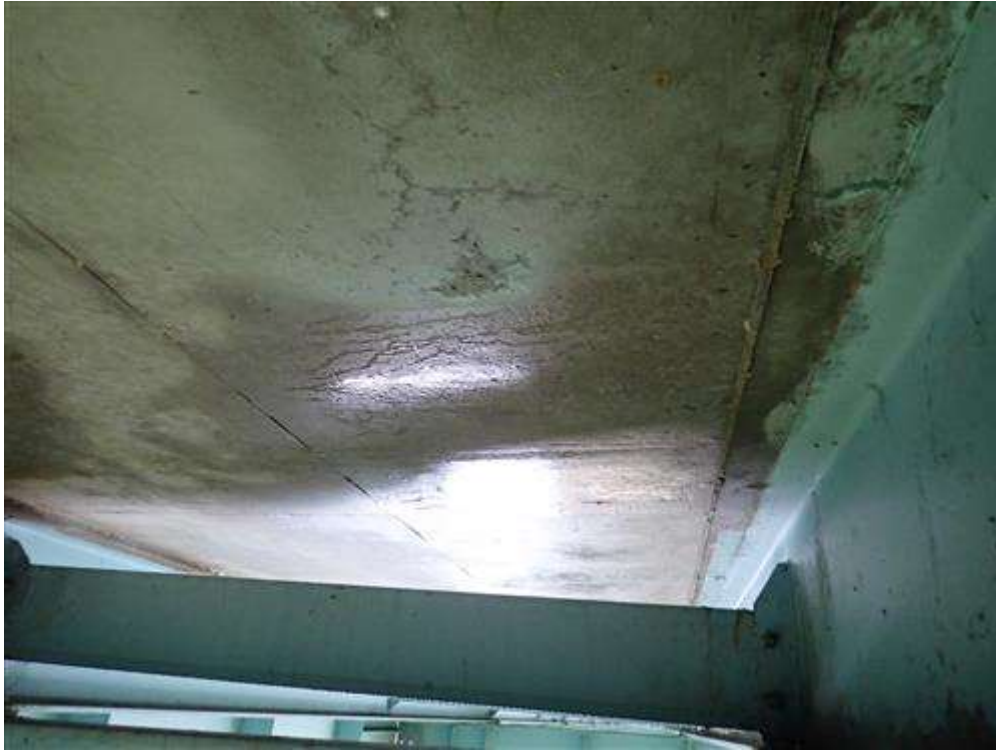
Photo Number: 11

Span 1 Underside of Deck

Note: Moisture.

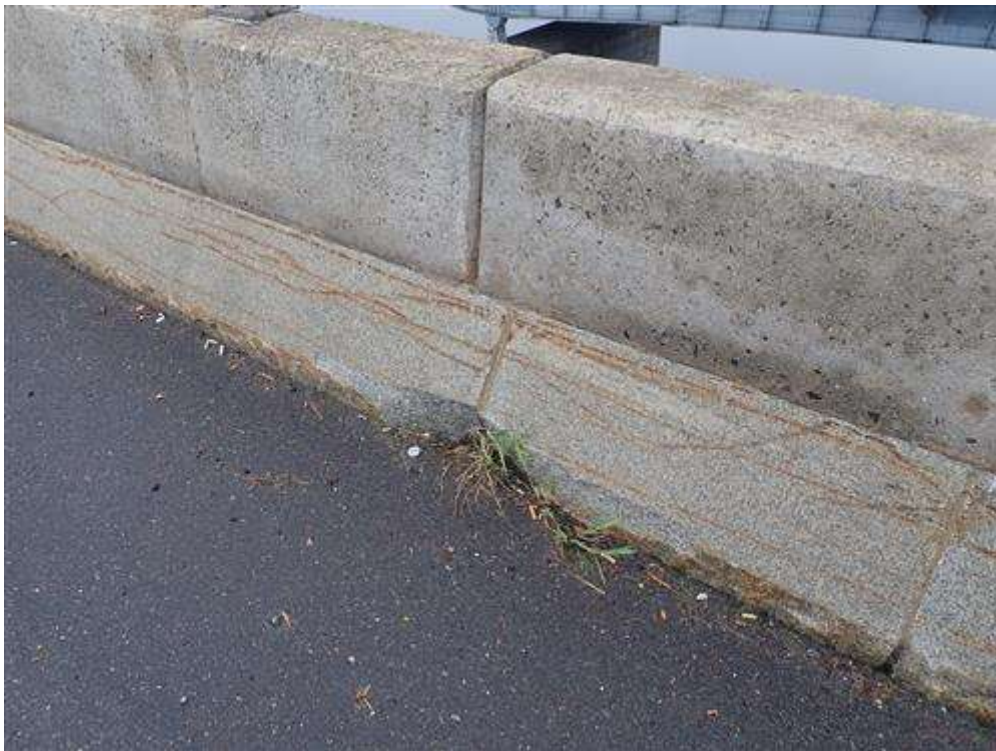
Photo Number: 12

<ul style="list-style-type: none"><li>• The approach curb at the southwest corner is laterally misaligned up to 6" over a 12' long section.</li></ul> <p>(See Sketches 2 - 6 and Photos 12 &amp; 13)</p>
Median:	N	
Sidewalks:	N	
Parapet:	6	<p>Reinforced concrete parapets have the following deficiencies:</p> <ul style="list-style-type: none"><li>• Random areas of scale up to 13' long x 1' wide x 1" deep.</li><li>• Spalls up to 18" long x 10" wide x 2" deep with and without exposed rebar. Some spalls undermine the railing post bases and have exposed anchor bolts.</li><li>• Random horizontal and full height vertical cracks open up to 1/8" wide.</li><li>• Random hollow areas up to 28" long x up to 1' wide.</li></ul> <p>(See Sketches 2 - 6 and Photos 13 - 15)</p>
Railing:	6	<p>Single aluminum railings on both parapets have the following deficiencies:</p> <ul style="list-style-type: none"><li>• Random collision scrapes.</li><li>• Random loose anchor bolt nuts.</li><li>• Right Railing in the South Approach has two rail posts (4th &amp; 6th) with (1) of (4) missing anchor bolt nut.</li><li>• Right Railing in the South Approach end angle cracked at 135 degree angle weld and at base plate weld.</li><li>• Left Railing in Span 3 has isolated posts with exposed anchor bolts due to parapet spalls or scaling.</li><li>• Left Railing in Span 4 has minor gouges from impact damage and (2) posts with up to (1) of (4) sheared off anchor bolts.</li><li>• Left Railing in Span 4 has a random bent base plate and (1) post has a 2-1/2" long crack in the stanchion due to previous impact damage (no change).</li></ul> <p>(See Sketches 2 - 6 and Photos 13, 16 - 18)</p>

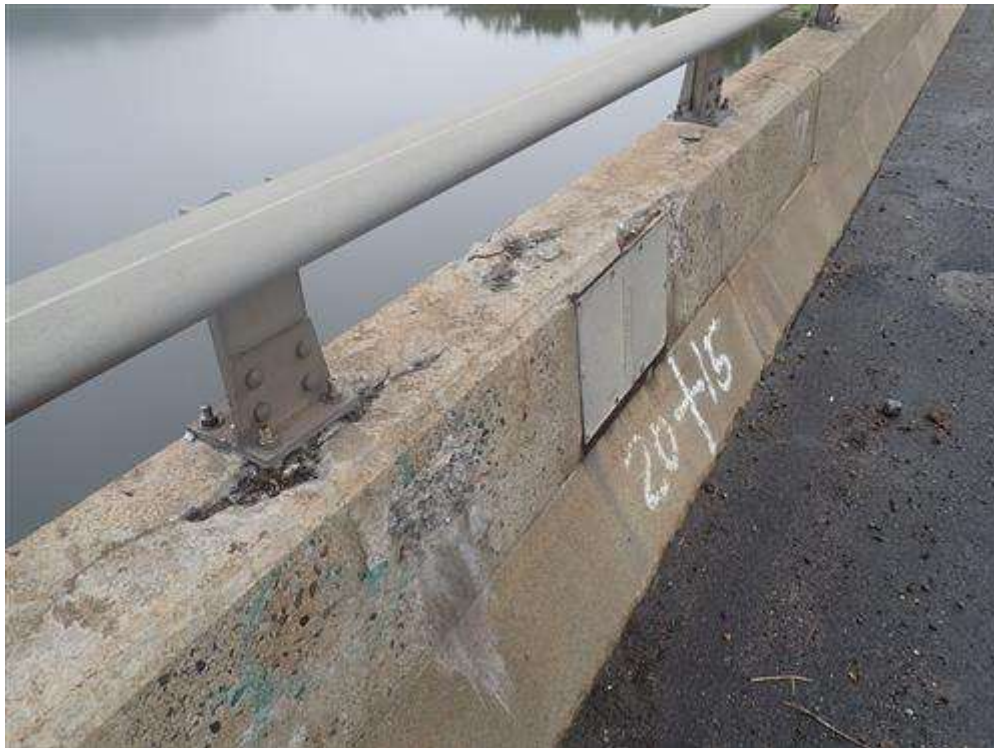
Photo Number: 14

Note: 10' long section with (4) spalls up to 1" deep and scaling.

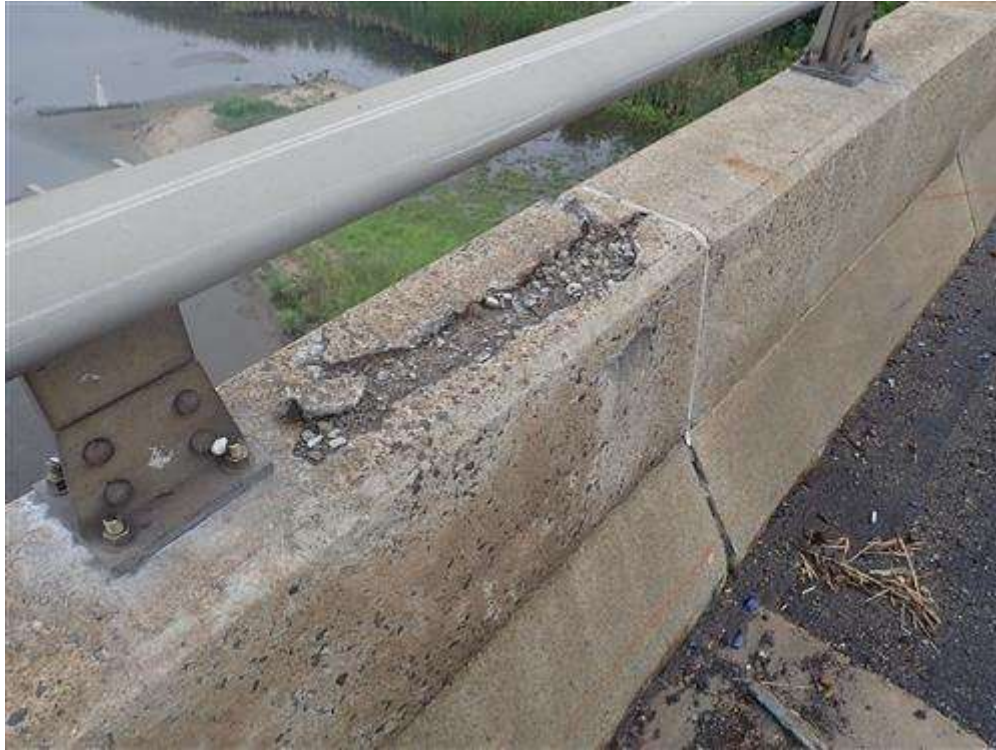
Photo Number: 15

Left Parapet

Note: Heavy scale on top face of parapet.

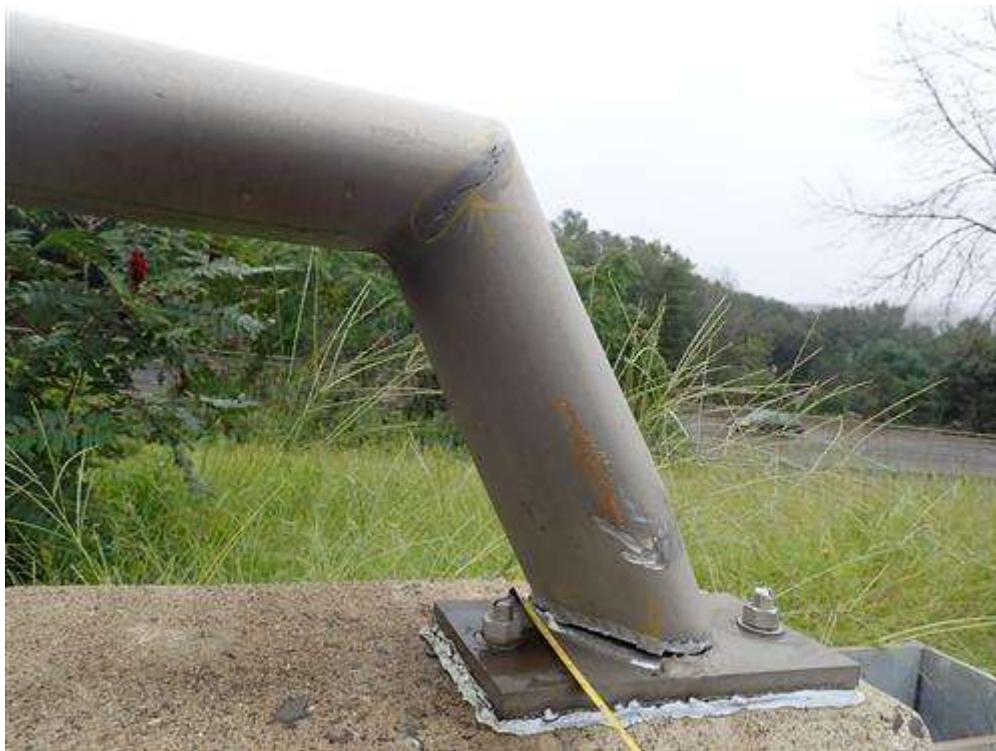
Photo Number: 16

Note: Two (2) cracks at end termination.

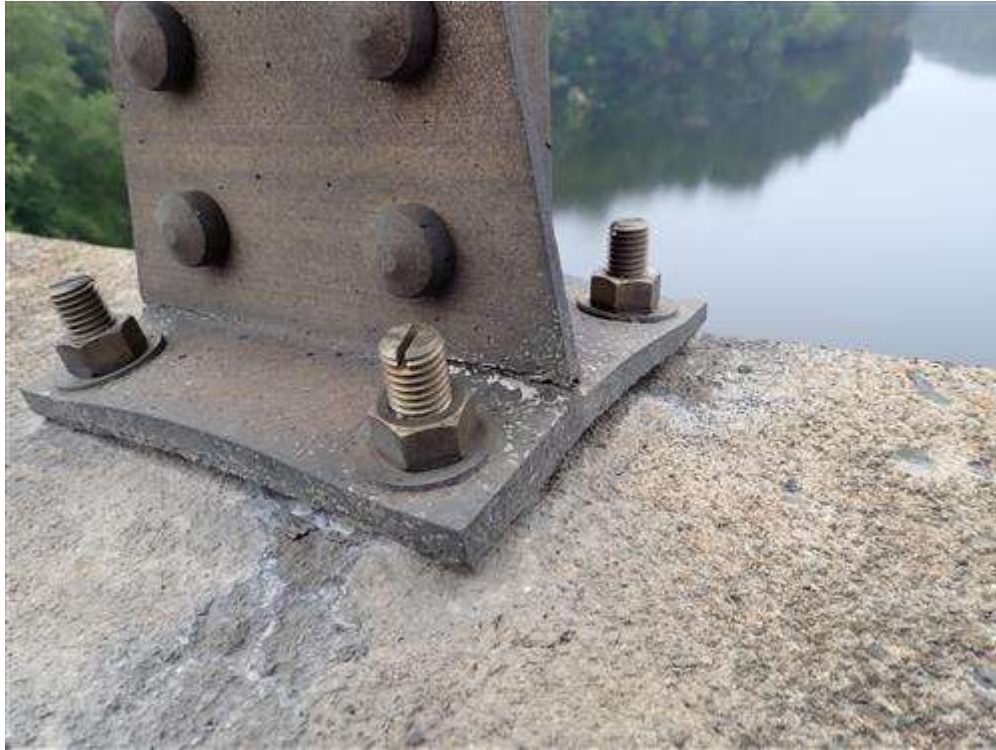
Photo Number: 17

Metal Bridge Rail Post

Note: Typical crack.

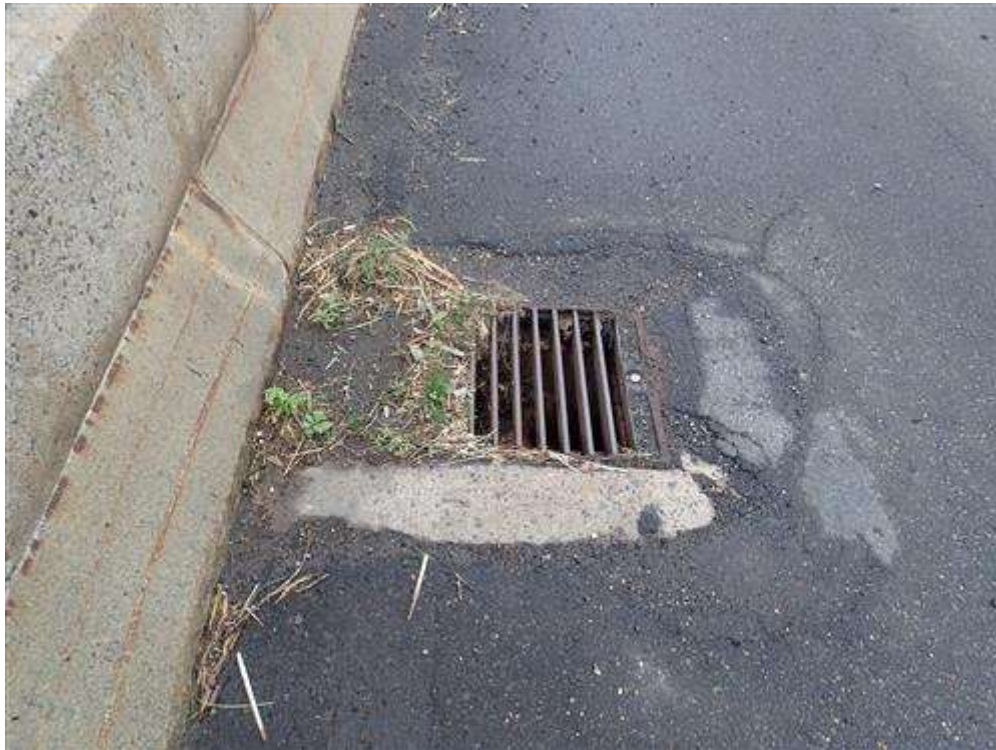
Photo Number: 19

Deck Drain (Typical)

Note: Debris.

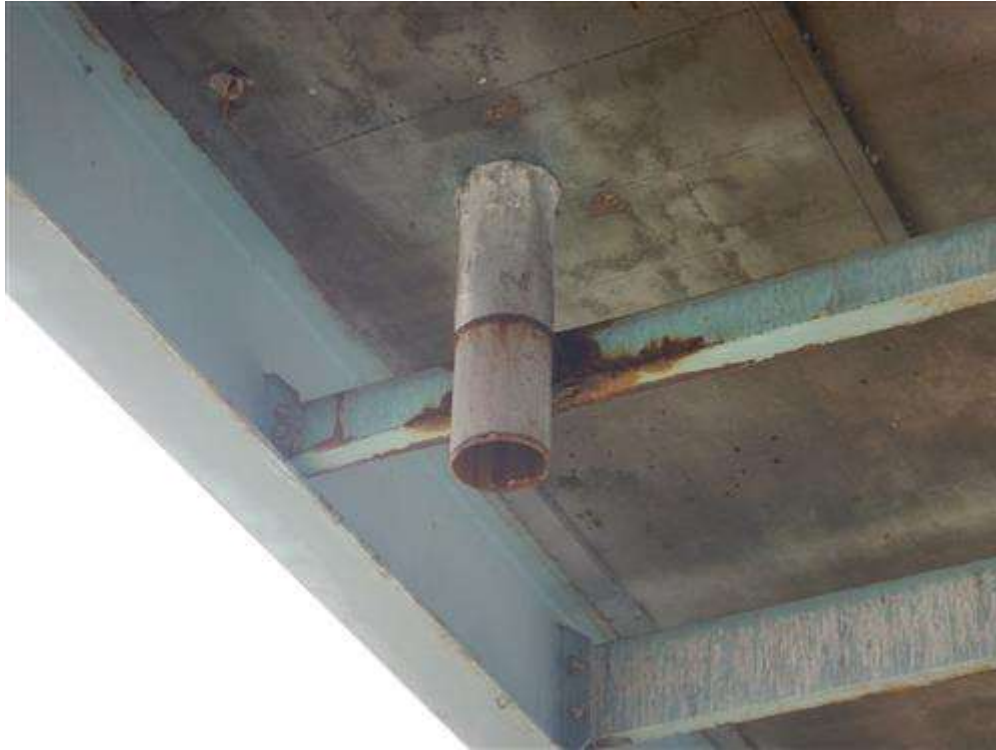
Photo Number: 21

Scupper Pipe (Typical)

Note: Laminar rust on inside of pipe, u-bolt and connection diaphragm.

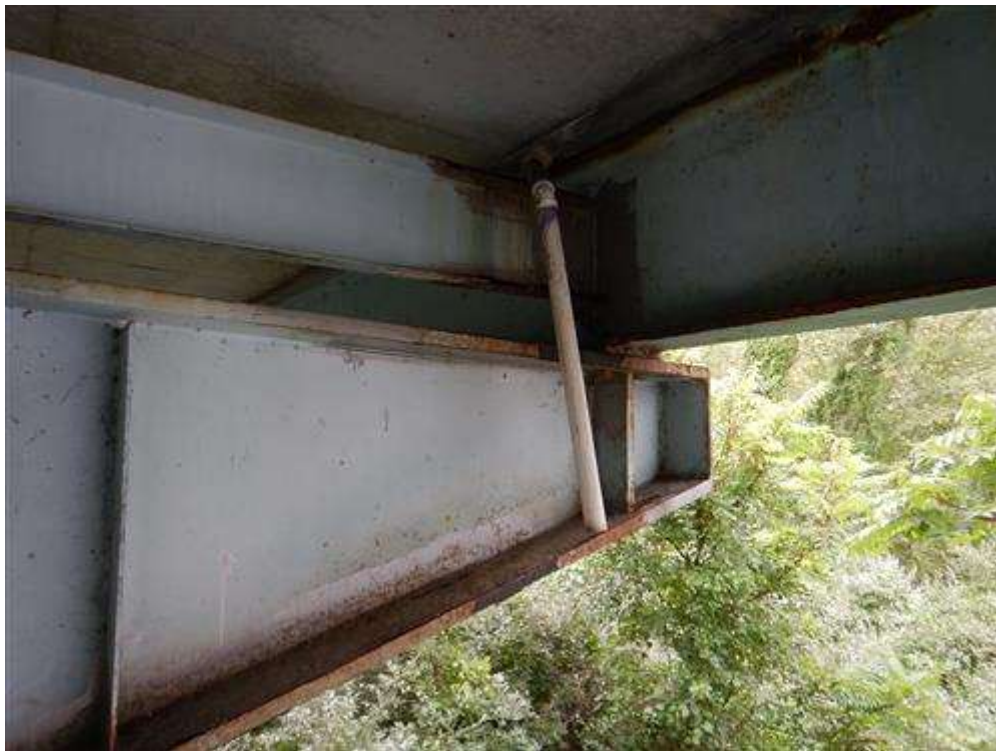
Photo Number: 22

Note: Laminar rust with 1/16" SL on diaphragm below.

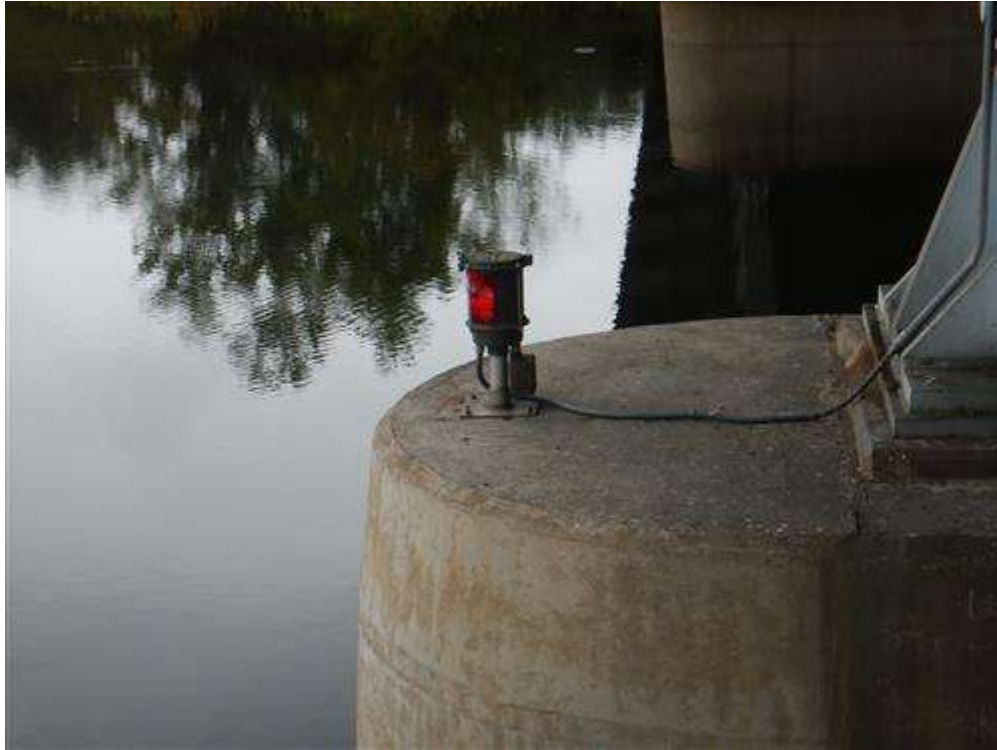
Photo Number: 23

Pier 2 Navigation Light (Typical)

Note: Not on during inspection.

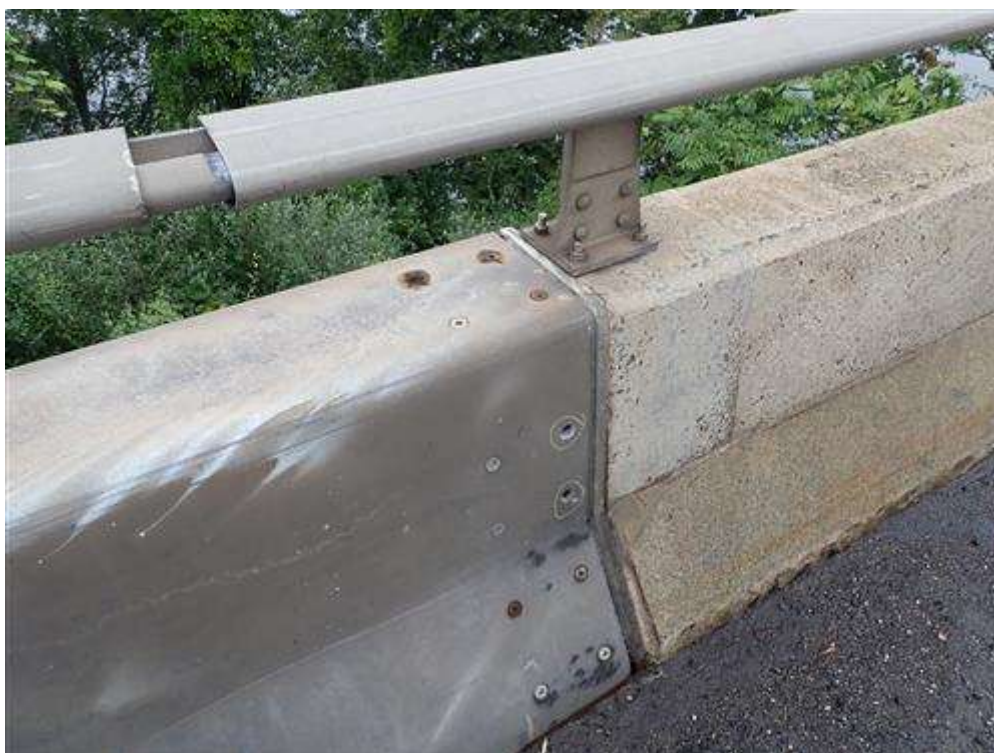
Photo Number: 26

Note: Joint sliding plate missing 3 of 12 screws.

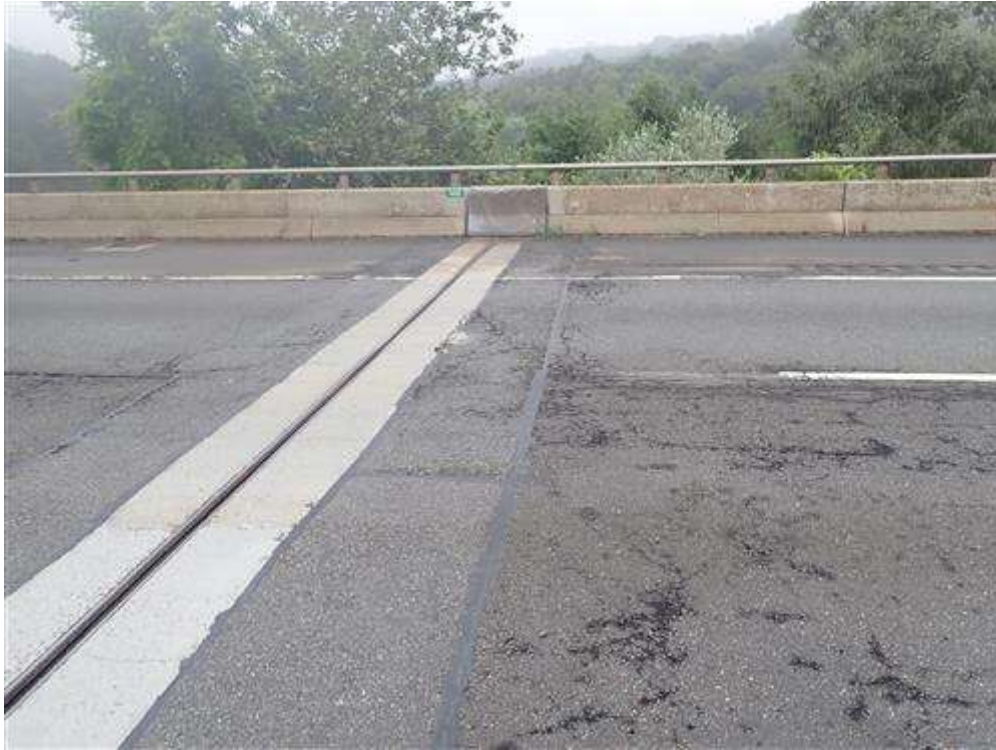
Photo Number: 33

North Approach Pavement

Note: Cracking

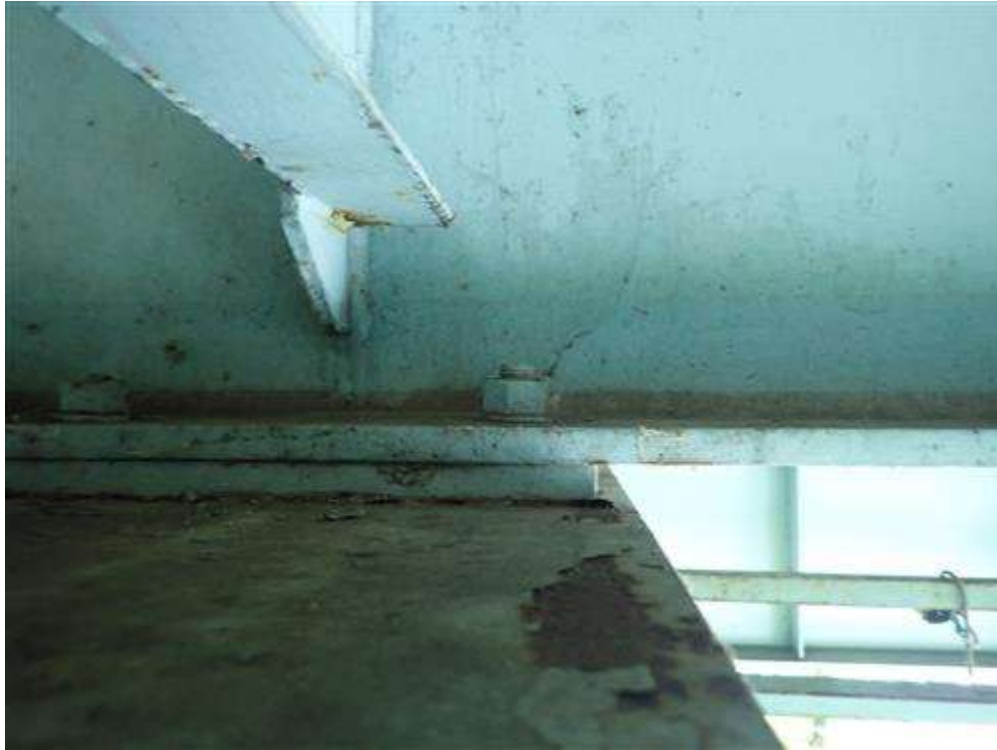
Photo Number: 39

Stringer Bearing

Note: Typical tipped anchor bolt.

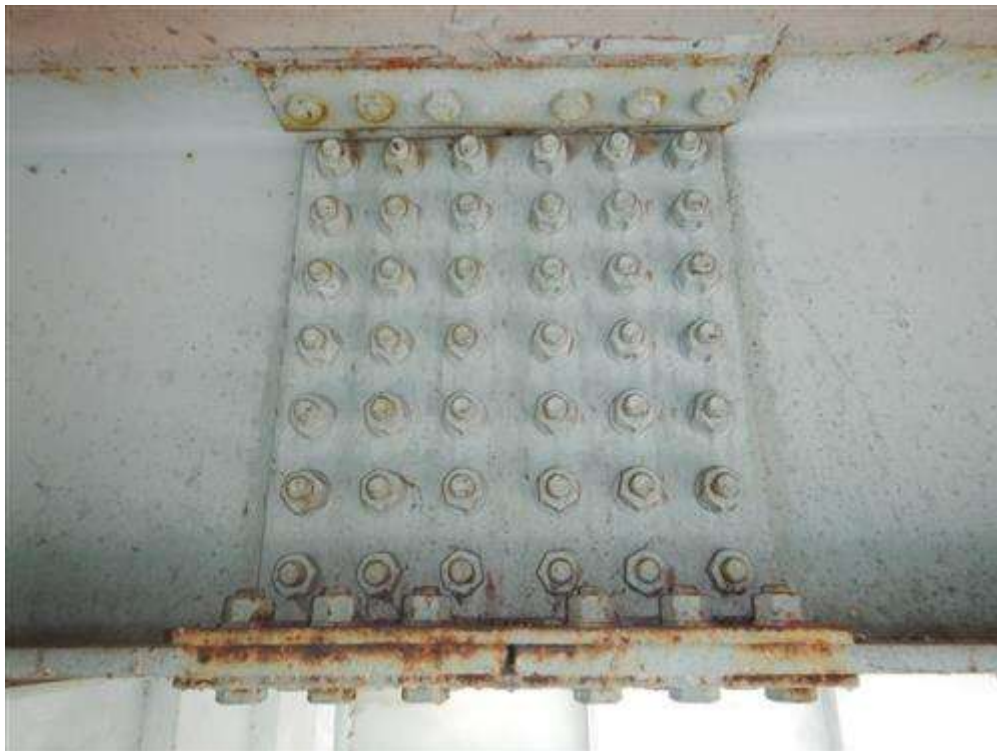
Photo Number: 40

Note: Up to 1/4" pack rust between bottom flange and bottom splice plate.

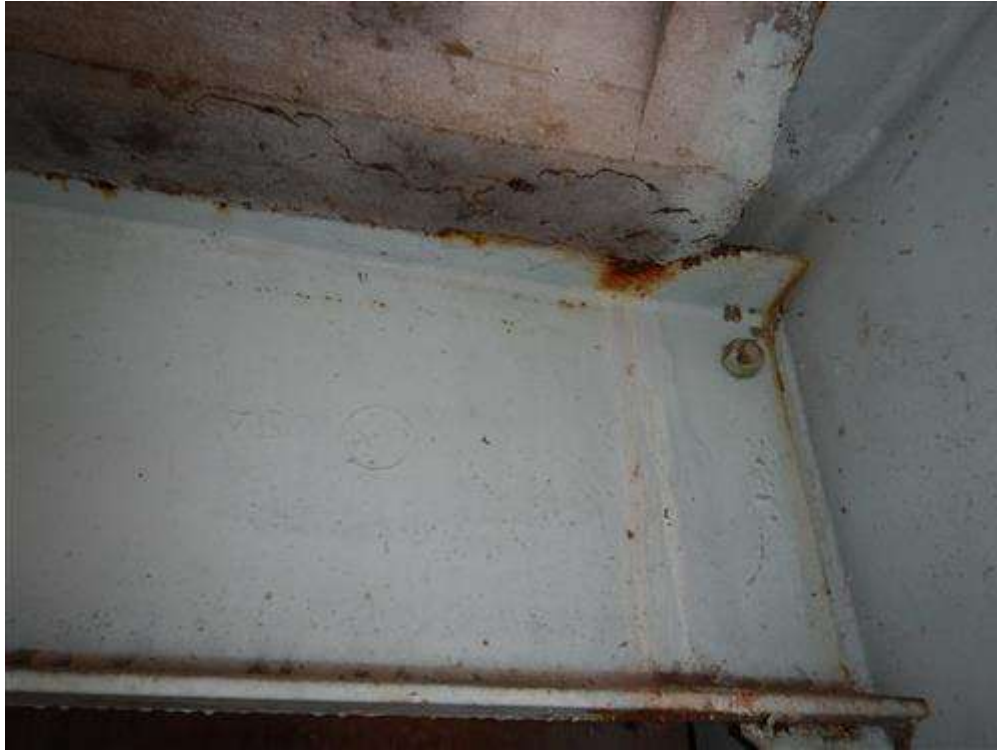
Photo Number: 45

Stringer Connection to Floor Beam 29

Note: S3 - S6 bottom two bolts are missing with holes plug welded.

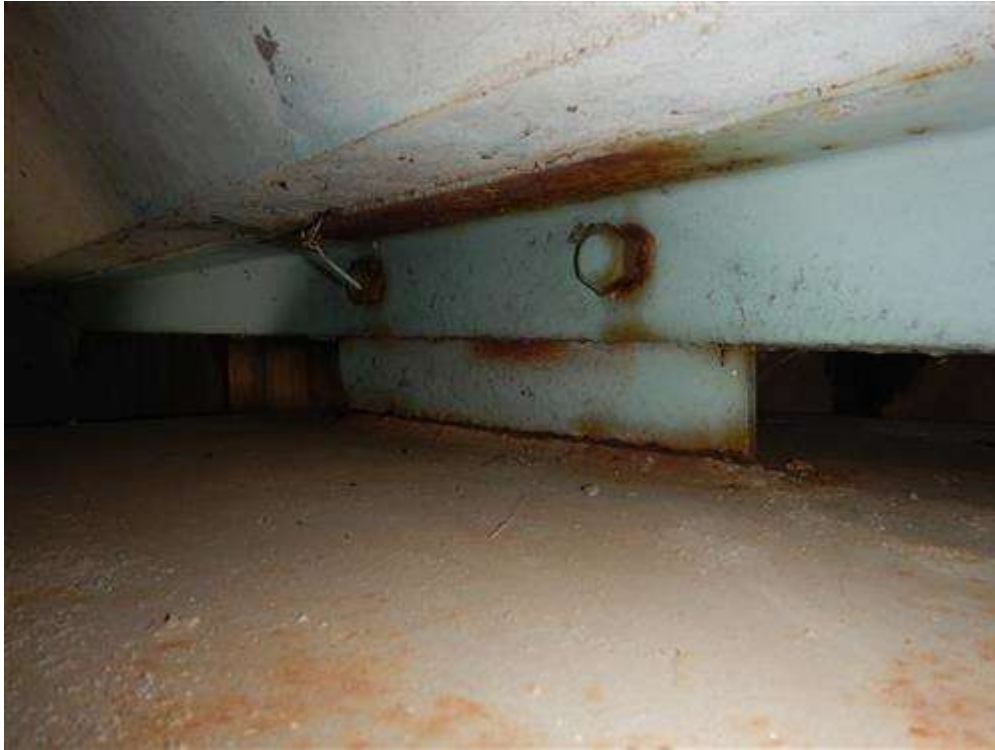
Photo Number: 51

Floor Beam 1 at Girder 1

Note: Full length broken weld at vertical tie plate between girder 1 top flange and diaphragm.

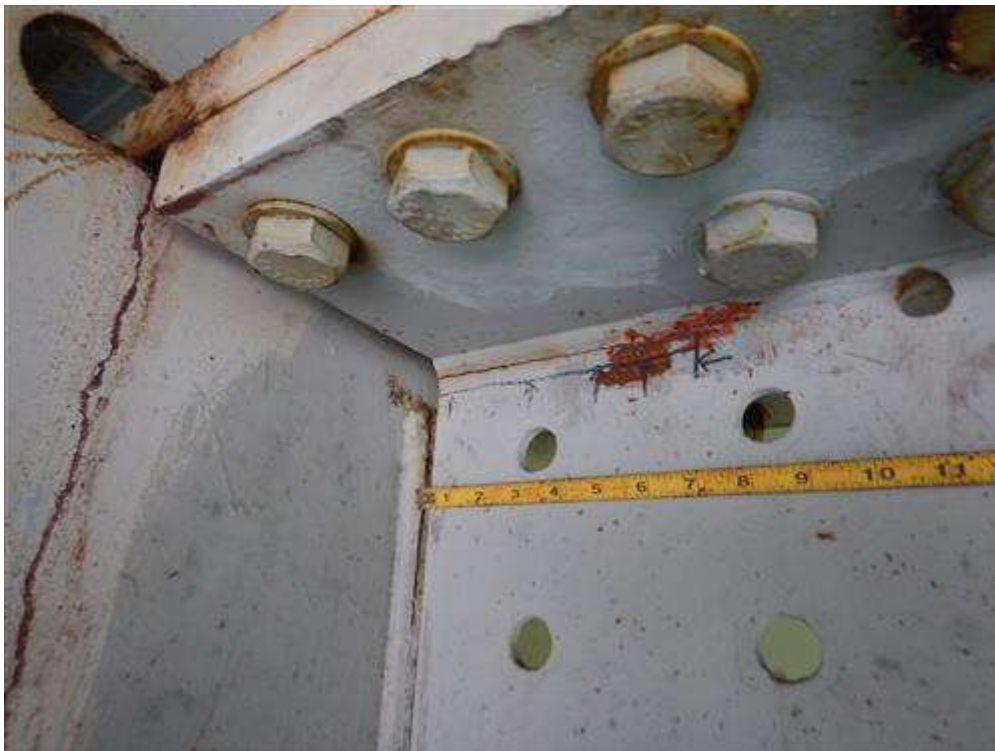
Photo Number: 52

Note: 6-3/4" crack between top flange and floor beam web.

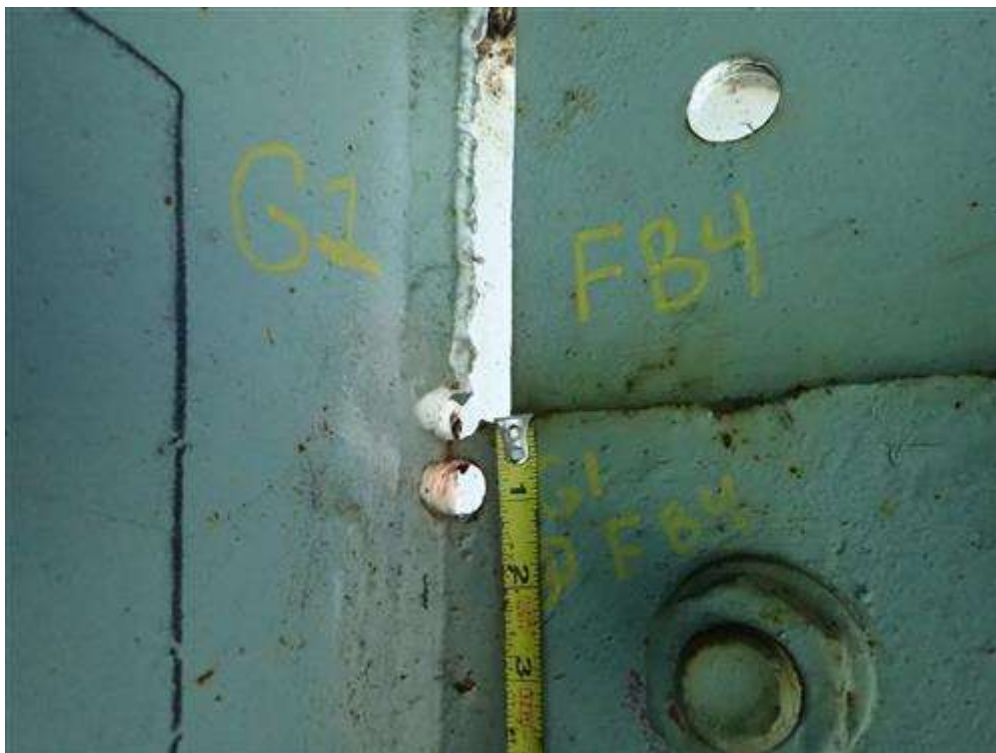
Photo Number: 54

Note: 1/2" long crack ends in stopper hole.

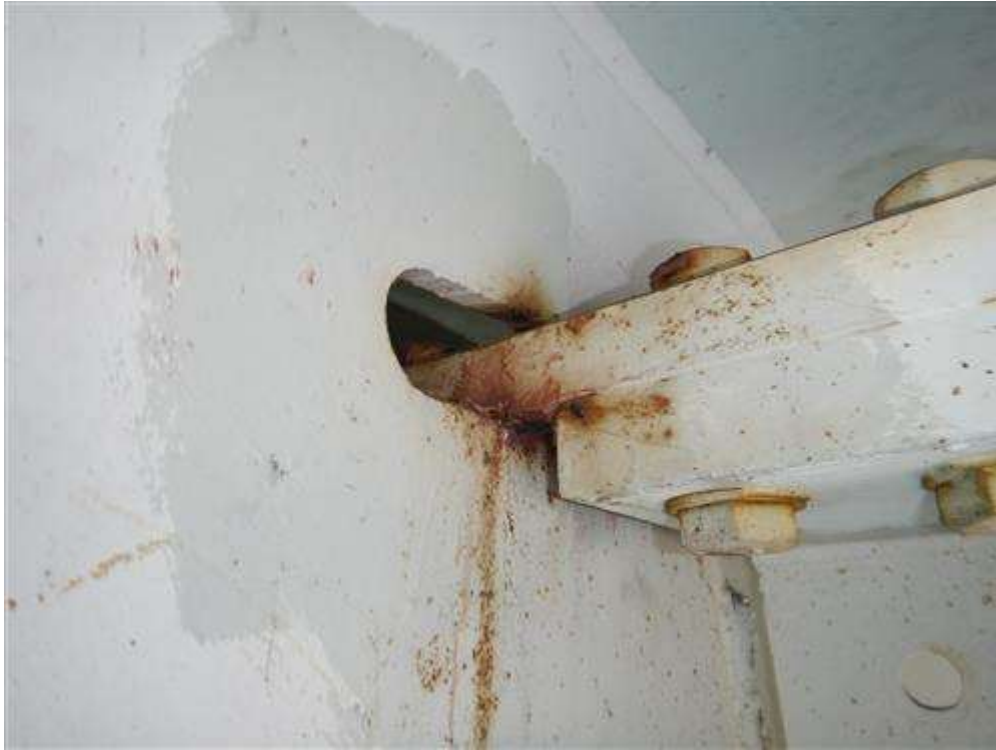
Photo Number: 55

Floor Beam 5 at Girder 1

Note: Broken tack weld between girder web at cut out and tie plate.

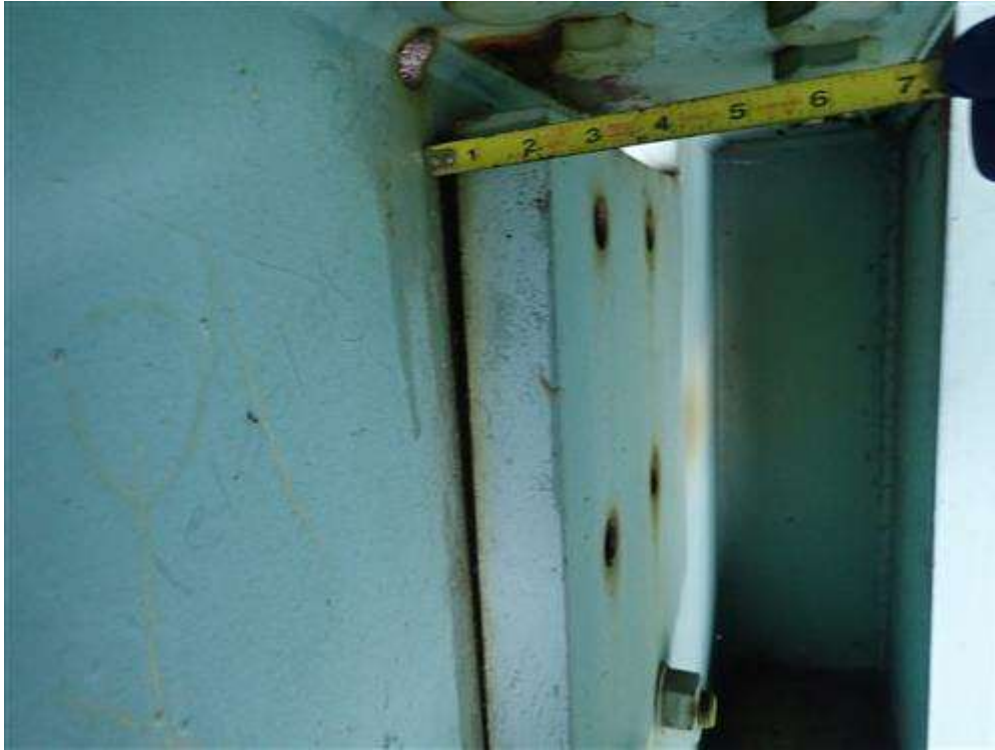
Photo Number: 57

Floor Beam 7 Web at Girder 2

Note: 3/8" gap between connection plate at web.

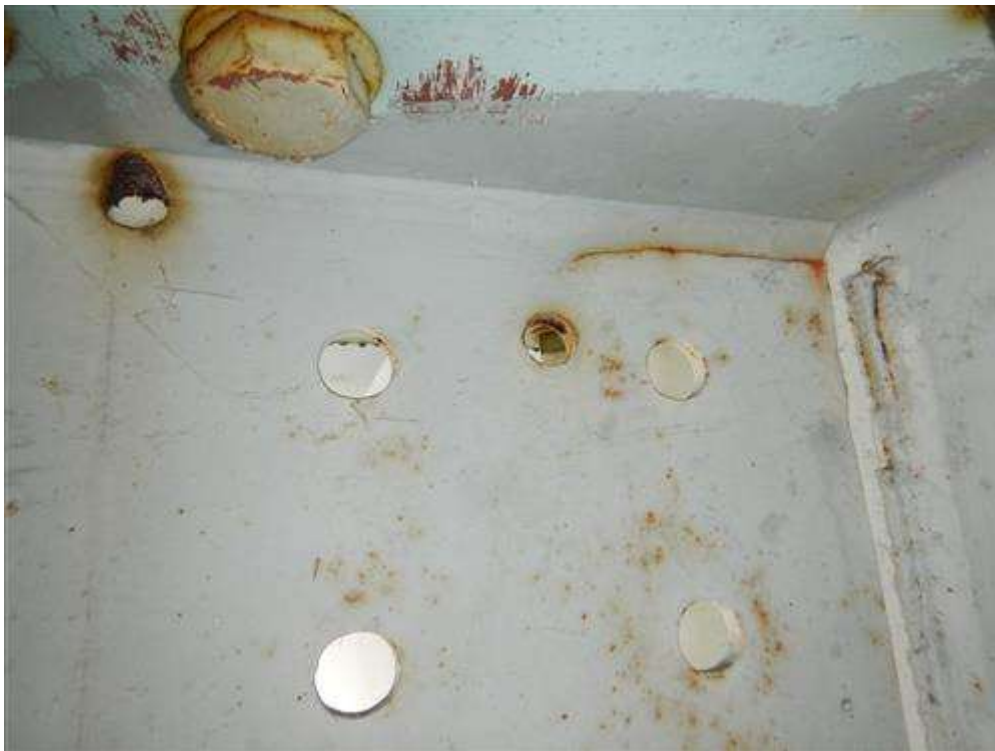
Photo Number: 58

Note: 2-1/2" vertical crack on connection plate weld and 5-7/8" horizontal crack on floor beam to top flange weld.

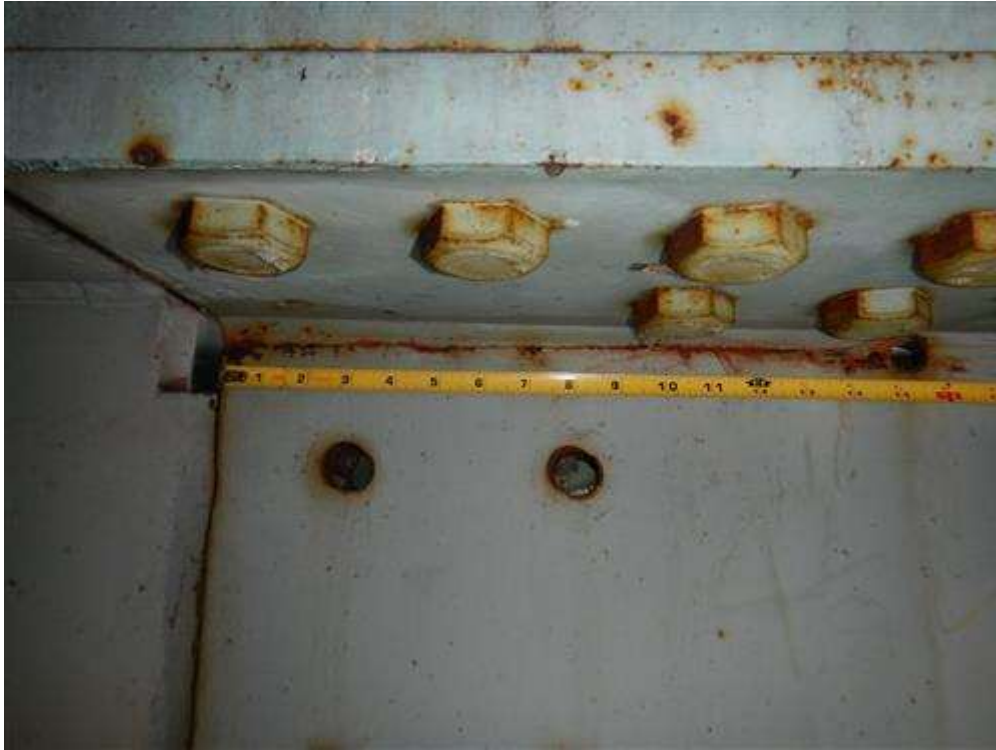
Photo Number: 59

Floor Beam 15 South Face at Girder 1

Note: 14-1/4" long crack between top flange and floor beam web with stop hole.

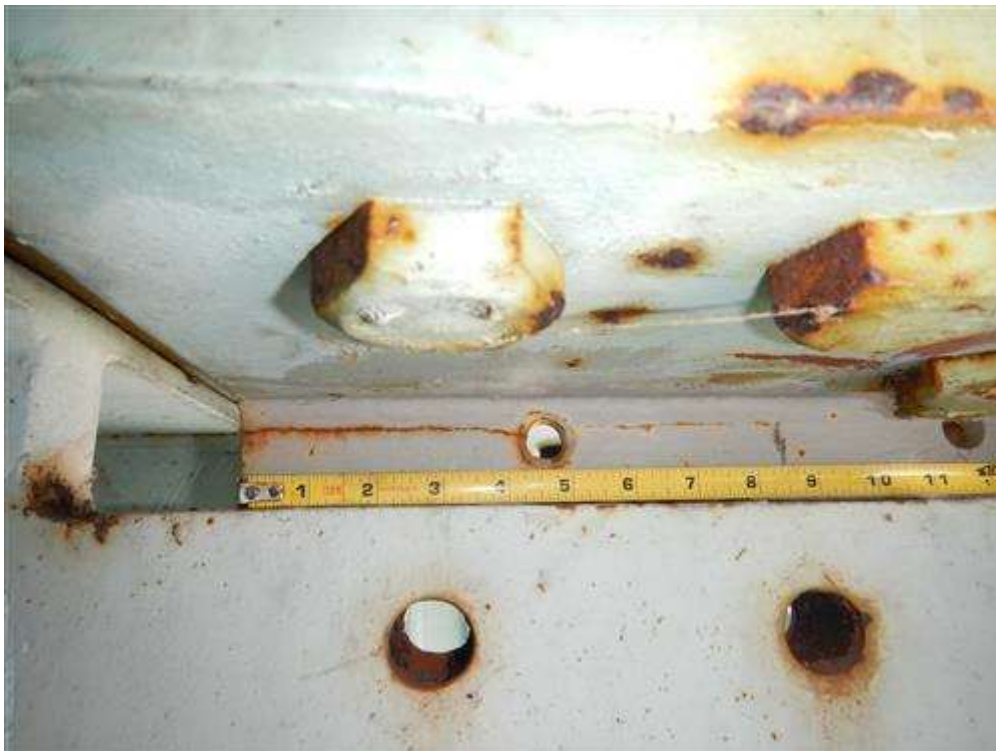
Photo Number: 60

Note: 8-1/4" long crack between top flange and floor beam web.
