## BRIDGE NO.04180

52980 - NEWTOWN  
INTERSTATE 84 WESTBOUND  
over  
HOUSATONIC RIVER

Fracture Critical and Routine Inspection

9/12/2018

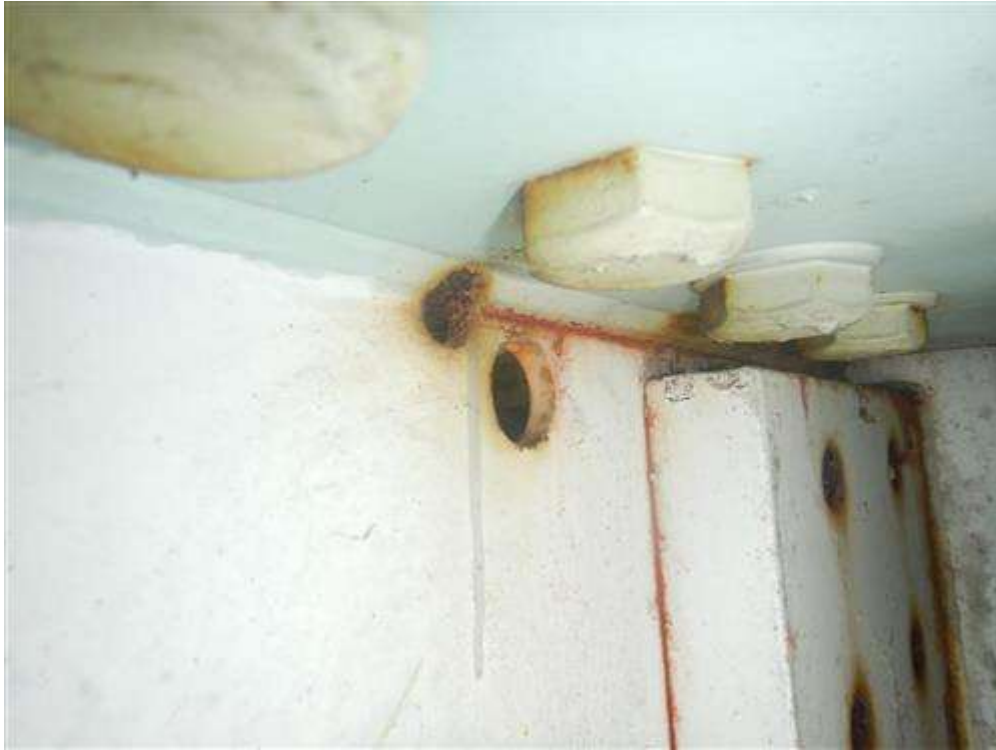
Photo Number: 61

Floor Beam 15 Right Cantilever at Girder 2

Note: 15" long crack between top flange and floor beam web.

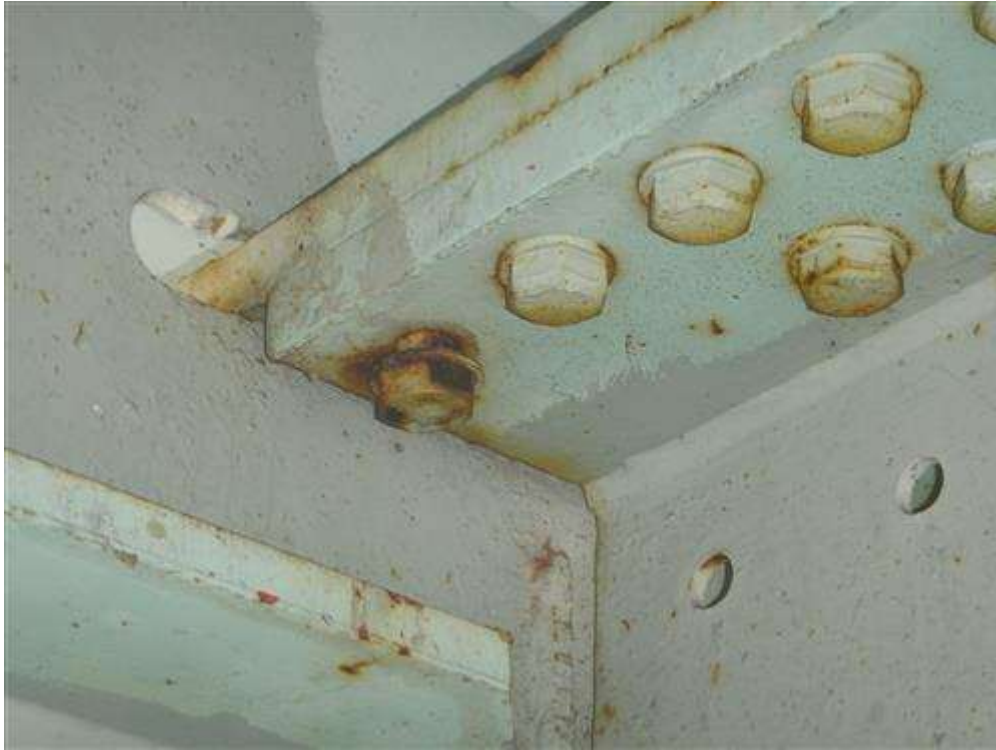
Photo Number: 63

Floor Beam 19 Top Flange Tie Plate at Girder 1

Note: Loose bolt with moderate rust and floor beam web is bowed 1/2".

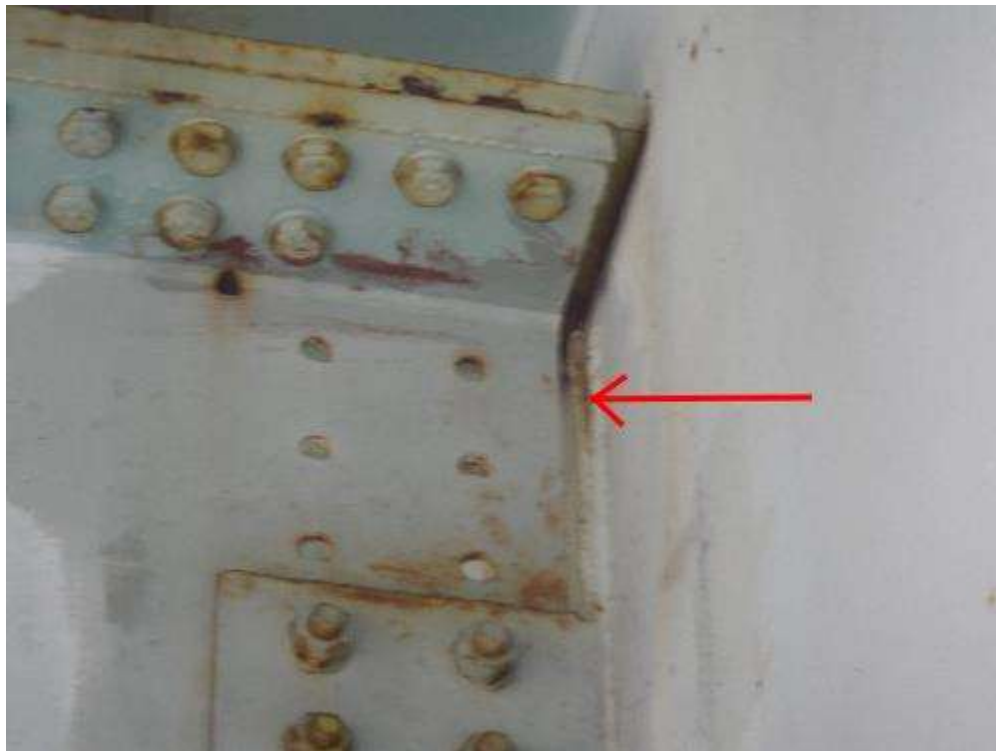
Photo Number: 64

Note: Connection plate weld at removed section has a 4" long vertical separation / crack that does not propagate into web.

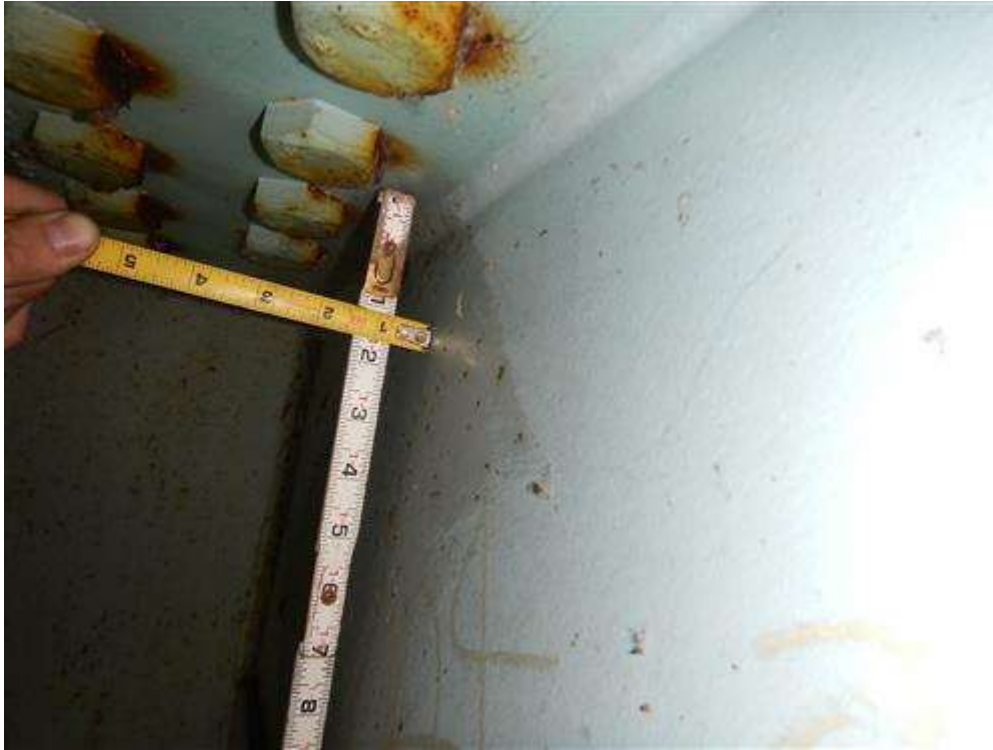
Photo Number: 65

Floor Beam 25 at Girder 1

Note: Web bowed 1/2" at top.

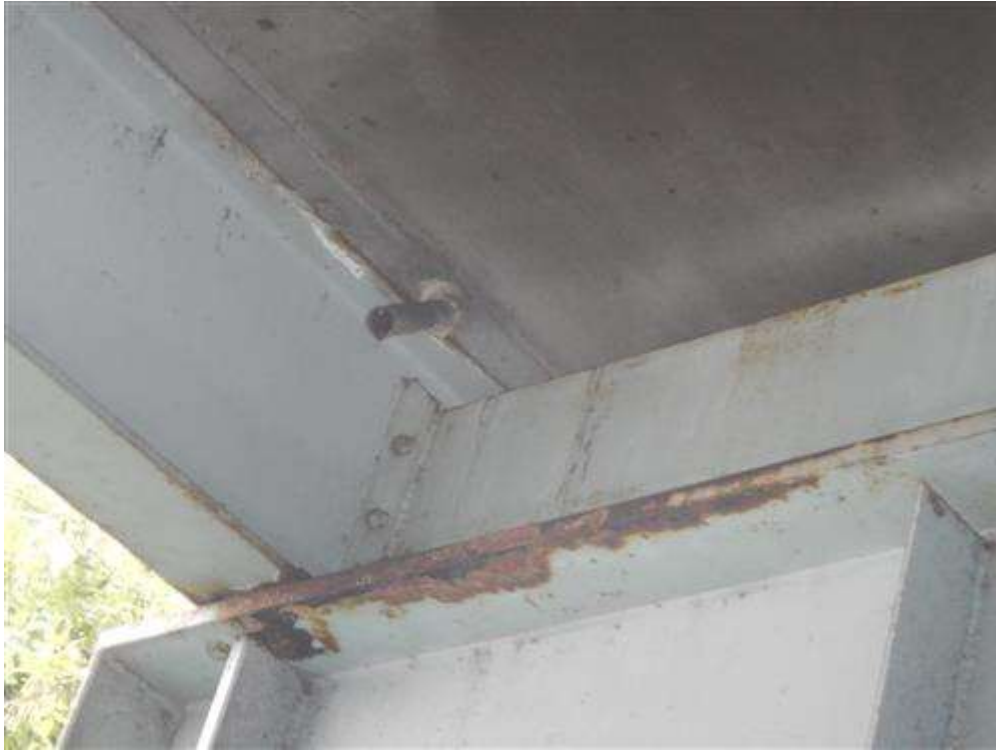
Photo Number: 67

Floor Beam 27 Left Overhang

Note: 3' long laminar rust with up to 1/16" deep pitting.

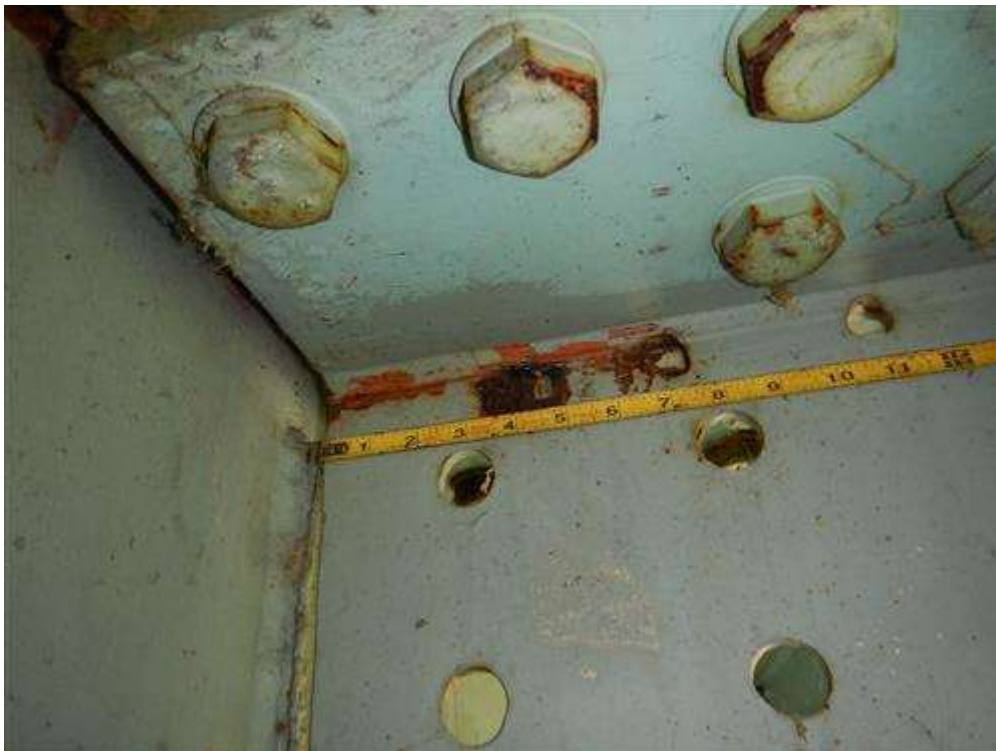
Photo Number: 68

Note: 7" long crack between top flange and floor beam web with stop hole.

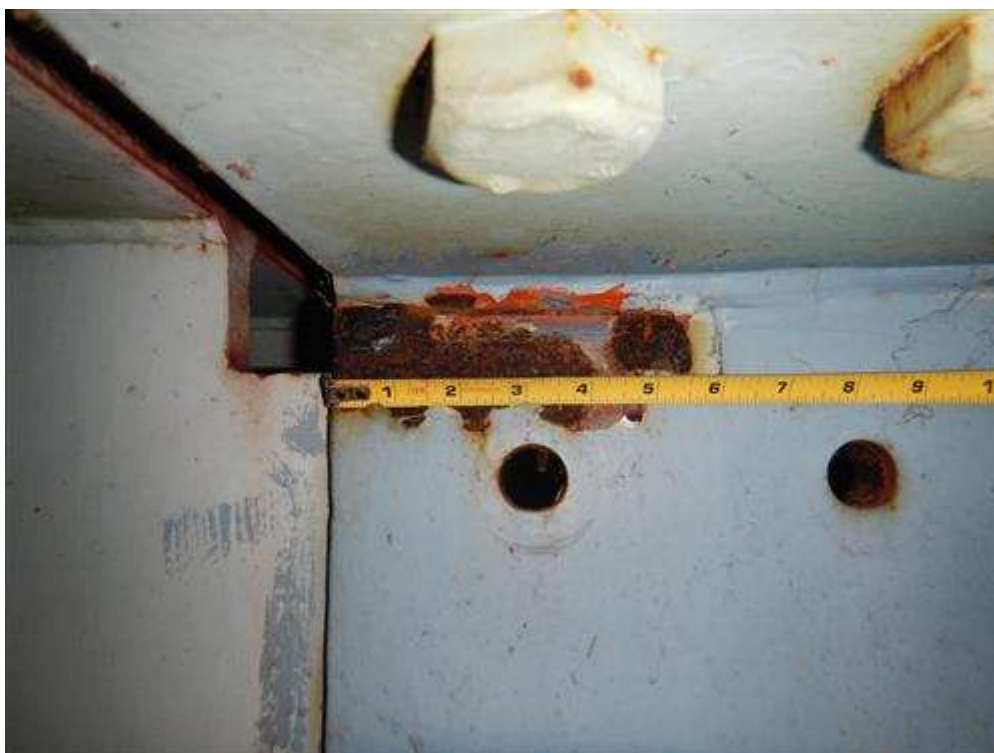
Photo Number: 70

Note: 3-3/8" crack in fillet weld between web and top flange.

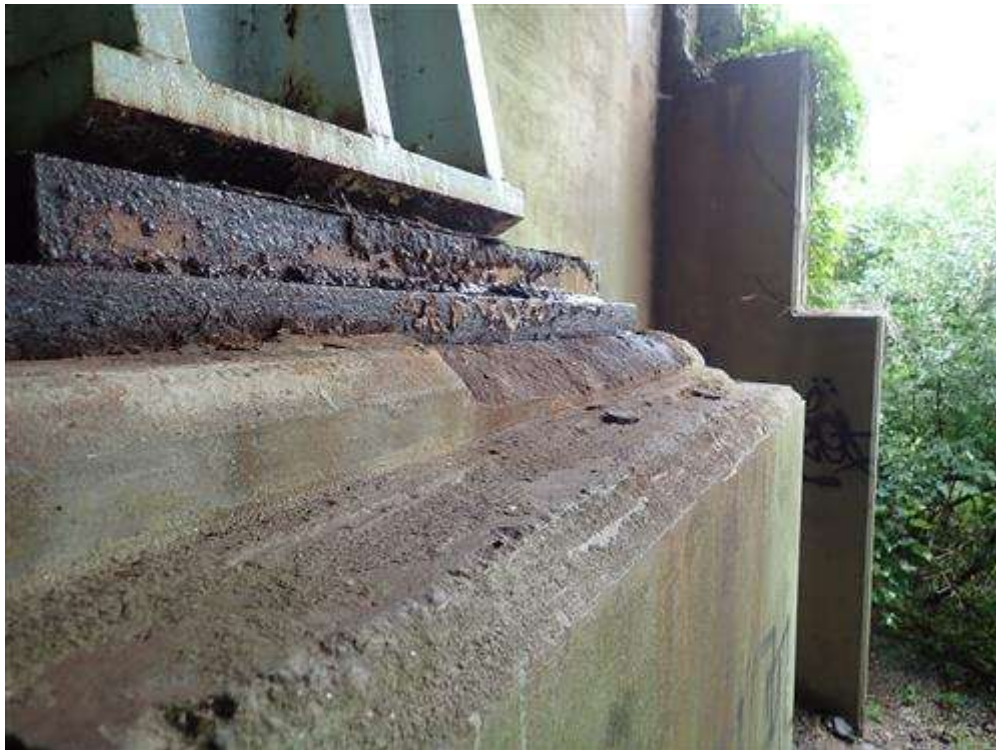
Photo Number: 72

Note: Spall.

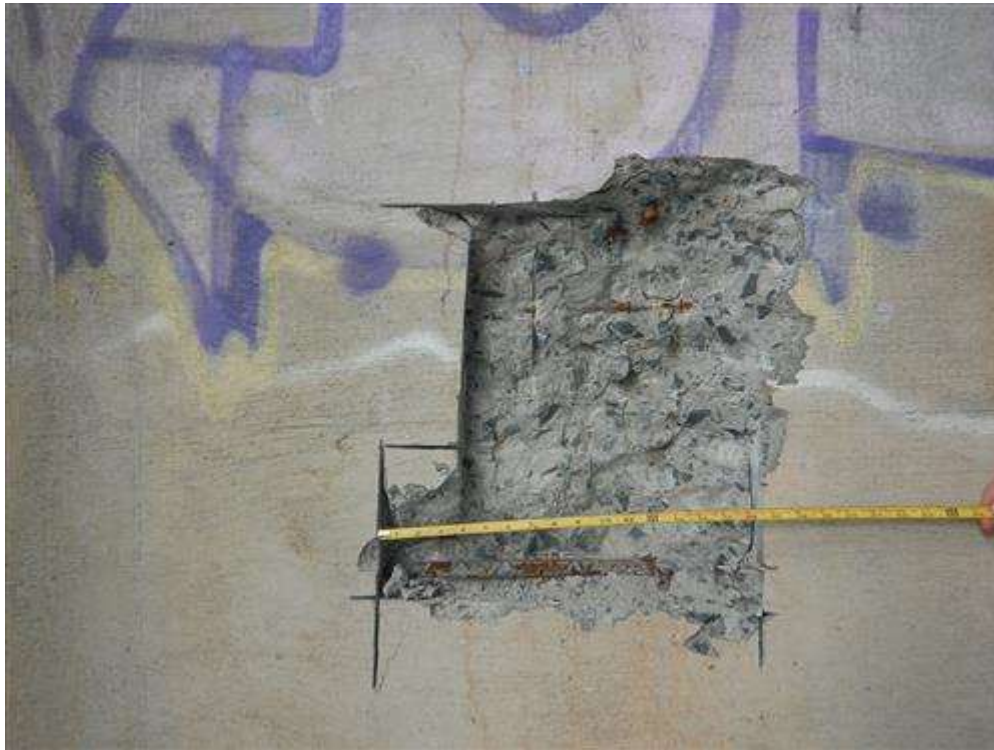
Photo Number: 75

Abutment 2 Near Girder 1 Pedestal

Note: 17" long x 18" high x up to 3-1/2" deep cut out / spall.
